NL/2020/05 Photographic record (Monthly Monitoring Report for Preservation of Plant Species of Conservation Importance – Nov 2023)

Tree Schedule for Survey of Plant Species of Conservation Importance

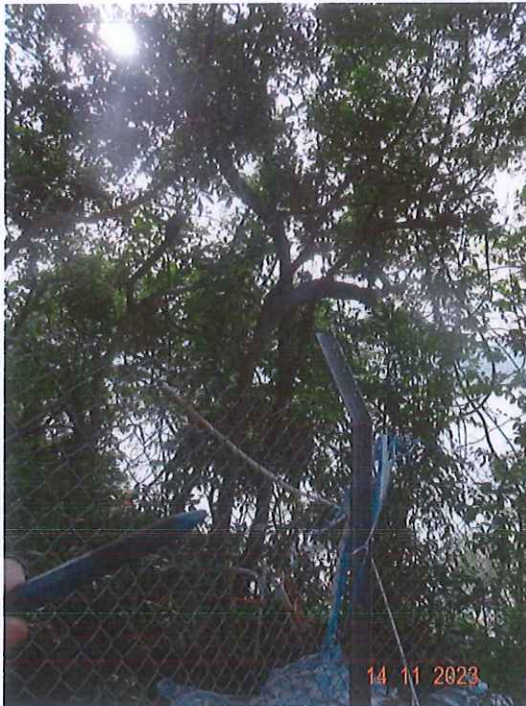
1: T8217

| Tree No. | Species | | | Measurements | | | Amenity Value (High(H) / Medium (M) / Low(L)) | Tree Condition (Good(G) / Average(A) / Poor(P)) | | | Recommendation (Retain / Transplant / Remove) | Findings | Remark |
|---|---|---|---|---|---|---|--|---|---|---|--|--|--|
| T8217 | <i>Canthium dicoccum</i> | 魚骨木 | IUCN:VU | 9 | 220 | 6 | L | P | A | P | Retain | No Particular Observation | There is no proper and safe assess towards T8231 & T8217, thus, plastics barriers were installed in lieu of 2m high barrier. |

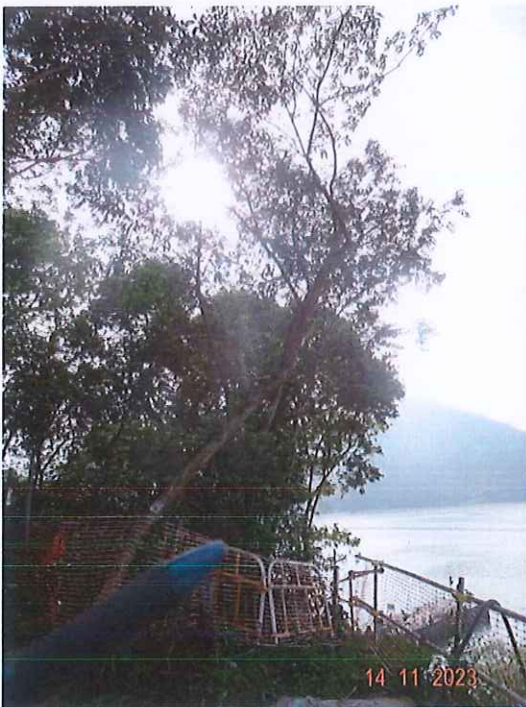
3: T8231

| Tree No. | Species | | | Measurements | | | Amenity Value (High(H) / Medium (M) / Low(L)) | Tree Condition (Good(G) / Average(A) / Poor(P)) | | | Recommendation (Retain / Transplant / Remove) | Findings | Remark |
|---|---|---|---|---|---|---|--|---|---|---|--|--|--|
| T8231 | <i>Canthium dicoccum</i> | 魚骨木 | IUCN:VU | 7 | 190 | 6 | L | P | A | P | Retain | No Particular Observation | There is no proper and safe assess towards T8231 & T8217, thus, plastics barriers were installed in lieu of 2m high barrier. |

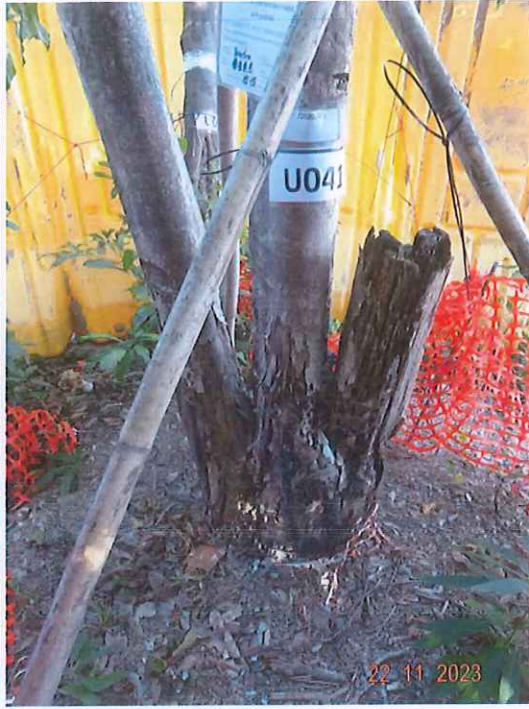
6: U041_Dead stump

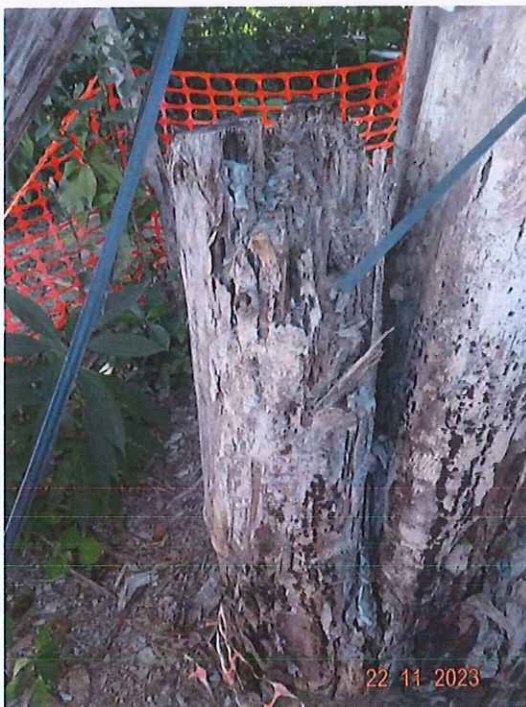
7: U041_Wood damage at trunk union

| Tree No. | Species | | | Measurements | | | Amenity Value (High(H) / Medium (M) / Low(L)) | Tree Condition (Good(G) / Average(A) / Poor(P)) | | | Recommendation (Retain / Transplant / Remove) | Findings | Remark |
|---|---|---|---|---|---|---|--|---|---|---|--|--|--|
| U041 | <i>Aquilaria sinensis</i> | 土沉香 | RPPHK; Cap.586; IUCN:VU | 10 | 318 | 4 | M | A | P | A | Retain | No obvious old termite track was found, damage of wood tissue was observed. Application of termiticide is recommended. | Located closed to cut slope and fenced off by 2m high barrier. Application of termiticide was conducted on 28 November 2023. |

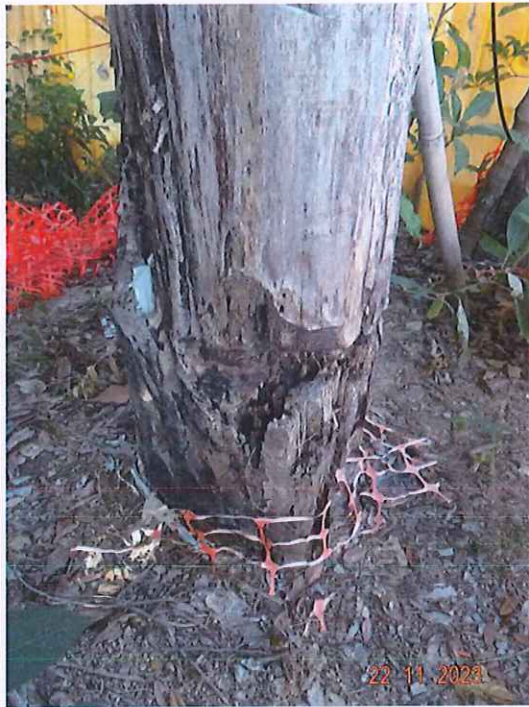
8: U041_Wood damaged by termite

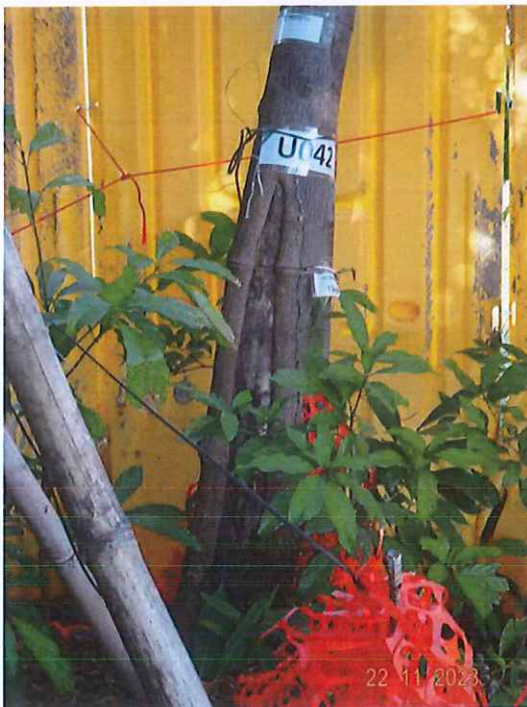
11: U042_Wound on trunk

| Tree No. | Species | | | Measurements | | | Amenity Value (High(H) / Medium (M) / Low(L)) | Tree Condition (Good(G) / Average(A) / Poor(P)) | | | Recommendation (Retain / Transplant / Remove) | Findings | Remark |
|---|---|---|---|---|---|---|--|---|---|---|--|--|--|
| U042 | <i>Gmelina chinensis</i> | 石梓 | RPPHK | 6 | 150 | 2 | M | A | P | A | Retain | Large wound near trunk base with wound wood development. Application of insecticide is recommended. | Located closed to cut slope and fenced off by 2m high barrier. Application of insecticide was conducted on 28 November. |

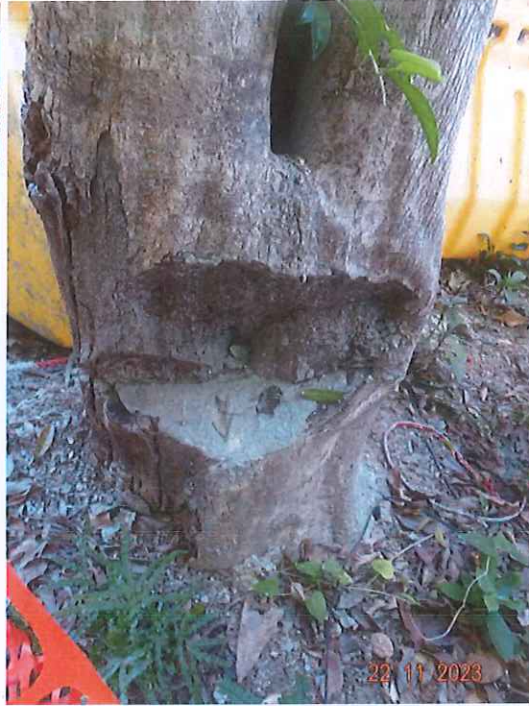
14: U043_Wound on trunk#1

| Tree No. | Species | | | Measurements | | | Amenity Value (High(H) / Medium (M) / Low(L)) | Tree Condition (Good(G) / Average(A) / Poor(P)) | | | Recommendation (Retain / Transplant / Remove) | Findings | Remark |
|---|---|---|---|---|---|---|--|---|---|---|--|--|--|
| U043 | <i>Aquilaria sinensis</i> | 土沉香 | RPPHK; Cap.586; IUCN:VU | 9 | 310 | 4 | M | A | P | A | Retain | Fungal fruiting bodies near trunk base. Application of fungicide is recommended. | Located closed to cut slope and fenced off by 2m high barrier. Application of fungicide was conducted on 28 November 2023. |

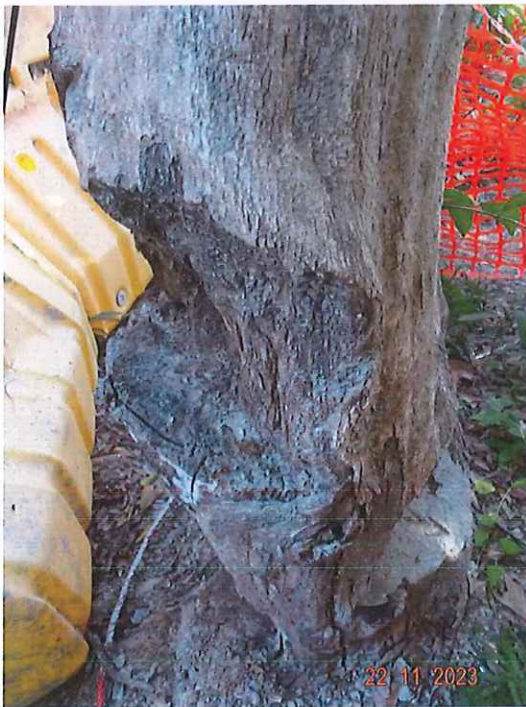
15: U043_Wound on trunk#2
