Tree Schedule for Survey of Plant Species of Conservation Importance

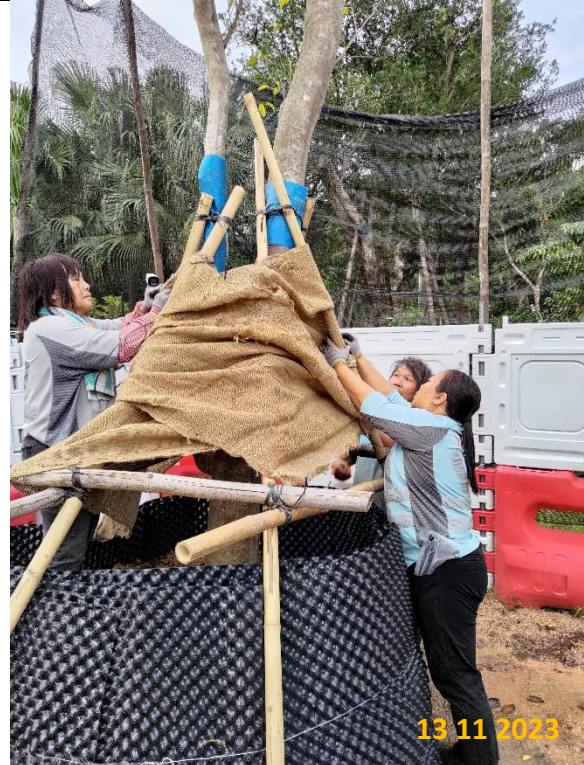
Trunk protection wrapping was adjusted away from the trunks on 13 Nov 2023. Slightly fertilizing was performed.

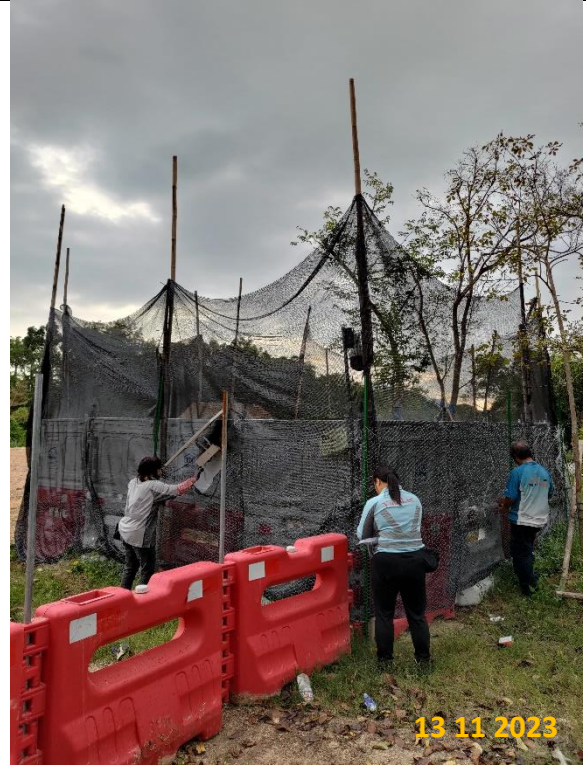
Additional shading net was installed

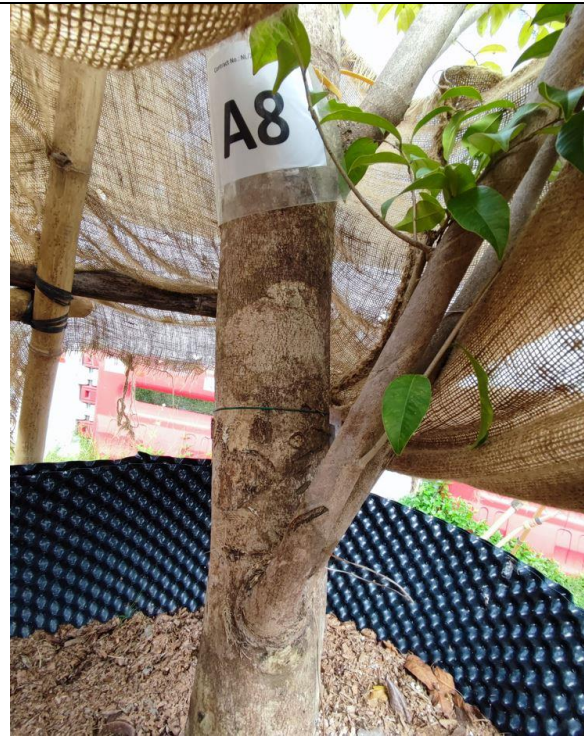
Original hessian fabrics wrapping around the trunk was removed – A8

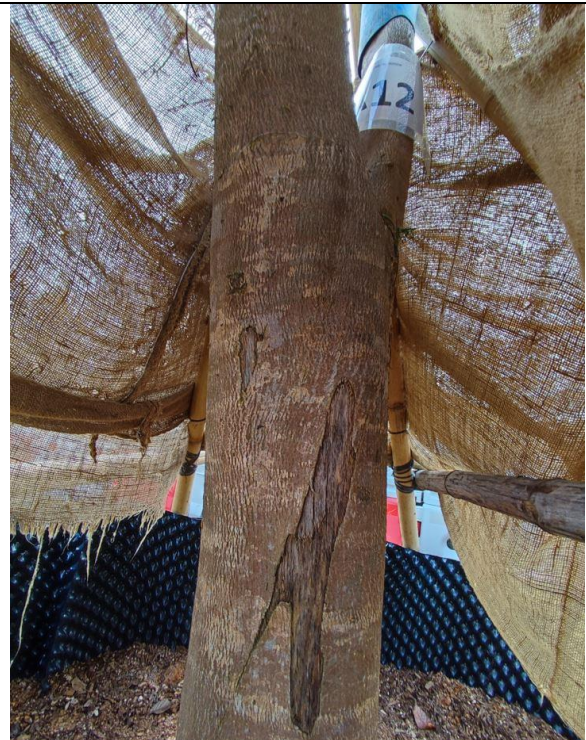
Original hessian fabrics wrapping around the trunk was removed – A12

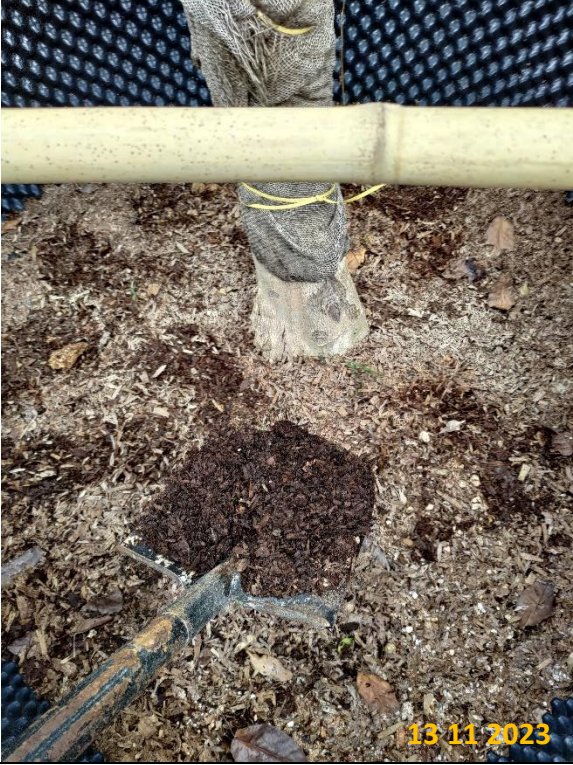
<p>Supplement mulching materials (Compost) for both A8 and A12</p>	<p>Slight fertilizing for both A8 and A12</p>

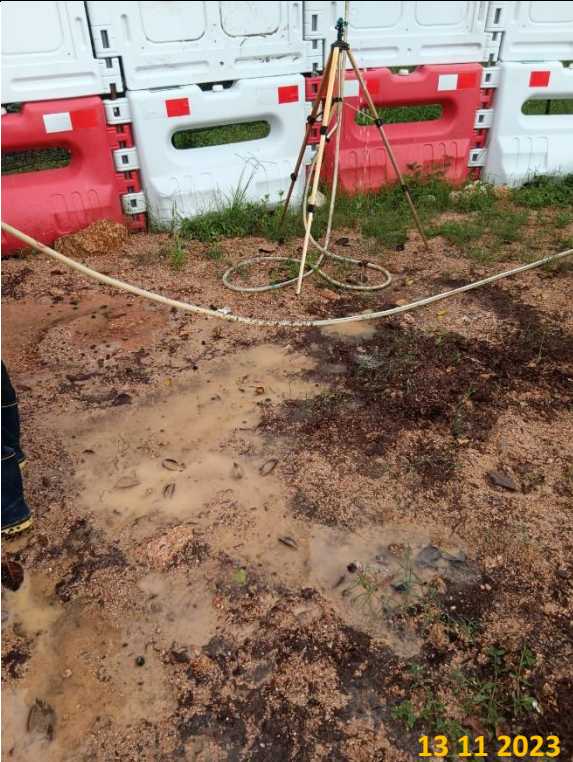
<p>13 11 2023</p>
<p>The semiautomatic irrigation was checked and is in order. Current watering frequency is three times per week</p>	<p>CCTV and fencing are in order</p>
