Tree Schedule for Survey of Plant Species of Conservation Importance

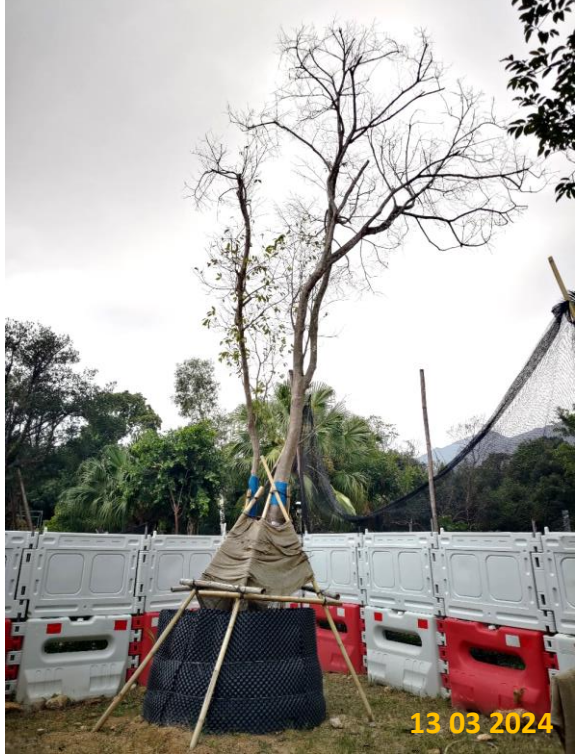
<p>A8 – Overall view</p>	<p>A8 – Foliage density was similar comparing to last inspection photos.</p>
  <p>A photograph showing a young tree (A8) supported by a wooden tripod frame. The tree is wrapped in a dark, patterned protective netting. A burlap sack is draped over the top of the frame. The tree is situated in a construction area with white and red plastic barriers in the background. A date stamp '13 03 2024' is visible in the bottom right corner.</p>	  <p>A close-up photograph of the foliage of tree A8, showing dense green leaves against a cloudy sky. A date stamp '13 03 2024' is visible in the bottom right corner.</p>
<p>A8 – Pruning wound previously damaged by typhoon KOINU (Oct 2023)</p>	<p>A8 – trunk condition.</p>
  <p>A close-up photograph of a pruning wound on the trunk of tree A8. The wound is a deep, vertical cut in the bark, showing a lighter-colored inner layer. A date stamp '13 03 2024' is visible in the bottom right corner.</p>	  <p>A close-up photograph of the trunk of tree A8, showing the wooden tripod support structure and the protective netting. A date stamp '13 03 2024' is visible in the bottom right corner.</p>

<p>A12 - Overall View</p>	<p>A12 – Foliage density is low since its collapse during Typhoon KOINU. The foliage density unchanged in current inspection.</p>

<p>A photograph showing a tree with sparse foliage. The base of the tree is protected by a structure made of bamboo poles, a black mesh, and a burlap sack. The tree is situated behind a row of white and red plastic barriers. A date stamp '13 03 2024' is visible in the bottom right corner.</p>	  <p>A photograph showing a close-up of the tree's canopy, which appears thin and sparse. The tree trunk is visible. A date stamp '13 03 2024' is visible in the bottom right corner.</p>
<p>A12 – Codominant branch with included bark</p>	<p>A12 – trunk and root condition</p>
  <p>A photograph showing a close-up of a branch with a visible inclusion bark, indicating a potential weak point. The branch is dark and has some sparse green leaves. A date stamp '13 03 2024' is visible in the bottom right corner.</p>	  <p>A photograph showing the base of the tree where the trunk meets the ground. The trunk is supported by a protective structure of bamboo poles and mesh. A date stamp '13 03 2024' is visible in the bottom right corner.</p>

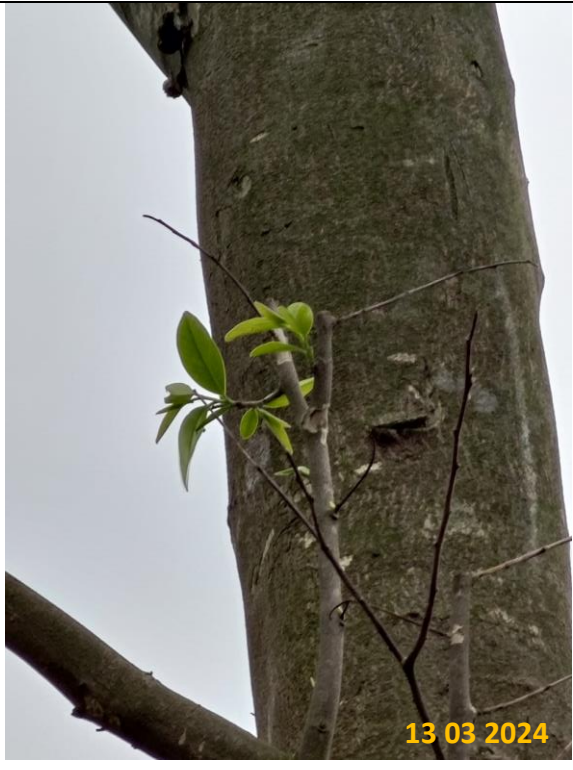
<p>A8 – A few new shoots were observed</p>	<p>A12 – A few new shoots were observed</p>

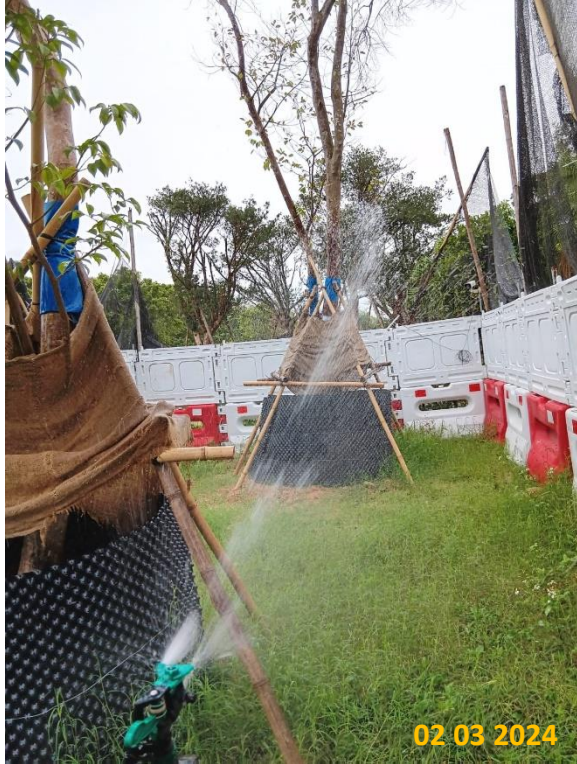
<p>Manual watering was carried out for A8 during the reporting period. The watering frequency is three time per week (will be adjusted due to wet season came).</p>	<p>Manual watering was carried out for A12 during the reporting period. The watering frequency is three time per week (will be adjusted due to wet season came).</p>

The semiautomatic irrigation was checked and is in order. The watering frequency is three times per week (will be adjusted due to wet season came).

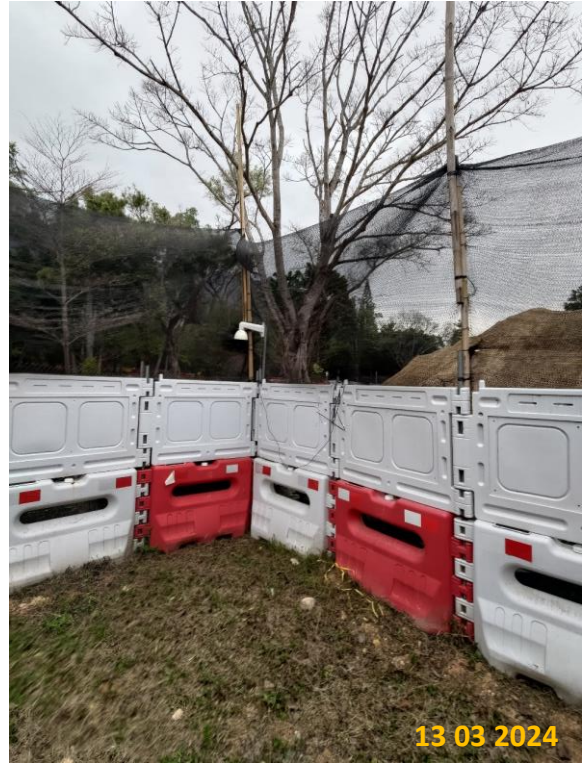
CCTV and fencing are in order
