Tung Chung New Town Extension – Site Formation and Infrastructure Works at Tung Chung Valley, Phase 1

Tree Schedule for Survey of Plant Species of Conservation Importance

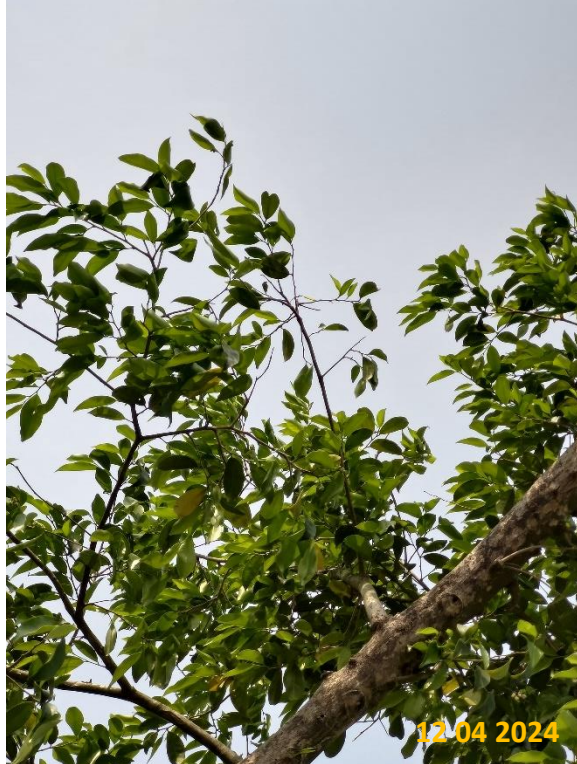
<p>A8 – Overall view</p>	<p>A8 – Foliage density was increased comparing to last inspection photos.</p>
  <p>A wide-angle photograph of tree A8. The tree is supported by a black mesh cage and wooden stakes. In the background, there are white and red plastic barriers and other trees. A date stamp '12 04 2024' is visible in the bottom right corner.</p>	  <p>A close-up photograph of the upper part of tree A8, showing a dense canopy of green leaves. A date stamp '12 04 2024' is visible in the bottom right corner.</p>
<p>A8 – Pruning wound previously damaged by typhoon KOINU (Oct 2023)</p>	<p>A8 – trunk condition.</p>
  <p>A close-up photograph of the trunk of tree A8, showing a large, irregular pruning wound. The wound is surrounded by green foliage. A date stamp '12 04 2024' is visible in the bottom right corner.</p>	  <p>A close-up photograph of the trunk of tree A8, showing the trunk condition. The trunk is supported by wooden stakes and a black mesh cage. A date stamp '12 04 2024' is visible in the bottom right corner.</p>

A8 – A few new shoots were observed. The tree is flowering.

Manual watering was carried out for A8 during the reporting period. The watering frequency is one to two times per week.

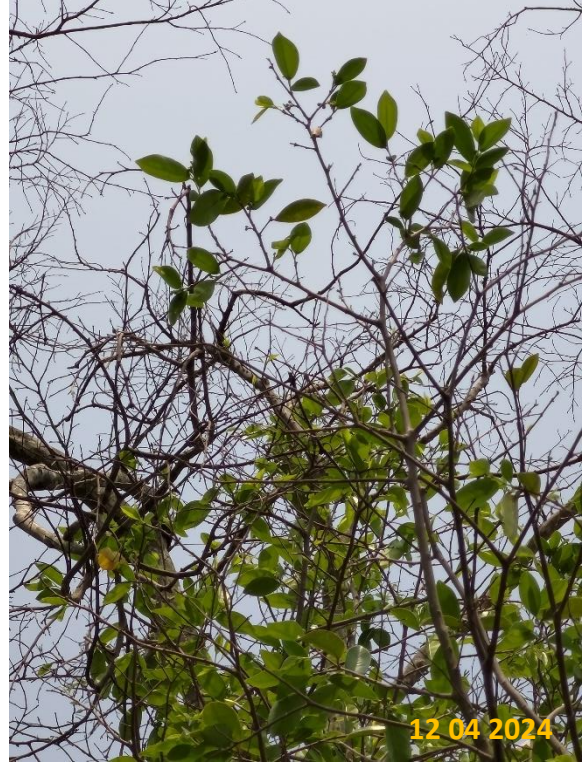
<p>A12 - Overall View</p>	<p>A12 – Foliage density is low since its collapse during Typhoon KOINU. The foliage density increased in current inspection.</p>
  <p>A photograph showing a tree with a support structure made of bamboo poles and a black mesh cage around its base. The tree is situated behind a row of white and red plastic barriers. The date '12 04 2024' is visible in the bottom right corner.</p>	  <p>A photograph showing a close-up of the tree's canopy, highlighting the increased foliage density. The date '12 04 2024' is visible in the bottom right corner.</p>
<p>A12 – Codominant branch with included bark</p>	<p>A12 – trunk and root condition</p>
  <p>A photograph showing a close-up of a codominant branch with included bark. The date '12 04 2024' is visible in the bottom right corner.</p>	  <p>A photograph showing a close-up of the tree's trunk and root condition, highlighting the support structure. The date '12 04 2024' is visible in the bottom right corner.</p>

A12 – A few new shoots were observed. The tree is flowering.

Manual watering was carried out for A12 during the reporting period. The watering frequency is one to two times per week.
