Tung Chung New Town Extension – Site Formation and Infrastructure Works at Tung Chung Valley, Phase 1

**Tree Schedule for Survey of Plant Species of Conservation Importance**

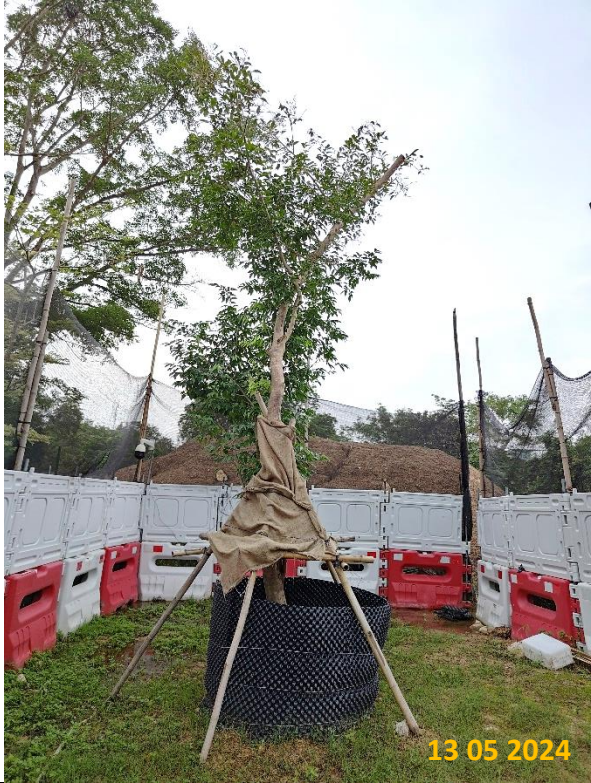
<p>A8 – Overall view</p>	<p>A8 – Foliage density was increased comparing to last inspection photos.</p>

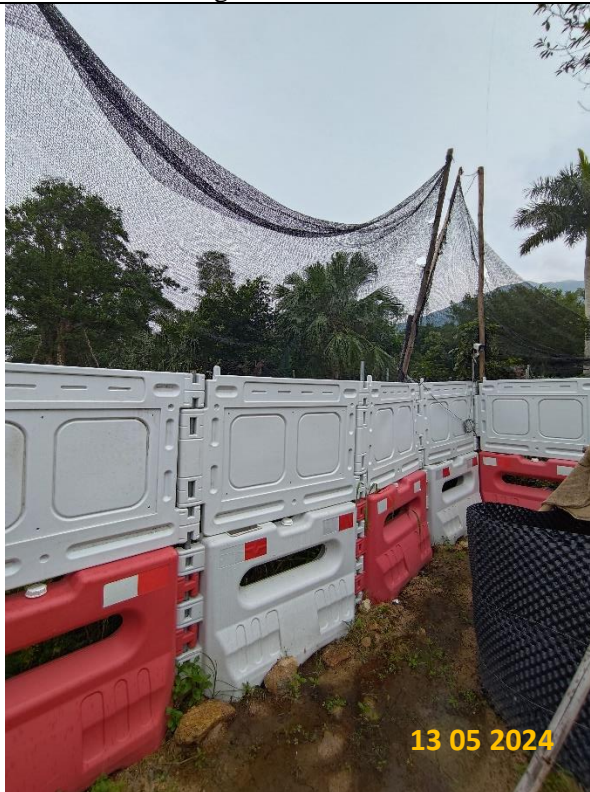
CCTV and fencing are in order
