Tung Chung New Town Extension – Site Formation and Infrastructure Works at Tung Chung Valley, Phase 1

Tree Schedule for Survey of Plant Species of Conservation Importance

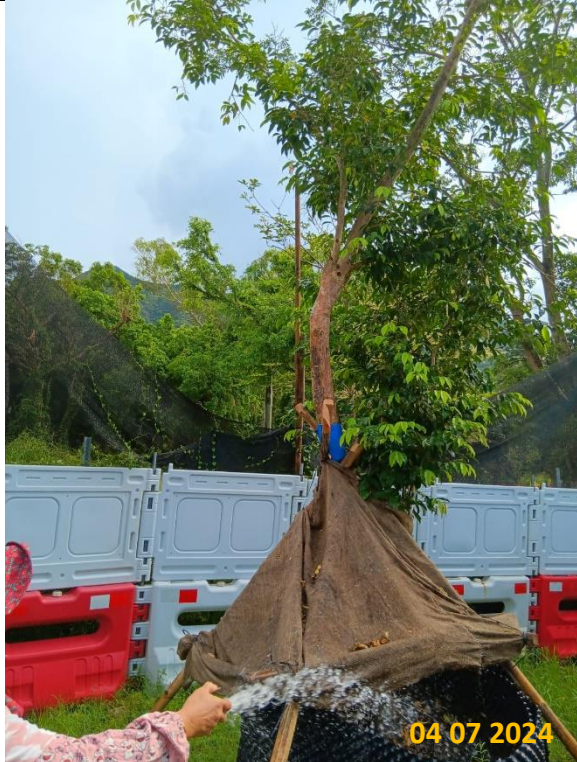
<p>A8 – Overall view</p>   <p>05 07 2024</p> <p>This photograph shows tree A8 in its entirety, supported by a tripod of wooden poles. The tree is situated in a grassy area enclosed by a white and red plastic safety fence. In the background, other trees and a blue sky with scattered clouds are visible.</p>	<p>A8 – Crown condition</p>   <p>05 07 2024</p> <p>This close-up photograph focuses on the upper portion of tree A8, showing its dense, green canopy of leaves against a cloudy sky.</p>
<p>A8 – Pruning wound previously damaged by typhoon KOINU (Oct 2023)</p>   <p>05 07 2024</p> <p>This close-up photograph shows a specific pruning wound on the trunk of tree A8. The wound is a clean, vertical cut in the bark, showing the underlying wood.</p>	<p>A8 – Trunk and root condition.</p>   <p>05 07 2024</p> <p>This photograph shows the base of tree A8, including its trunk and the root collar. The tree is supported by a tripod of wooden poles, and a black mesh net is wrapped around the base of the trunk for protection.</p>

Manual watering was carried out for A8 during the reporting period. The watering frequency is one to two times per week.

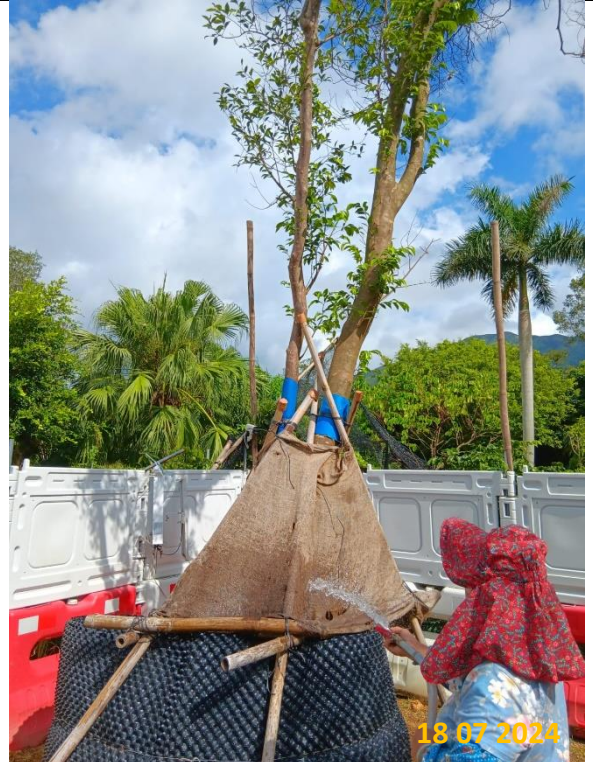
<p>A8 – Fruiting</p>	<p>A12 - Overall View</p>
  <p>05 07 2024</p>	  <p>05 07 2024</p>
<p>A12 – Foliage density is low since its collapse during Typhoon KOINU. Dieback observed.</p>	<p>A12 – Trunk and root condition</p>
  <p>05 07 2024</p>	  <p>05 07 2024</p>

Manual watering was carried out for A12 during the reporting period. The watering frequency is one to two times per week.

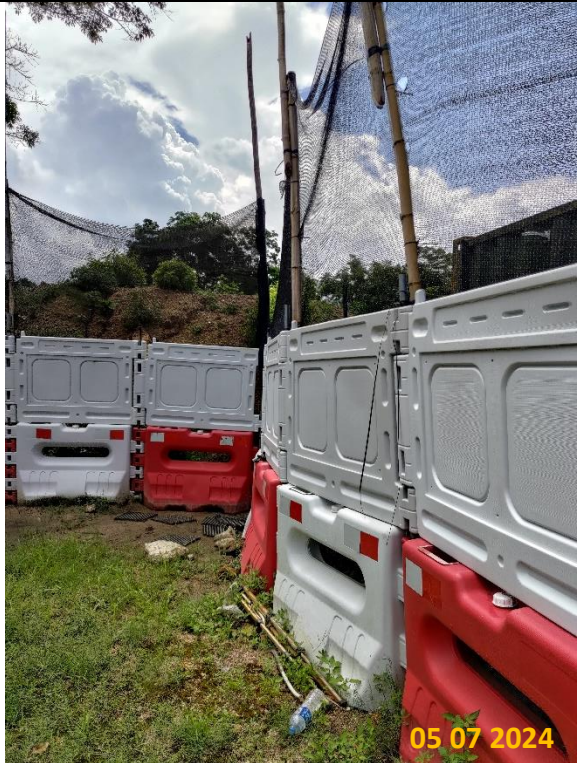
CCTV and fencing are in order

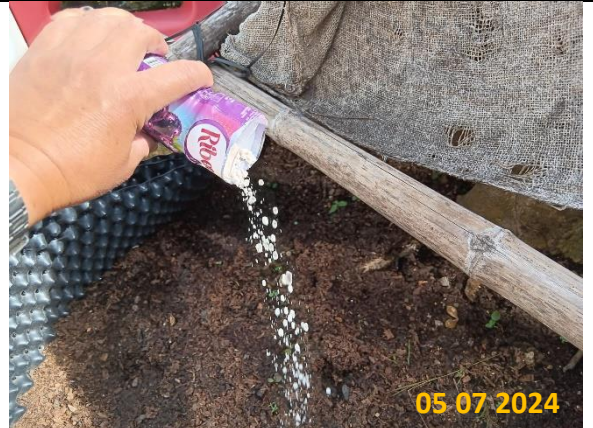
Slight fertilizing was carried out on 5 July 2024

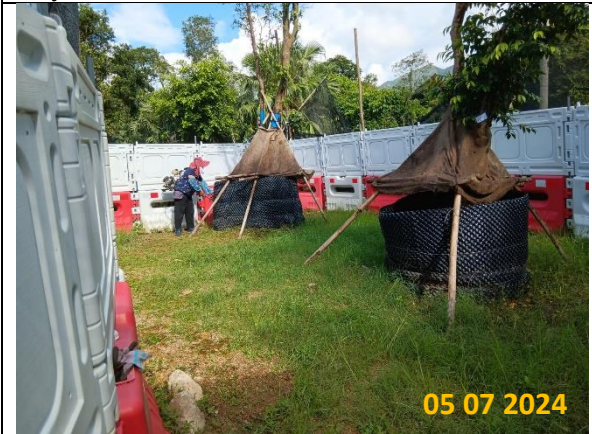
Grass cutting and weeding were carried out on 5 July 2024

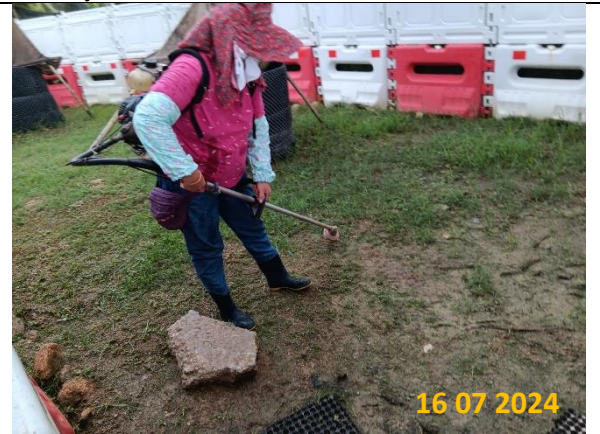
Grass cutting and weeding were carried out on 16 July 2024
