Tung Chung New Town Extension – Site Formation and Infrastructure Works at Tung Chung Valley, Phase 1

Tree Schedule for Survey of Plant Species of Conservation Importance

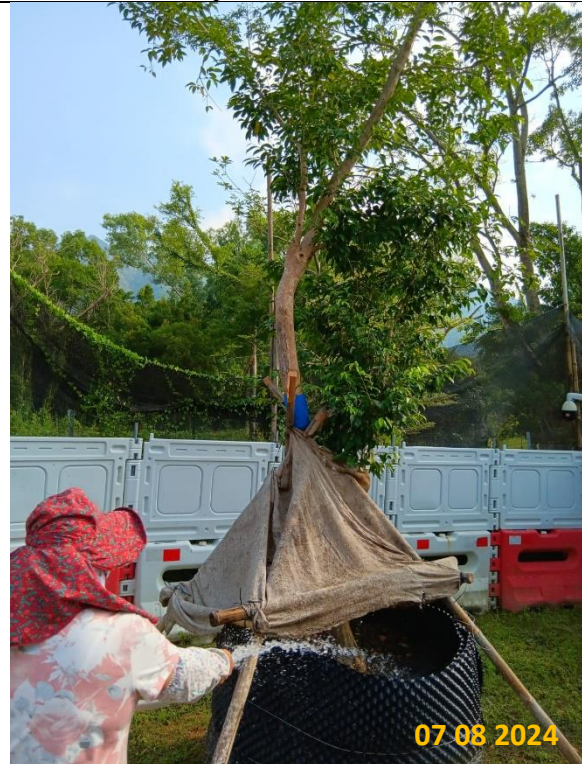
<p>A8 – Overall view</p>   <p>08 08 2024</p> <p>This photograph shows a tree (A8) in a construction site. The tree is supported by a protective structure consisting of a black mesh cylinder and a grey tarp roof held up by wooden poles. The tree is surrounded by a perimeter of grey and red plastic barriers. The ground is grassy.</p>	<p>A8 – Crown condition</p>   <p>08 08 2024</p> <p>This photograph shows the upper portion of the tree's crown, displaying dense green foliage against a clear blue sky with some light clouds.</p>
<p>A8 – Pruning wound previously damaged by typhoon KOINU (Oct 2023)</p>   <p>08 08 2024</p> <p>This close-up photograph shows a vertical cut on the tree trunk, which is a pruning wound. The wound is surrounded by green leaves and branches.</p>	<p>A8 – Trunk and root condition.</p>   <p>08 08 2024</p> <p>This photograph shows the lower part of the tree, including the trunk and the base of the protective structure. The trunk appears healthy and is supported by the same mesh and pole structure seen in the overall view.</p>

Manual watering was carried out for A8 during the reporting period. The watering frequency is one to two times per week.

No.	Species		Conservation Status	Measurements			Tree Condition (Good(G) / Average(A) / Poor(P))			Recommendation (Retain / Transplant / Remove)	Findings	Remark
	Scientific Name	Chinese name		DBH (mm)	Height (m)	Crown (m)	Form	Health	Structure			
A8 (T8996)	<i>Aquilaria sinensis</i>	土沉香	RPPHK; Cap.586; IUCN:VU	110	5	4	P	A	P	Transplant	There was dieback. Insect feeding signs were previously observed (current infestation rate is low).	Originally located at Site 1. Trunk wounds were observed before transplant operation. Shallow root. Sudden defoliation happened in May 2023 but recovered in Aug 2023. It was translocated to the temporary holding nursery on 29 Sep 2023. A branch (5cm) was broken and foliage density decreased due to typhoon in Oct 2023.
A12 (T3537)	<i>Aquilaria sinensis</i>	土沉香	RPPHK; Cap.586; IUCN:VU	185	8	3	P	P	A	Transplant	There was dieback. The foliage density is low. Insect feeding signs were previously observed (current infestation rate is low).	Originally located at Site 5. Trunk wounds were observed before transplant operation. Shallow root. Original root ball was full of stones which were removed partially during the translocation. It was translocated to the temporary holding nursery on 29 Sep 2023. It collapsed during typhoon dated Oct 2023 resulted in largely reduction in foliage density.

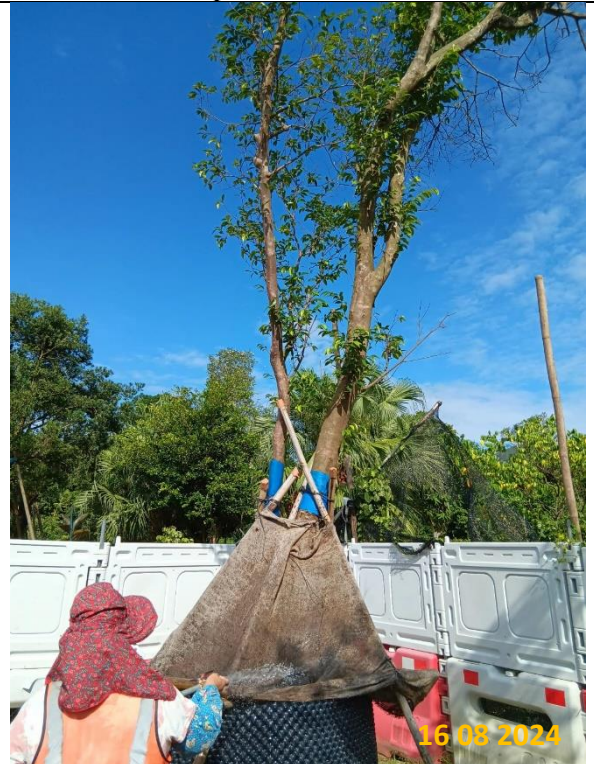
A12 - Overall View	A12 - Foliage density increased but is still low. Dieback observed.
  <p>08 08 2024</p>	  <p>08 08 2024</p>
A12 – Dieback observed.	A12 – Trunk and root condition
  <p>08 08 2024</p>	  <p>08 08 2024</p>

Manual watering was carried out for A12 during the reporting period. The watering frequency is one to two times per week.

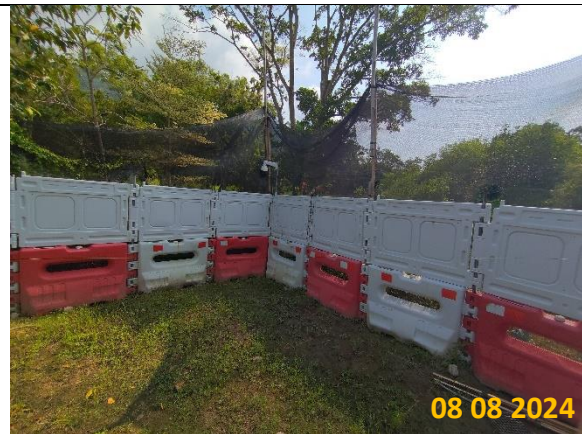
CCTV and fencing are in order.

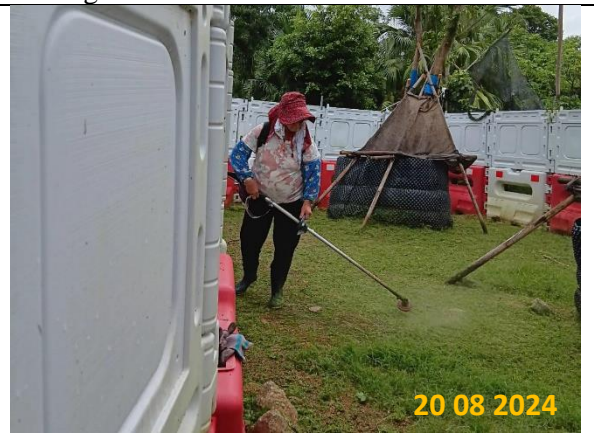
Grass cutting and weeding were carried out on 20 August 2024
