Tung Chung New Town Extension – Site Formation and Infrastructure Works at Tung Chung Valley, Phase 1

Tree Schedule for Survey of Plant Species of Conservation Importance

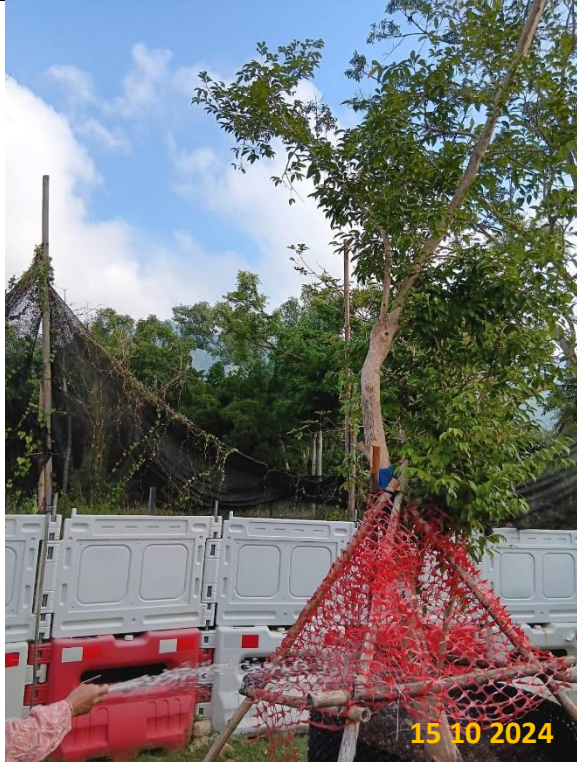
Manual watering was carried out for A8 during the reporting period. The watering frequency is one to two times per week.

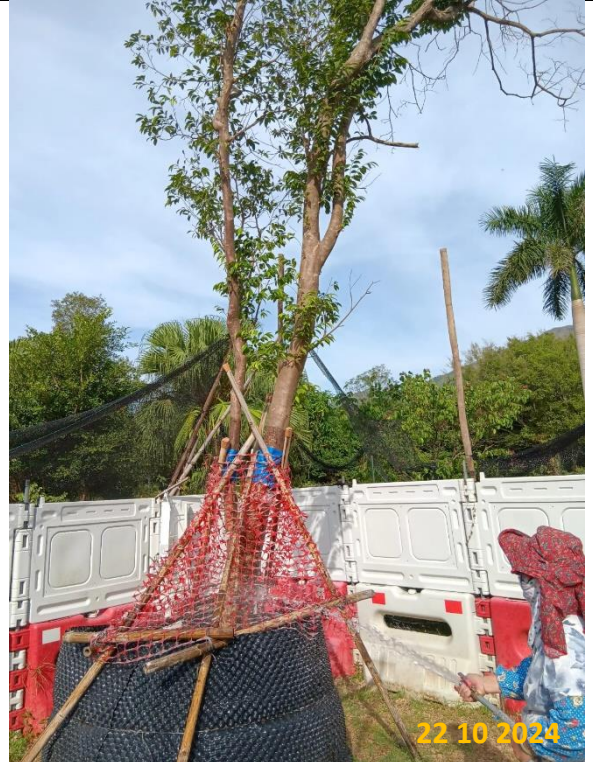
Manual watering was carried out for A12 during the reporting period. The watering frequency is one to two times per week.

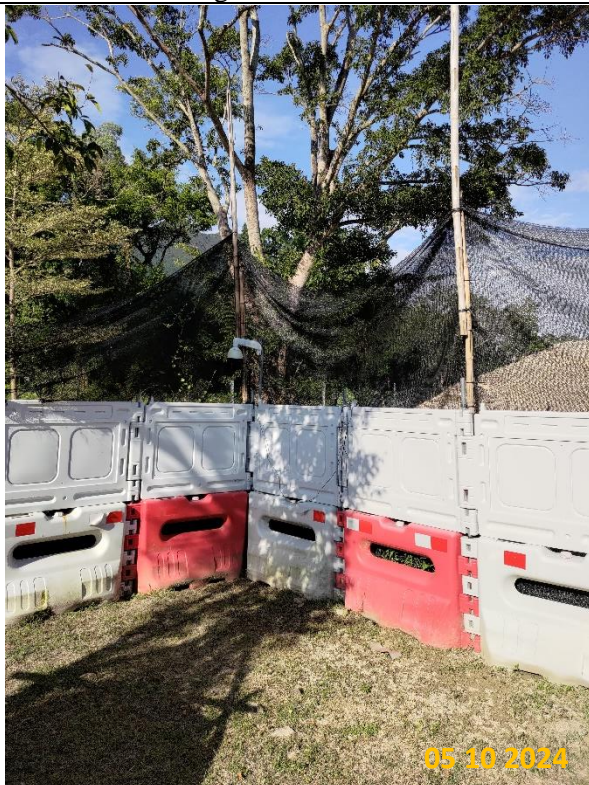
CCTV and fencing are in order.

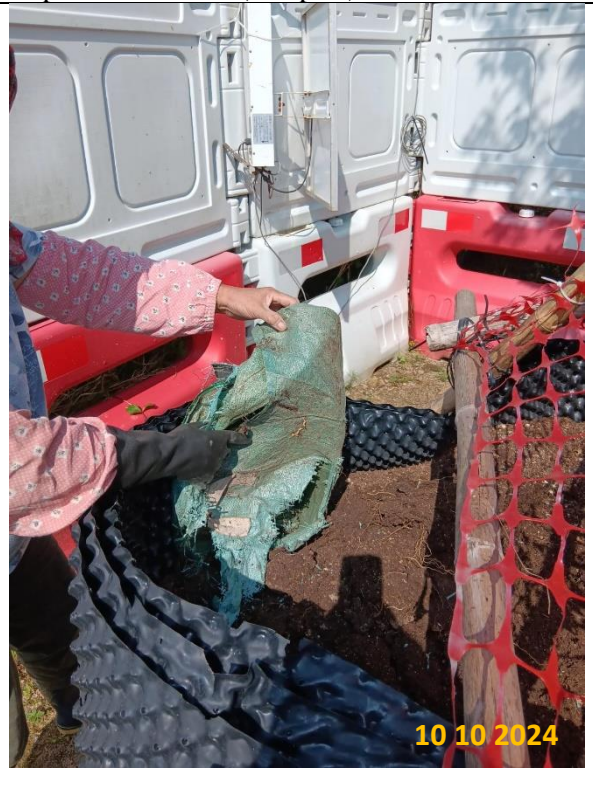
Repenish of mulch (compost) on 10 Oct 2024
