Tree Schedule for Survey of Plant Species of Conservation Importance

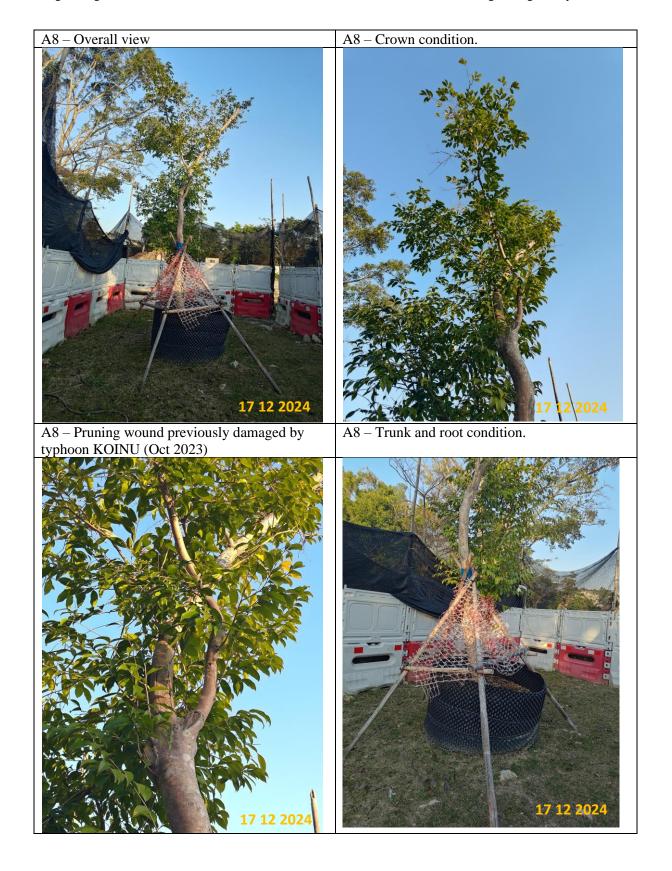
A8 – Decaying wound on trunk (size: ~180mm x170mm)

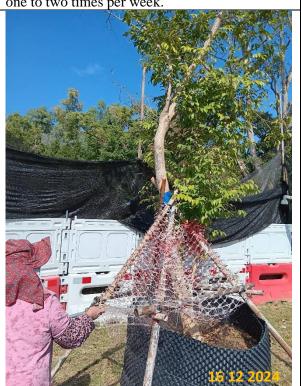
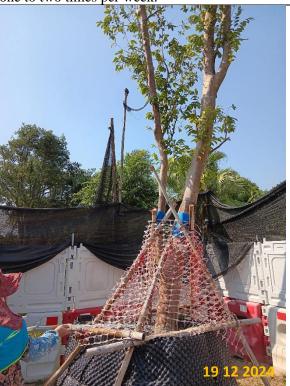
CCTV and fencing are in order.
