Tung Chung New Town Extension – Site Formation and Infrastructure Works at Tung Chung Valley, Phase 1

Tree Schedule for Survey of Plant Species of Conservation Importance

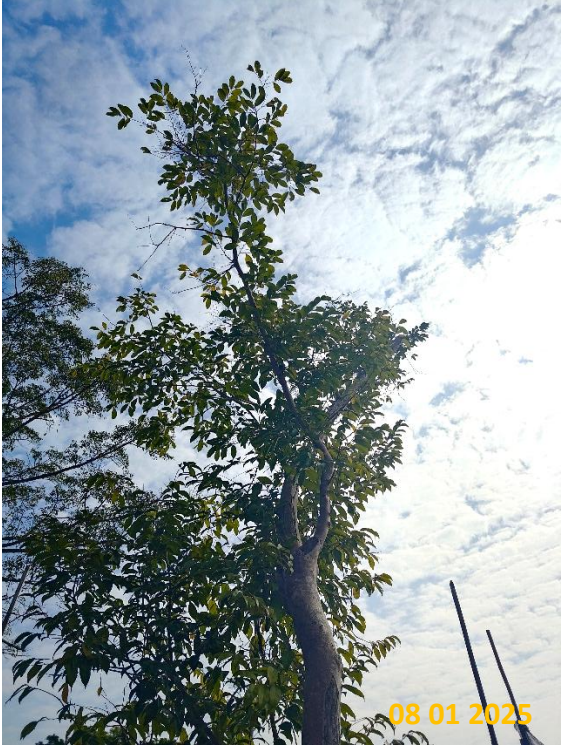
<p>08 01 2025</p> <p>This photograph shows a young tree, identified as A8, supported by a tripod structure of wooden poles. The tree is planted in a black mesh tree well. The background features a grey and red plastic safety fence and other trees under a cloudy sky.</p>	<p>A8 – Crown condition.</p>

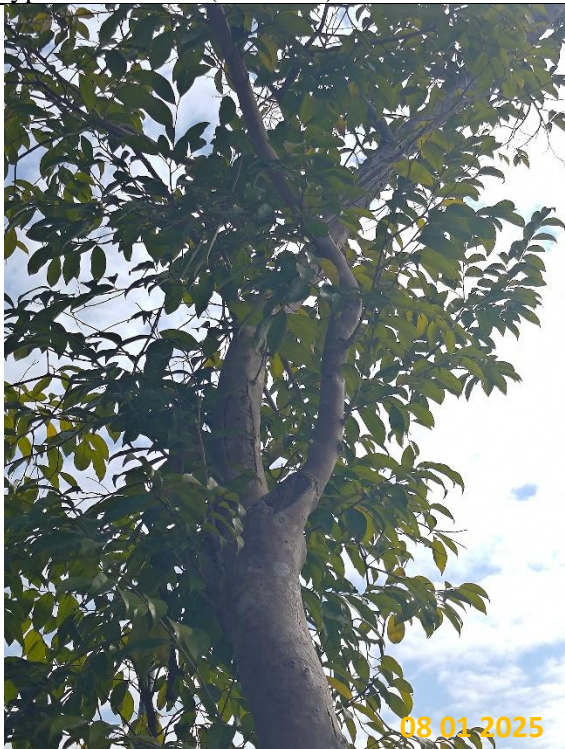
<p>08 01 2025</p> <p>This photograph provides a close-up view of the upper canopy of tree A8, showing dense green foliage against a bright, cloudy sky.</p>
<p>A8 – Pruning wound previously damaged by typhoon KOINU (Oct 2023)</p>

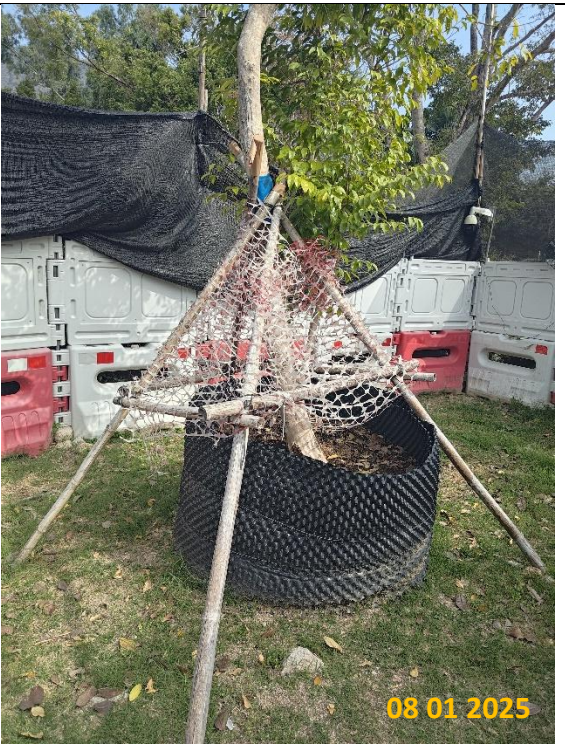
<p>08 01 2025</p> <p>This photograph shows a close-up of a pruning wound on the trunk of tree A8. The wound is a vertical cut in the bark, showing the underlying wood. The surrounding leaves are green.</p>	<p>A8 – Trunk and root condition.</p>

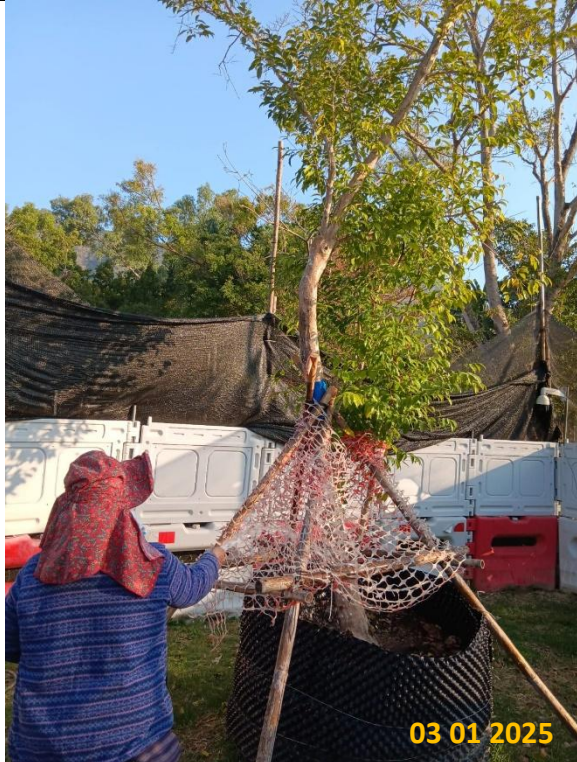
Manual watering was carried out for A8 during the reporting period. The watering frequency is one to two times per week.

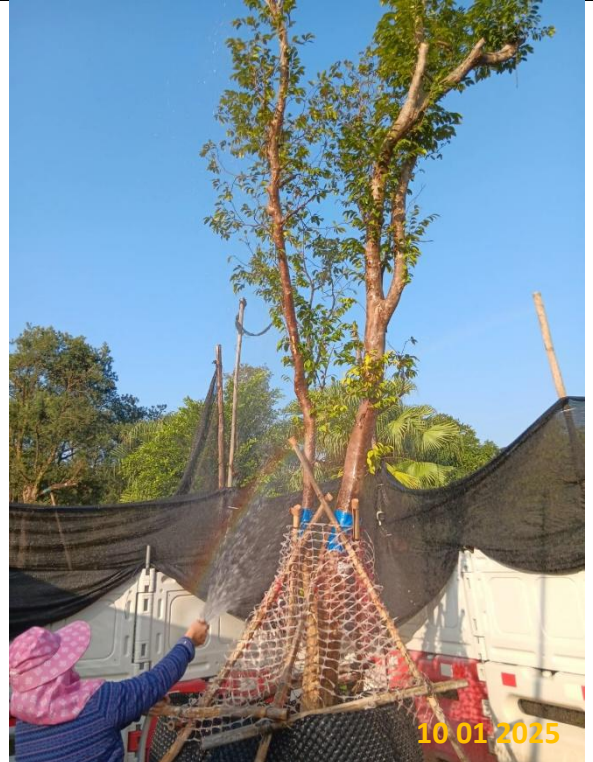
Manual watering was carried out for A12 during the reporting period. The watering frequency is one to two times per week.

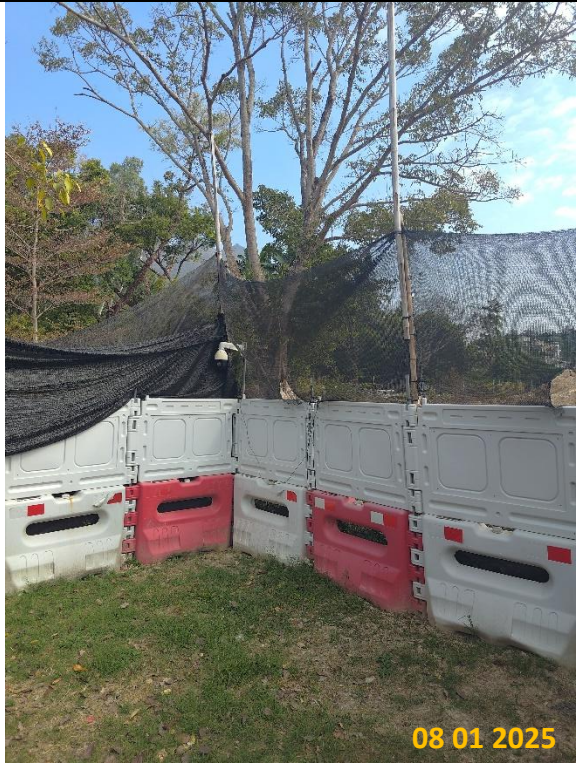
CCTV and fencing are in order.

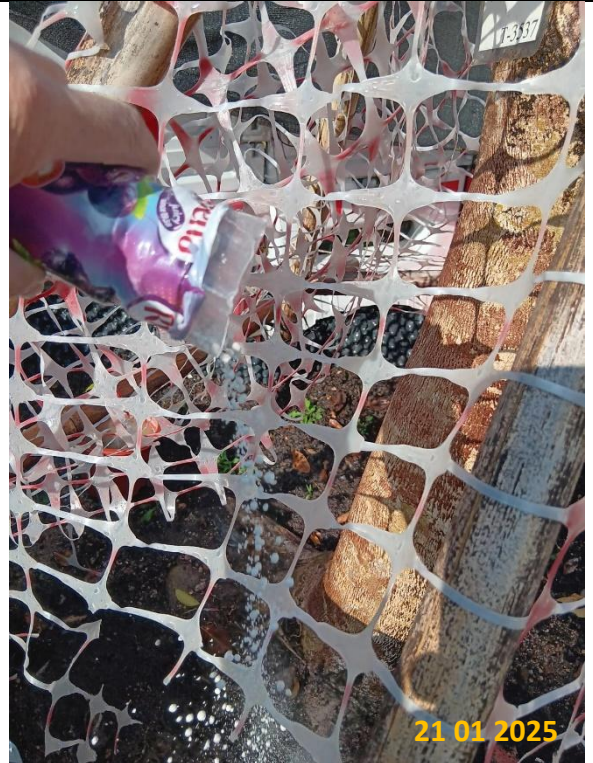
Slightly fertilizing was done on 21/01/2025
