Tree Schedule for Survey of Plant Species of Conservation Importance

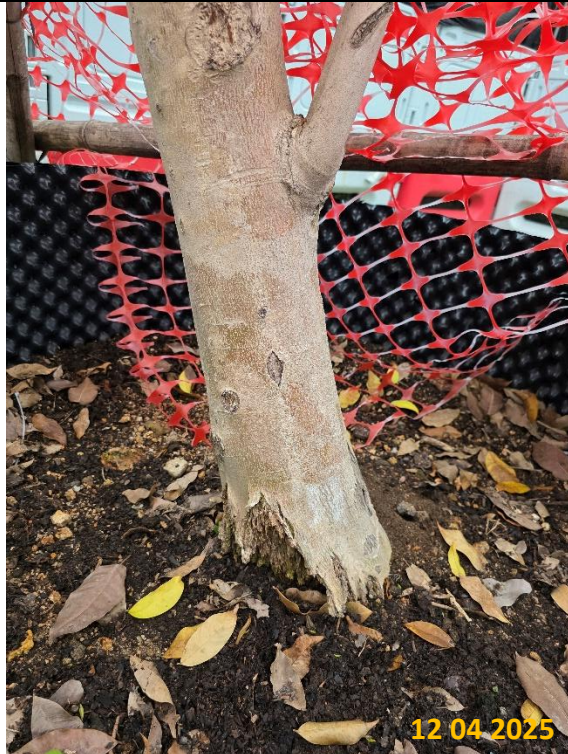
A8 – Decaying wound at trunk base
(size: ~180mm x170mm)

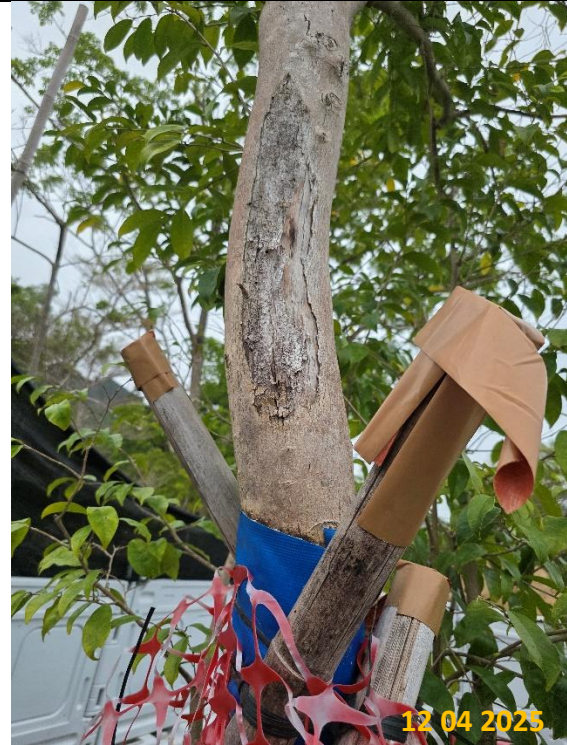
A8 – Decaying wound on trunk

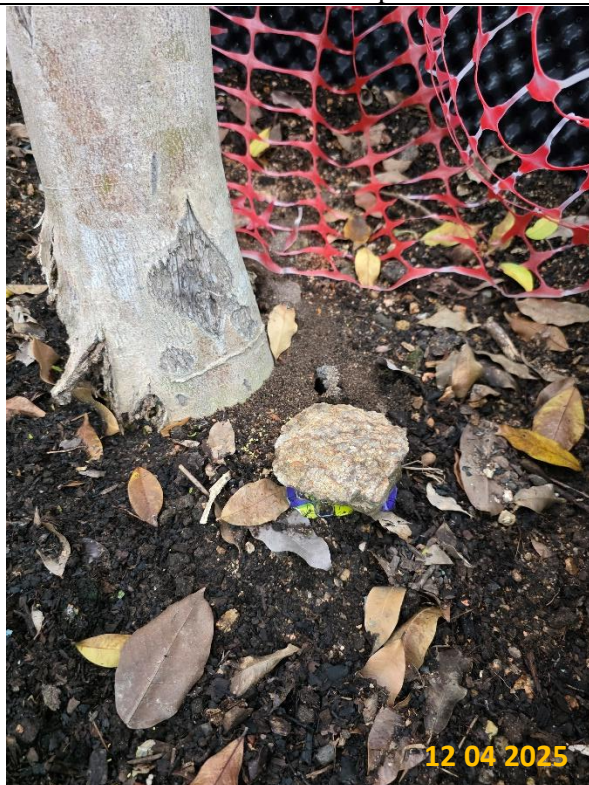
A8 – Ant nest was found at the pot

Toxic bait for ant was placed inside the pot of A8 on 30 March 2025

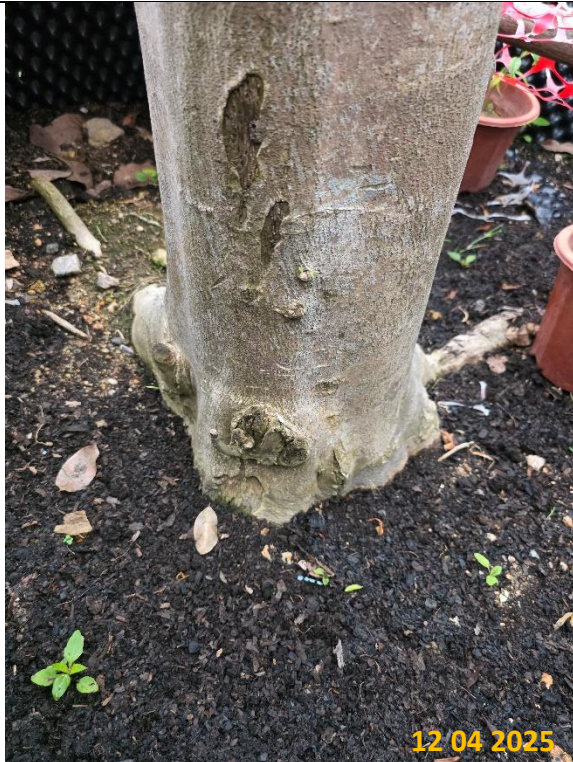
A12 –Wound at trunk base

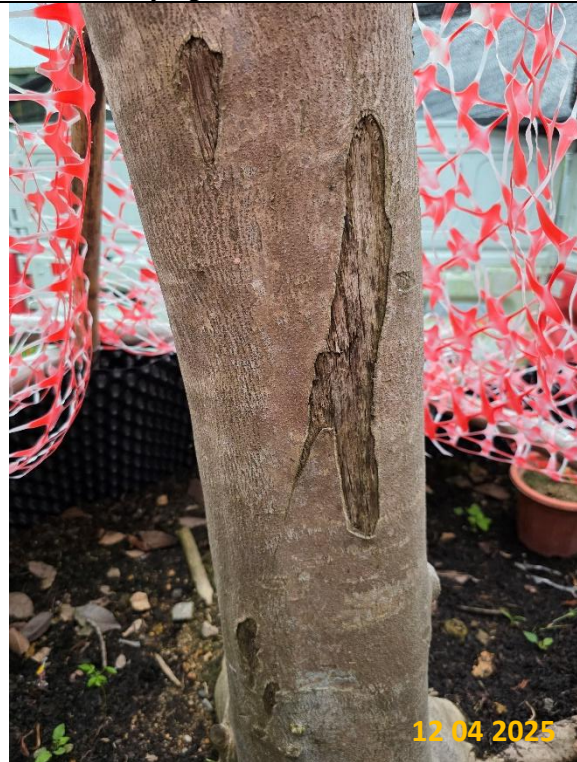
A12 – Decaying wound on trunk
