Tree Schedule for Survey of Plant Species of Conservation Importance

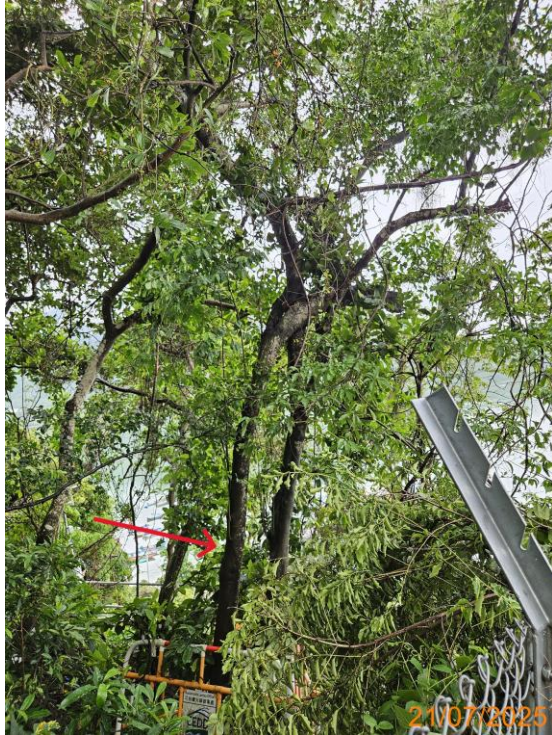
1: T8217

Tree No.	Species			Measurements			Amenity Value (High(H) / Medium (M) / Low(L)	Tree Condition (Good(G) / Average(A) / Poor(P))			Recommendation (Retain / Transplant / Remove)	Findings	Remark
	Scientific Name	Chinese Name	Conservation Status	Height (m)	DBH (mm)	Crown Spread (m)		Form	Health	Structure			
T8217	<i>Canthium dicoccum</i>	魚骨木	IUCN:VU	9	220	6	L	P	A	P	Retain	Branch failure of T8217 was found on 21 July 2025 due to Typhoon signal No. 10. Overall condition of tree and its remaining part is fair.	There is no proper and safe assess towards T8231 & T8217, thus, plastics barriers were installed in lieu of 2m high barrier. Branch failure of T8217 was found on 21 July 2025. It was identified that the fallen part was one of the branches on upper position of tree. No decay was observed on the tearing position. No other collapsed part was observed due to adverse weather during time of inspection. Overall condition of tree and its remaining part is fair. Pruning of jagged wound to provide a clean cut is recommended. The pruning work the completed on 21 July 2025.

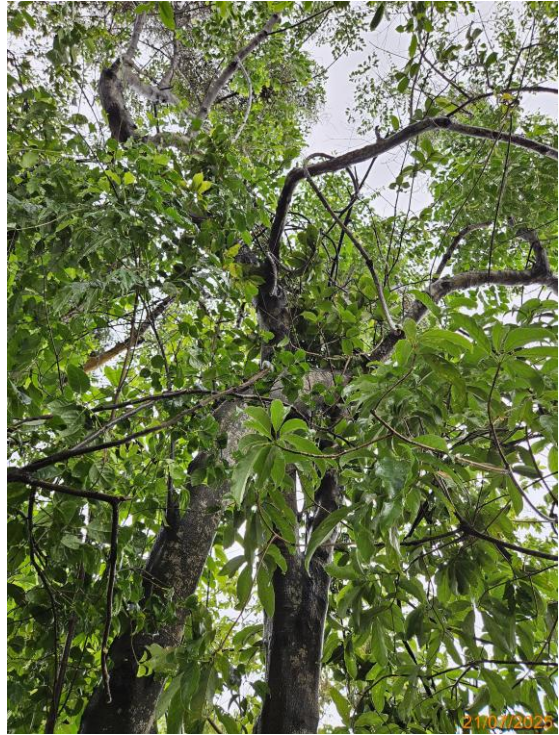
2: T8217_Cross branches

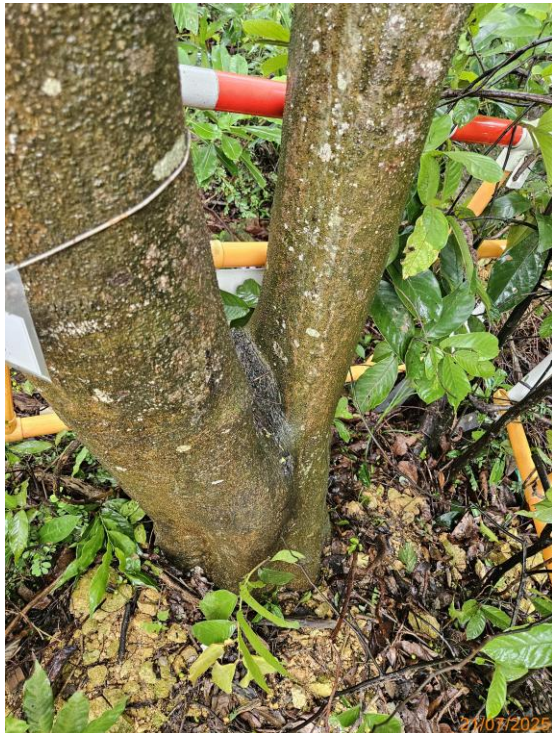
3: T8217_Trunk base

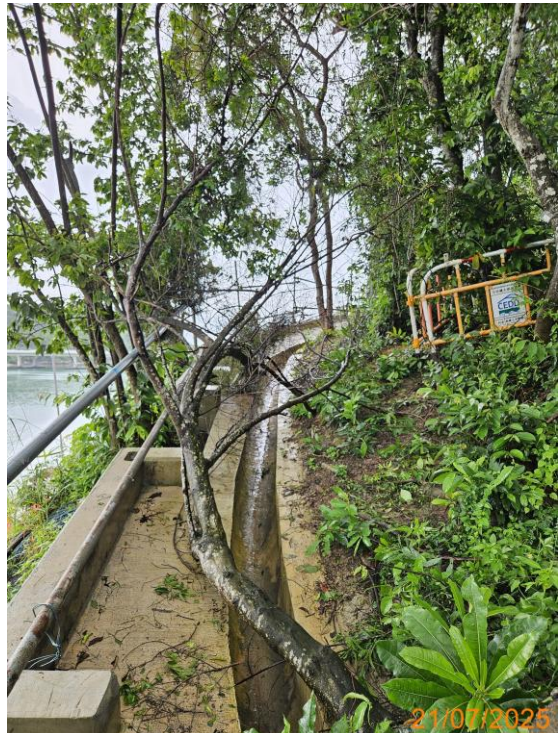
4: T8217_Fallen branch

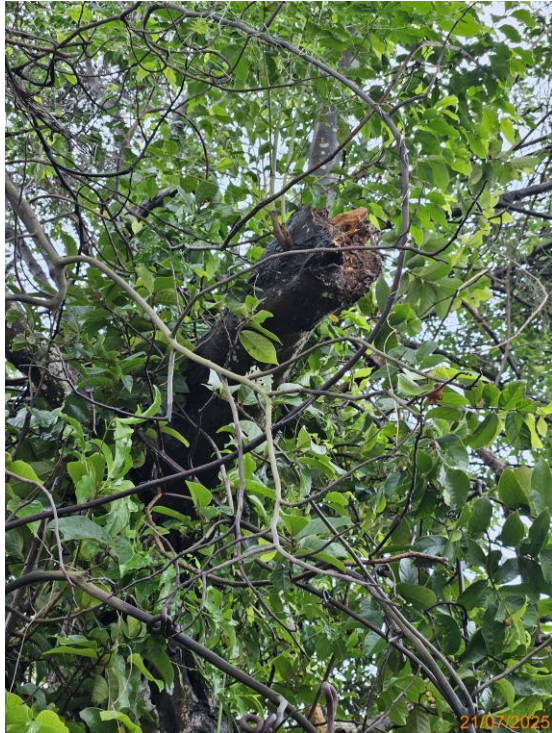
5: T8217_Position of tearing wound

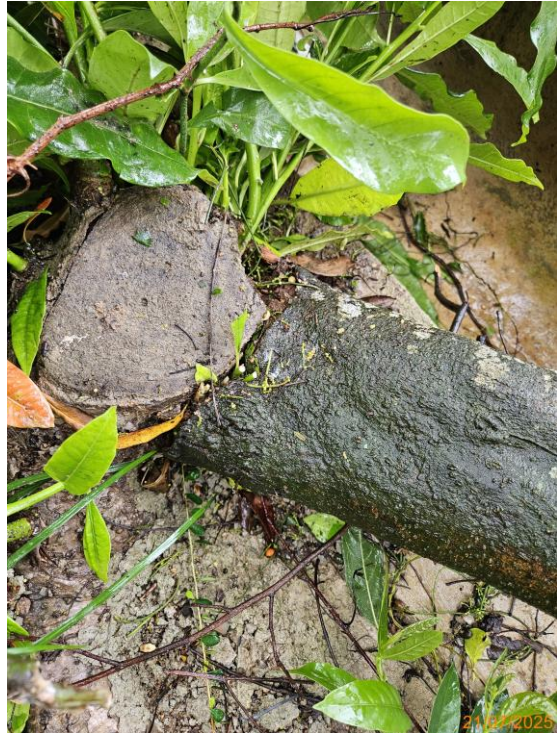
6: T8217_Tearing wound from branch

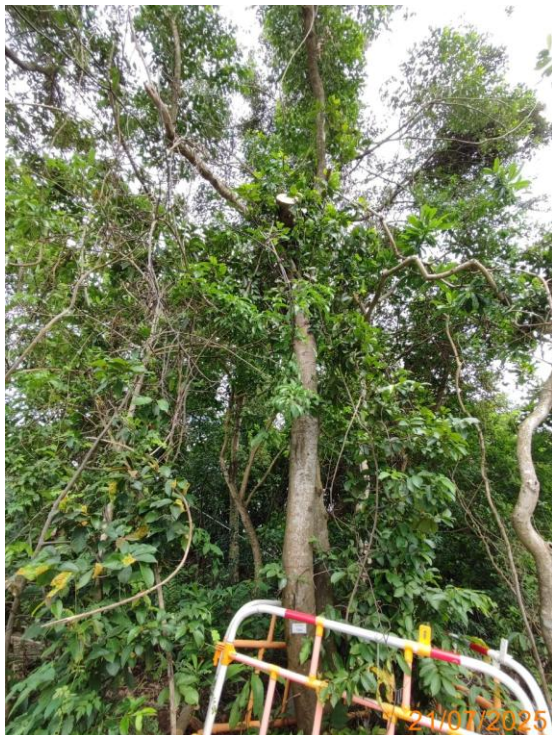
7: T8217_After pruning works

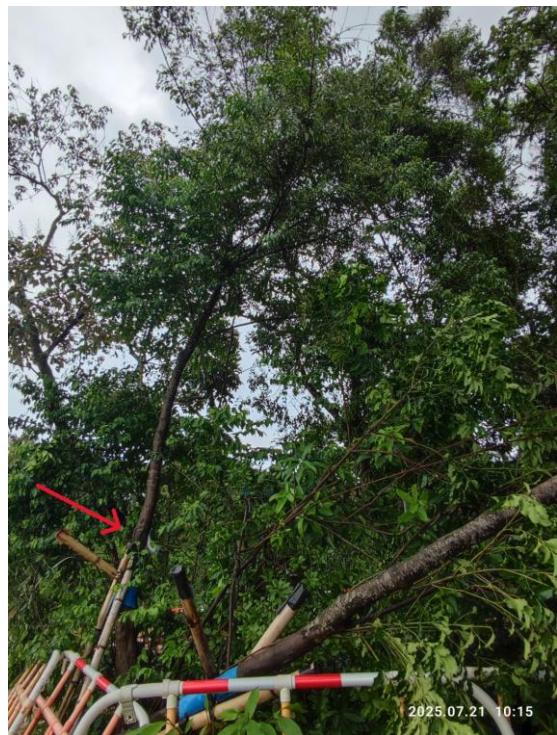
8: T8231

T8231	<i>Canthium dicoccum</i>	魚骨木	IUCN:VU	7	190	6	L	P	A	P	Retain	Second epicormic failure was found on 21 July 2025 due to Typhoon signal No. 10. Overall condition of tree and its remaining part is fair	There is no proper and safe assess towards T8231 & T8217, thus, plastics barriers were installed in lieu of 2m high barrier. Epiconmic branch failure was found on 03 May 2024. Staking to provide extra support and pruning of jagged wound to provide a clean cut was conducted on 16 May 2024. Application of insecticide and fungicide on wound was conducted on 4 July 2025. The Staking was in normal condition during the time of inspection. No further significant defects were observed. Second epicormic failure was found on 21 July 2025. Overall condition of tree and its remaining part is fair. Pruning of jagged wound to provide a clean cut is recommended. Pruning works was completed on 21 July 2025.

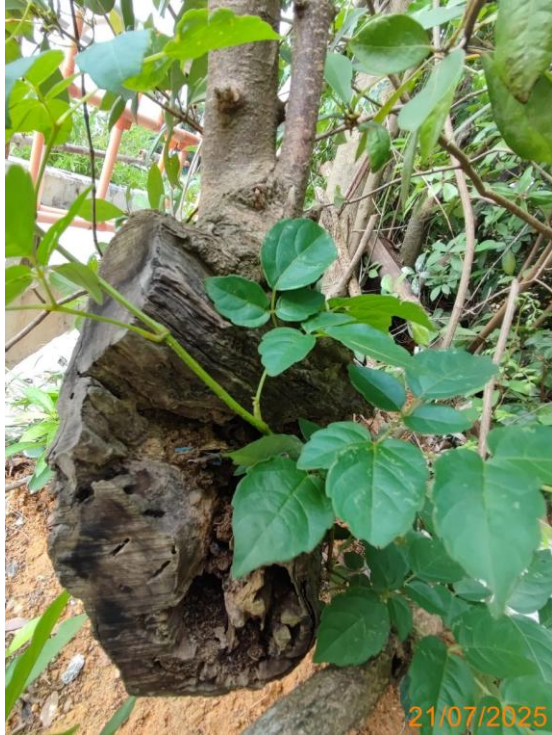
9: T8231_Borer hole#1

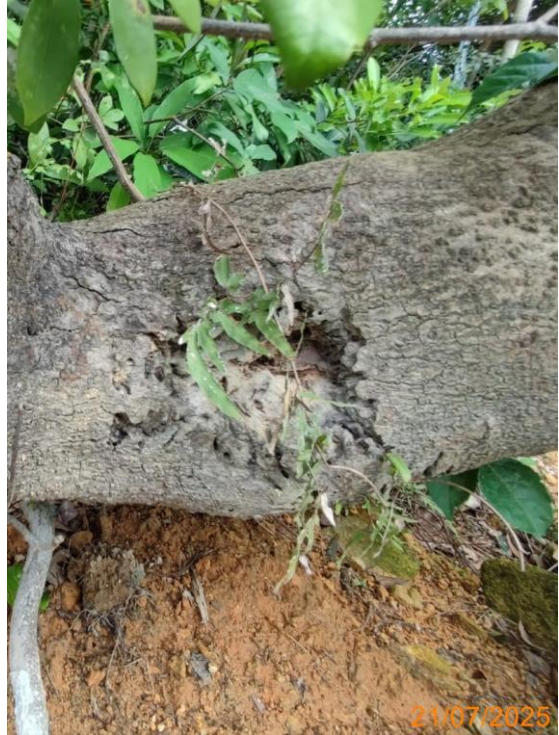
10: T8231_Borer hole#2

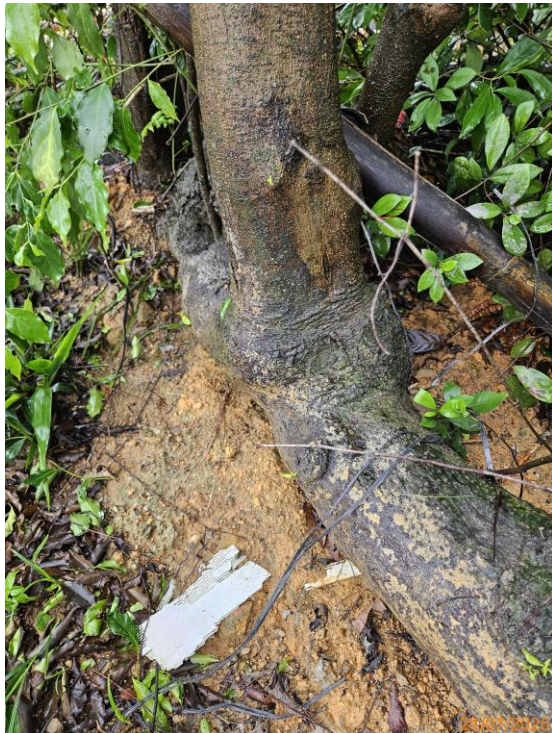
11: T8231_Trunk base

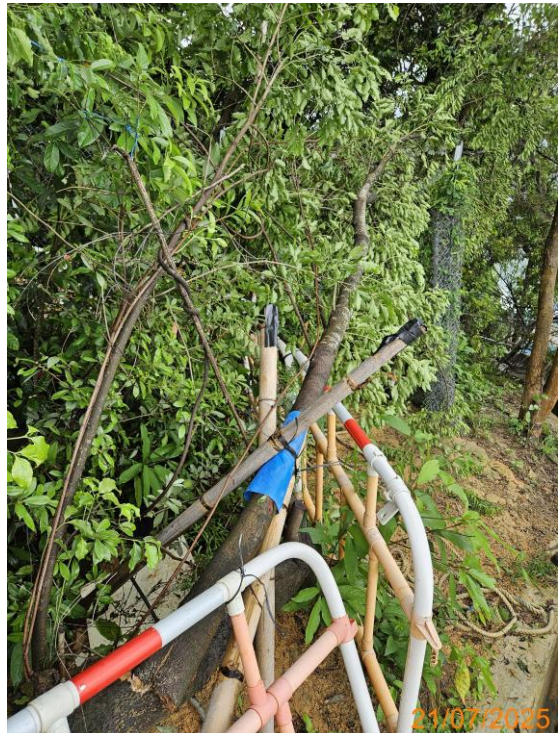
12: T8231_Fallen branch

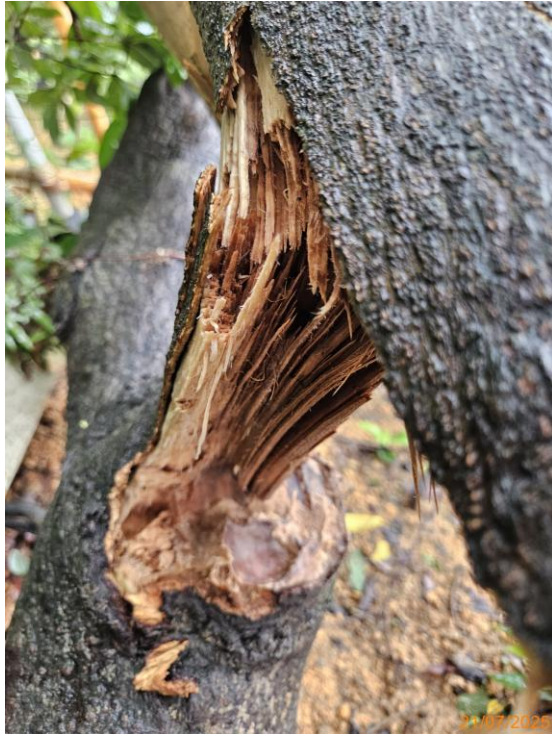
13: T8231_Position of tearing wound

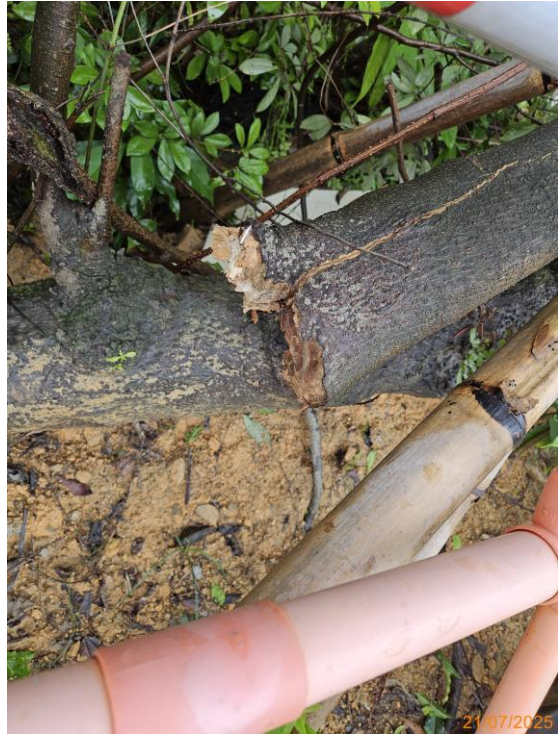
14: T8231_Tearing wound from branch

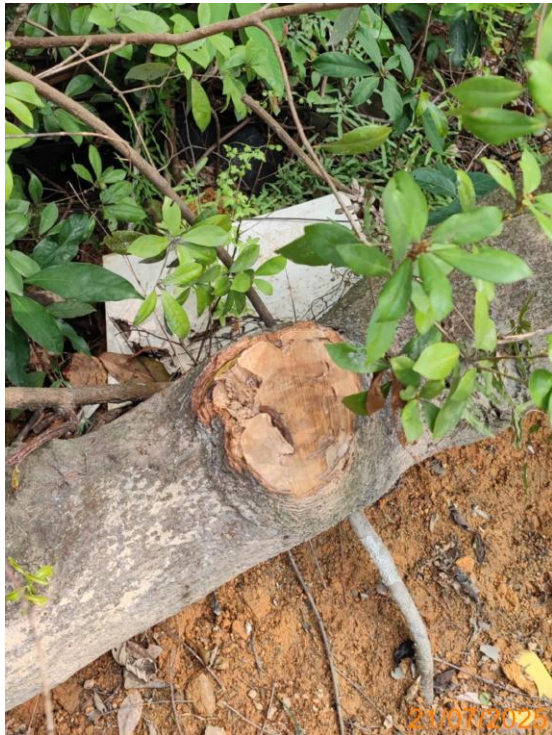
15: T8231_After pruning works

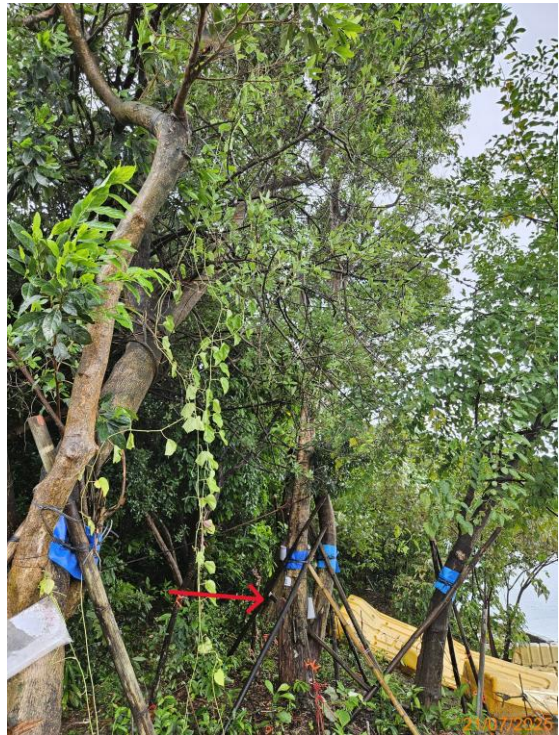
16: U041

U041	<i>Aquilaria sinensis</i>	土沉香	RPPHK; Cap.586; IUCN:VU	10	318	4	M	A	P	P	Retain	No obvious old termite track was found, damage of wood tissue was observed. Peeling off of bark and sign of split of internal wood tissue was observed. Trunk wound significantly decayed. High trunk failure risk.	Located closed to cut slope. The crack on trunk was found slightly larger since late March 2024. Peeling off of bark and split of internal wood tissue was observed in July 2024. Abnormal bark crack was found in December 2024. Additional guying for tree no. U041 has been installed as an enhanced stabilization measure alongside the bamboo staking in May 2025. Adjustment of guying and application of insecticide and fungicide was conducted on 4 July 2025.
U042	<i>Gmelina chinensis</i>	石梓	RPPHK	6	150	2	M	A	P	A	Retain	Large wound near trunk base with wound wood development. Trunk wound is decaying.	Located closed to cut slope. Application of insecticide and fungicide as preventive measure was conducted on 4 July 2025.

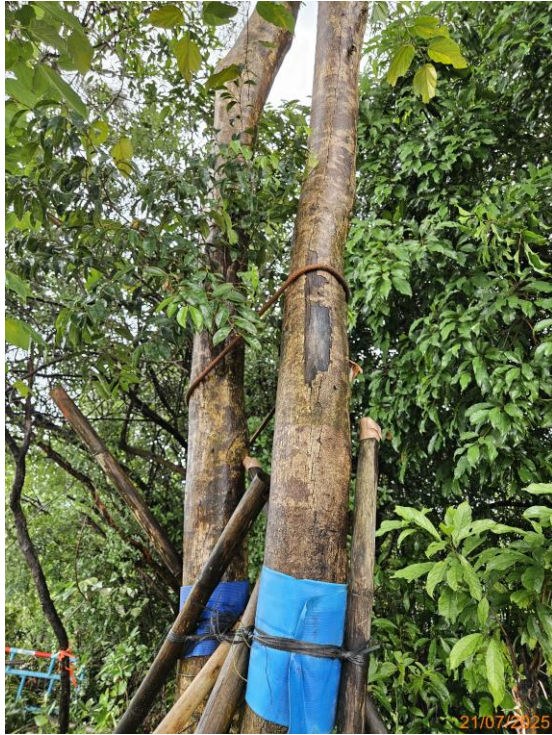
17: U041_Abnormal bark crack on trunk

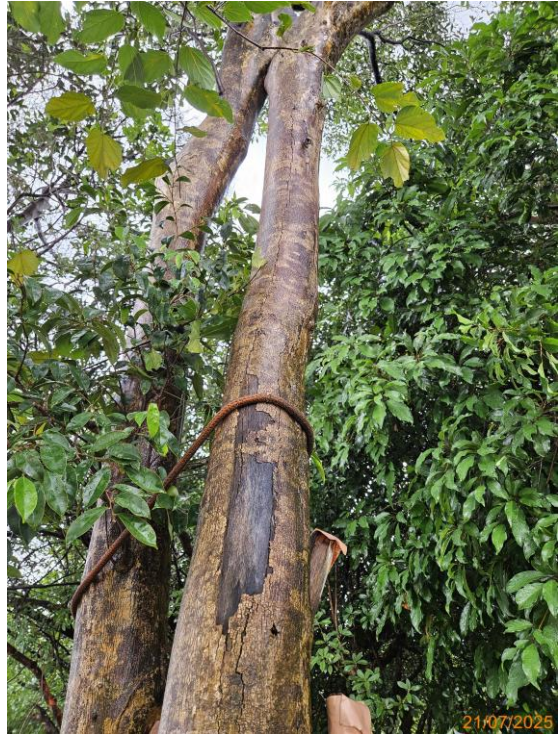
18: U041_Abnormal bark crack on trunk_Close up

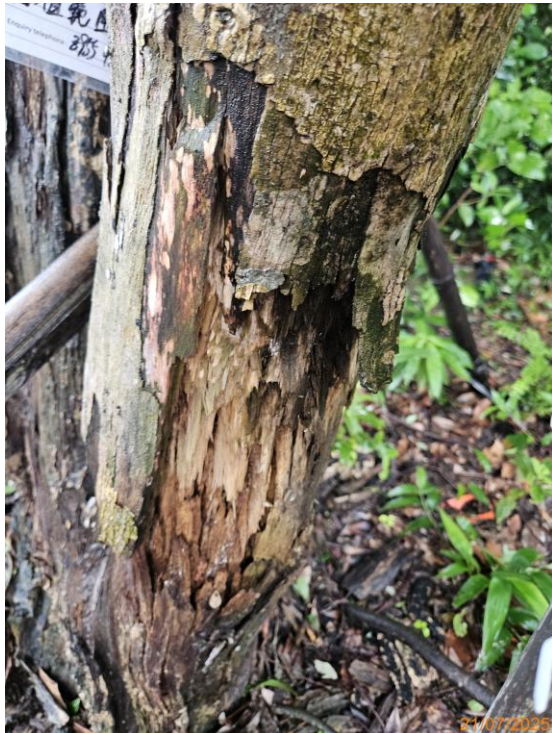
19: U041_Crack on trunk

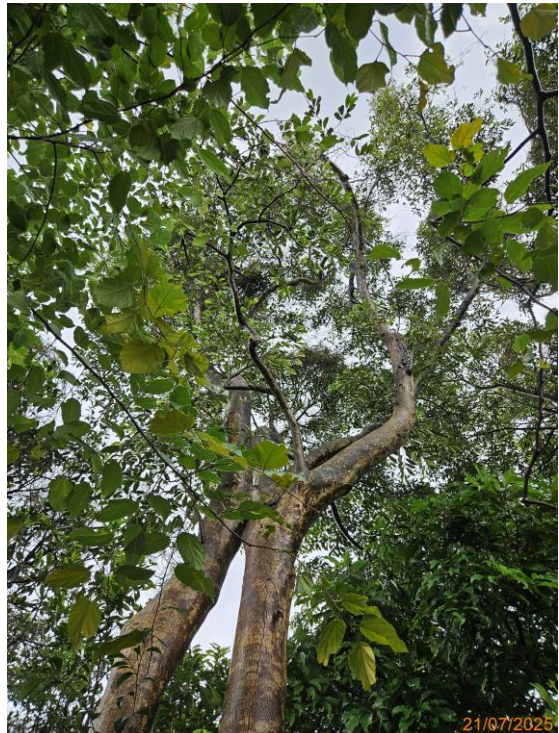
20: U041_Crown

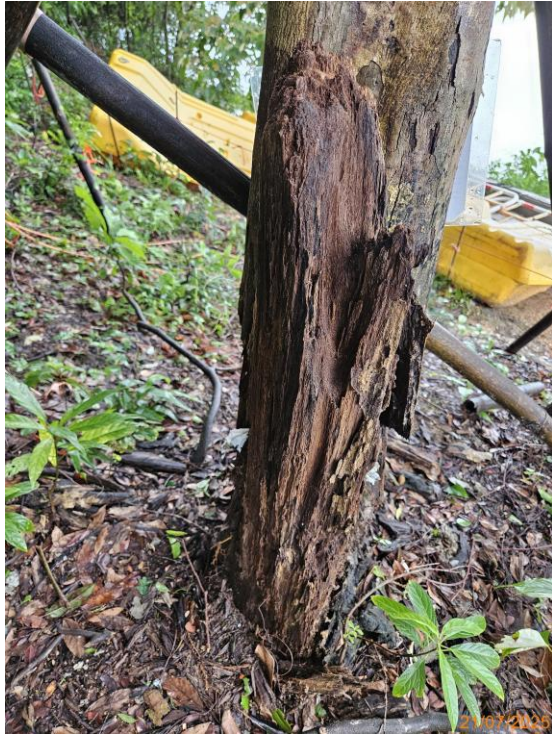
21: U041_Wood damage at trunk union#1

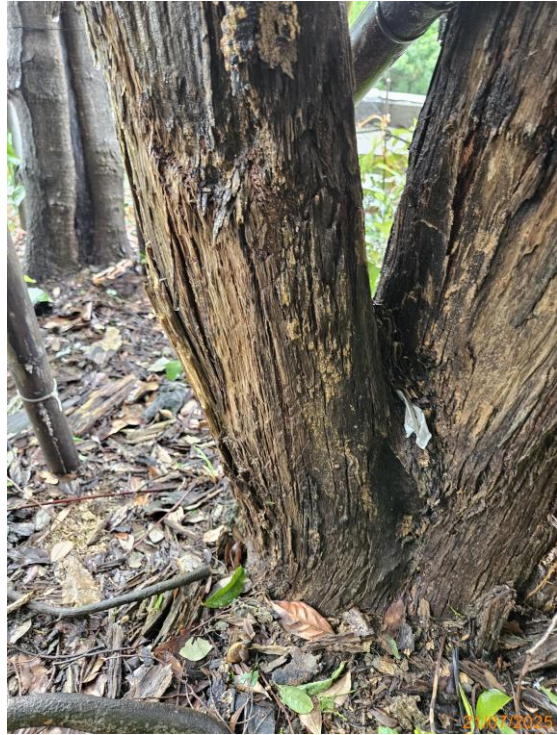
22: U041_Wood damage at trunk union#2

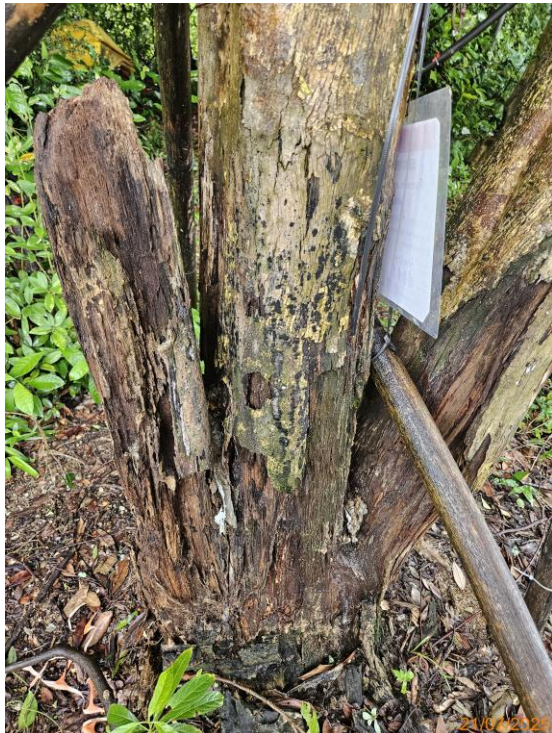
23: U041_Wood damage at trunk union#3

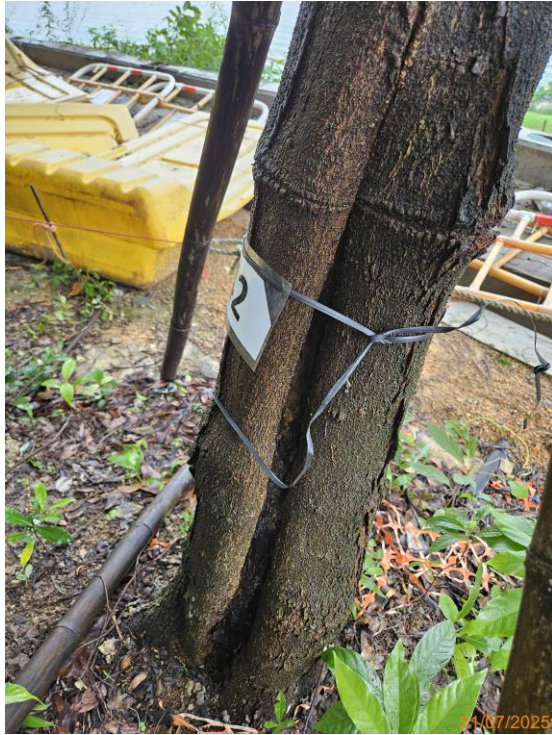
25: U042_Wound on trunk base

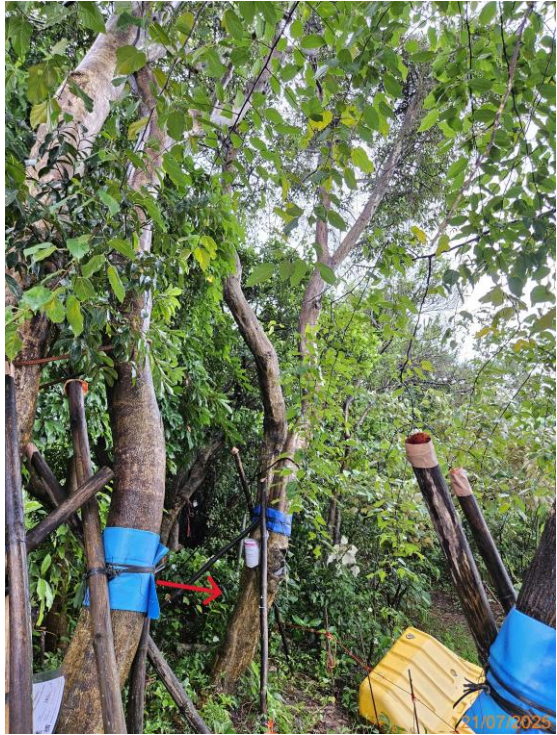
26: U043

U043	<i>Aquilaria sinensis</i>	土沉香	RPPHK; Cap.586; IUCN:VU	9	310	4	M	A	P	P	Retain	Crack on trunk base. Trunk wound significantly decayed. High trunk failure risk.	Located closed to cut slope and fenced off by 2m high barrier. Application of insecticide and fungicide was conducted on 4 July 2025.

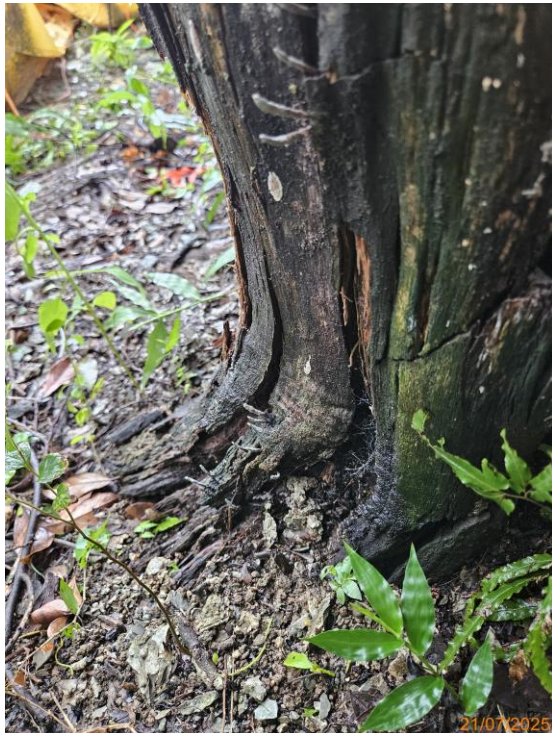
27: U043_Crack on trunk

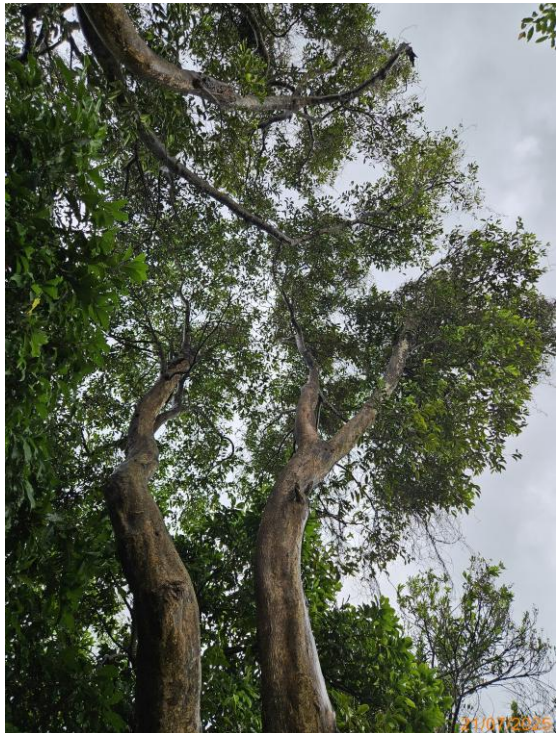
28: U043_Crown

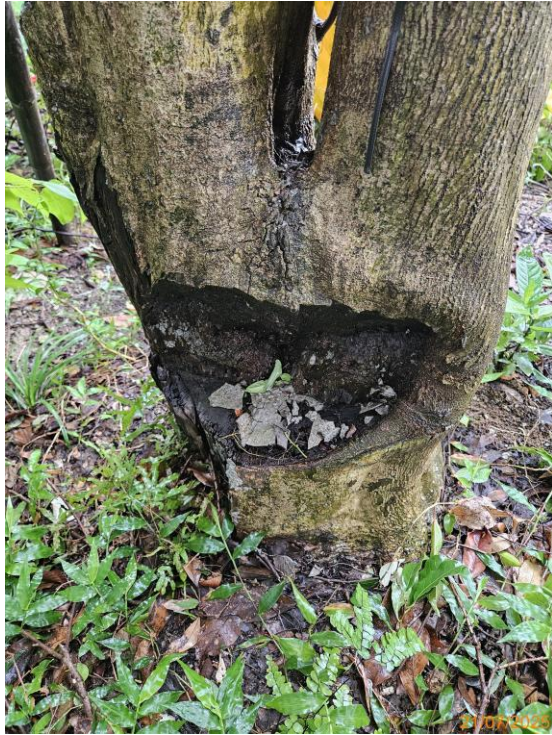
29: U043_Wound on trunk#1

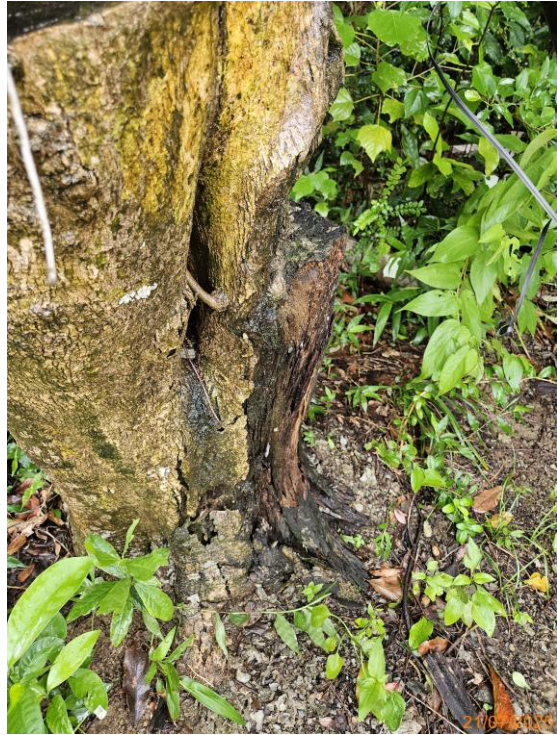
30: U043_Wound on trunk#2

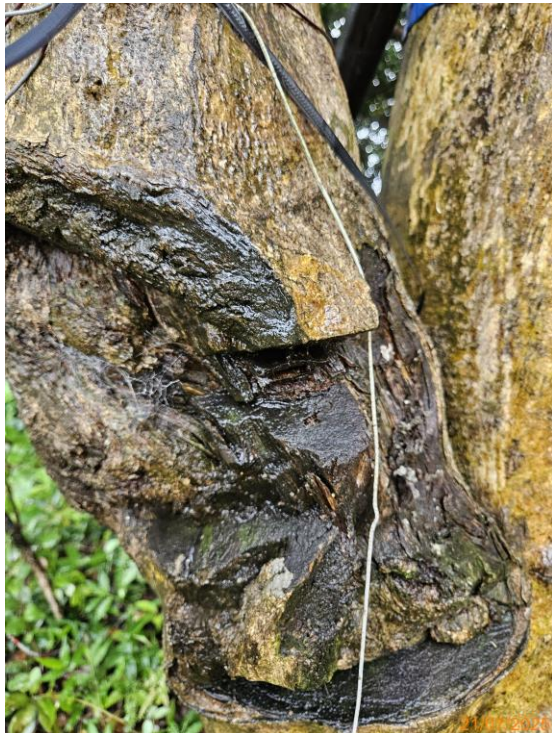
31: U043_Wound on trunk#3
