Tree Schedule for Survey of Plant Species of Conservation Importance

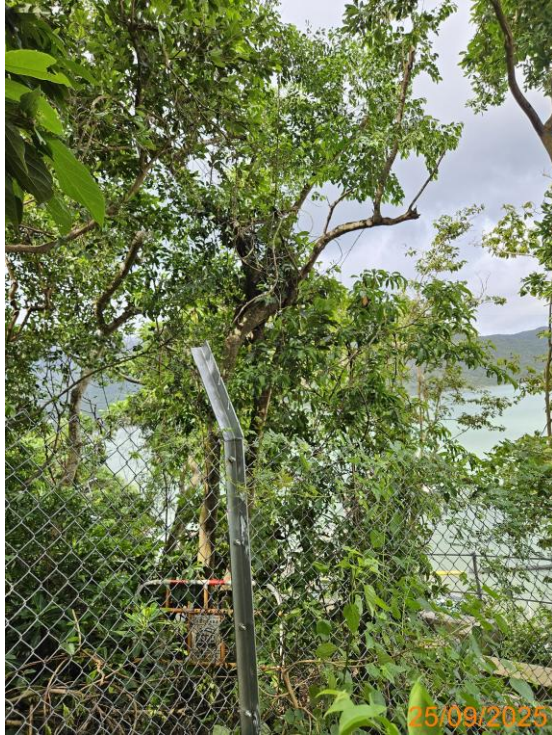
1: T8217

| Tree No. | Species | | | Measurements | | | Amenity Value<br>(High(H) / Medium (M) / Low(L) | Tree Condition (Good(G) / Average(A) / Poor(P)) | | | Recommendation<br>(Retain / Transplant / Remove) | Findings | Remark |
|---|---|---|---|---|---|---|---|---|---|---|---|---|---|
| T8217 | <i>Canthium dicoccum</i> | 魚骨木 | IUCN:VU | 9 | 220 | 6 | L | P | A | P | Retain | Branch failure of T8217 was found on 21 July 2025 due to Typhoon signal No. 10. Overall condition of tree and its remaining part is fair. | There is no proper and safe assess towards T8231 & T8217, thus, plastics barriers were installed in lieu of 2m high barrier. Branch failure of T8217 was found on 21 July 2025. It was identified that the fallen part was one of the branches on upper position of tree. No decay was observed on the tearing position. No other collapsed part was observed due to adverse weather during time of inspection. Overall condition of tree and its remaining part is fair. Pruning of jagged wound to provide a clean cut is recommended. The pruning work the completed on 21 July 2025. Application of insecticides and fungicides on wound was conducted to prevent infection of wound on 18 September 2025. |

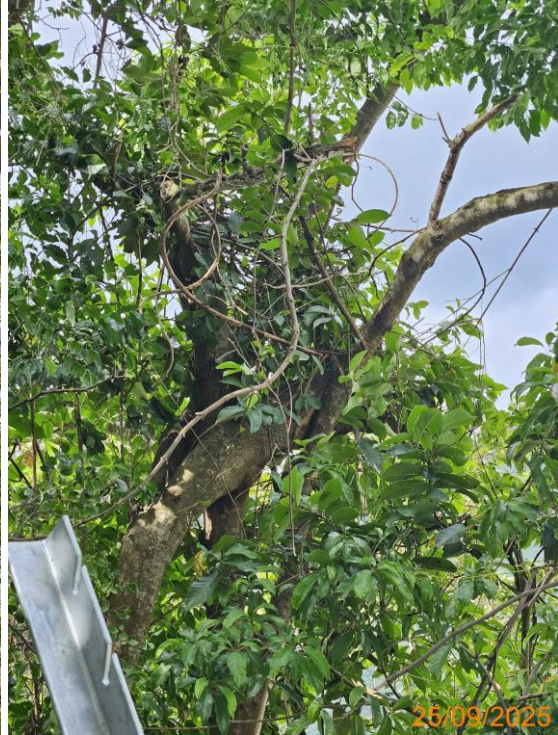
2: T8217\_Cross branches

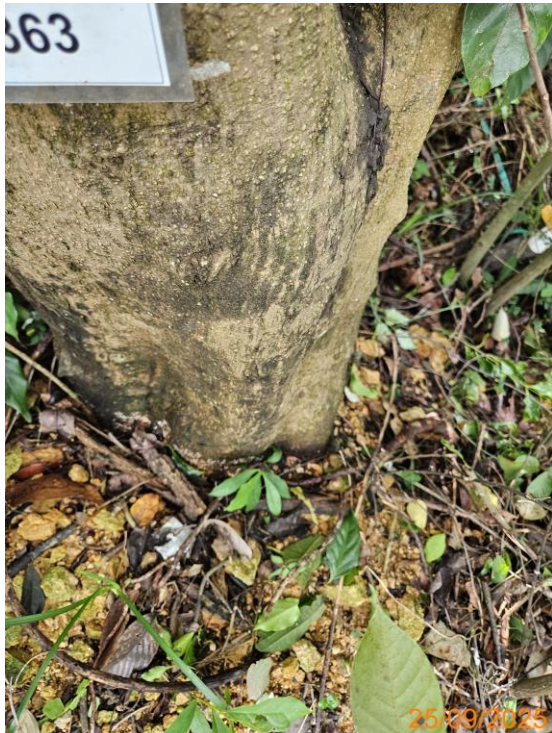
3: T8217\_Trunk base

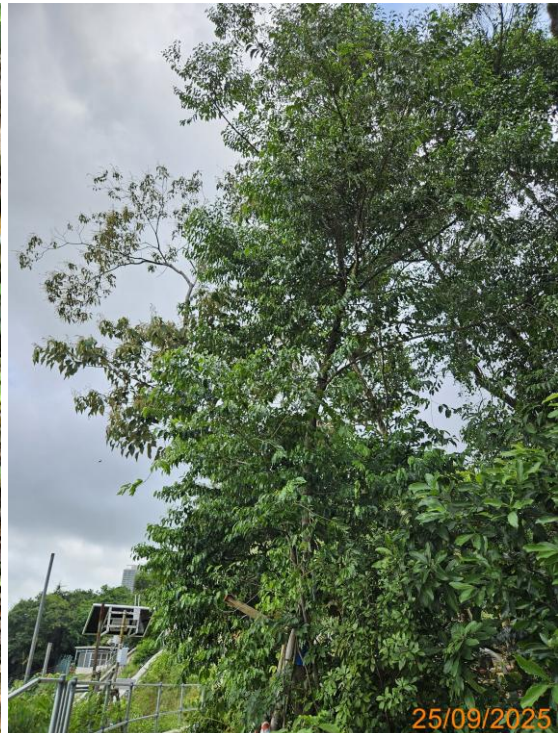
4: T8231

| Tree No. | Species | | | Measurements | | | Amenity Value<br>(High(H) / Medium (M) / Low(L) | Tree Condition (Good(G) / Average(A) / Poor(P)) | | | Recommendation<br>(Retain / Transplant / Remove) | Findings | Remark |
|---|---|---|---|---|---|---|---|---|---|---|---|---|---|
| T8231 | <i>Canthium dicoccum</i> | 魚骨木 | IUCN:VU | 7 | 190 | 6 | L | P | A | P | Retain | Second epicormic failure was found on 21 July 2025 due to Typhoon signal No. 10. Overall condition of tree and its remaining part is fair | There is no proper and safe assess towards T8231 & T8217, thus, plastics barriers were installed in lieu of 2m high barrier. Epicormic branch failure was found on 03 May 2024. Staking to provide extra support and pruning of jagged wound to provide a clean cut was conducted on 16 May 2024. Application of insecticide and fungicide on wound was conducted on 18 September 2025. Adjustment of trunk protection pad was conducted on 18 September 2025 and 25 September 2025. The Staking was in normal condition during the time of inspection. No further significant defects were observed. Second epicormic failure was found on 21 July 2025, Overall condition of tree and its remaining part is fair. Pruning of jagged wound to provide a clean cut is recommended. Pruning works was completed on 21 July 2025. |

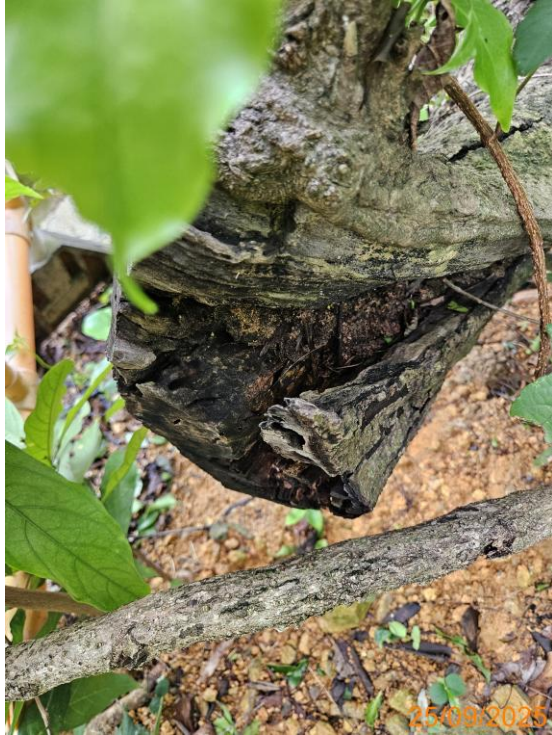
5: T8231\_Borer hole#1

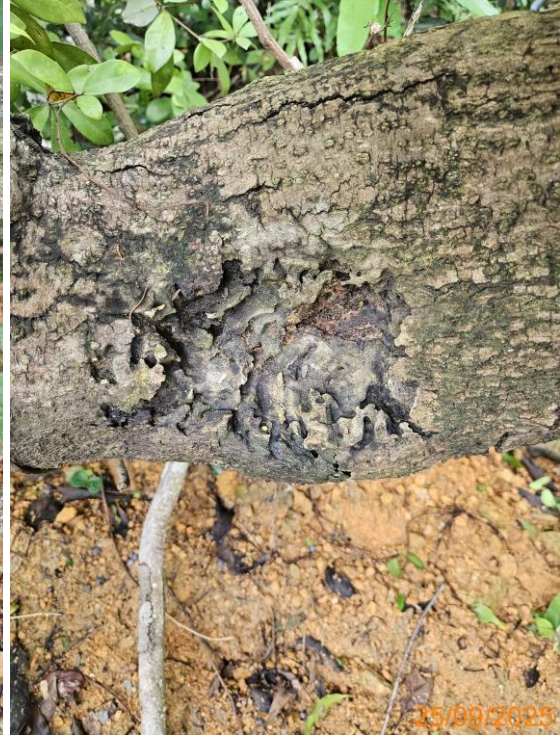
6: T8231\_Borer hole#2

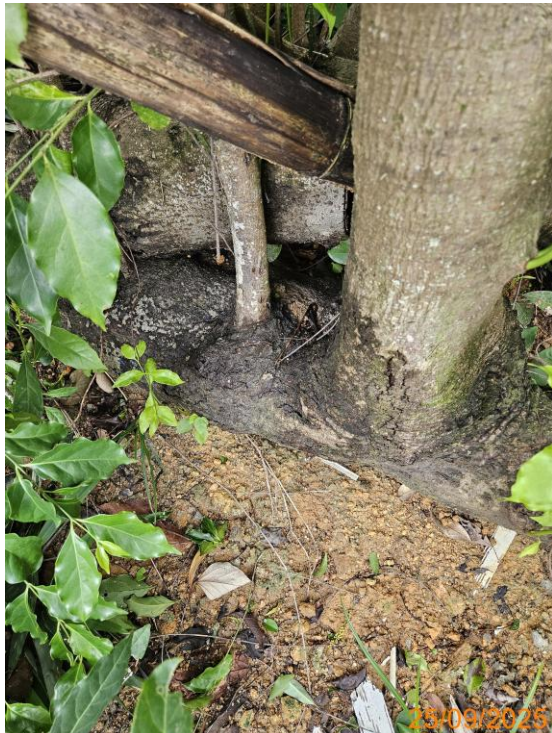
7: T8231\_Trunk base

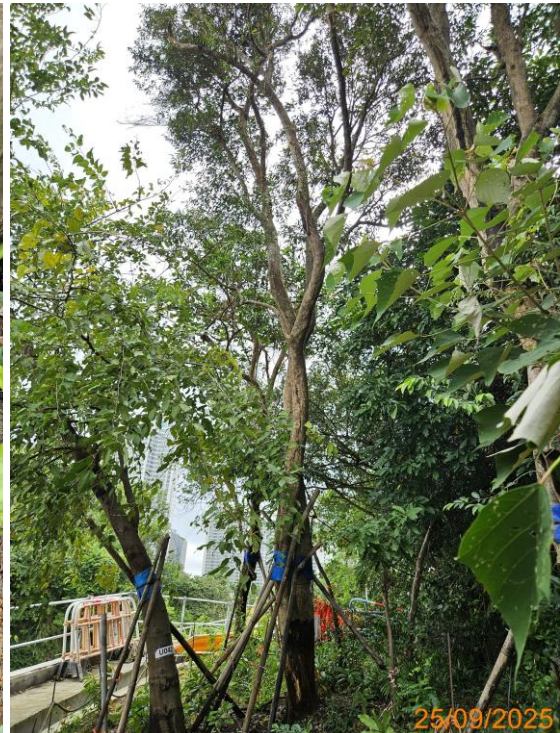
8: U041

| Tree No. | Species | | | Measurements | | | Amenity Value<br>(High(H) / Medium (M) / Low(L) | Tree Condition (Good(G) / Average(A) / Poor(P)) | | | Recommendation<br>(Retain / Transplant / Remove) | Findings | Remark |
|---|---|---|---|---|---|---|---|---|---|---|---|---|---|
| U041 | <i>Aquilaria sinensis</i> | 土沉香 | RPPHK;<br>Cap.586;<br>IUCN:VU | 10 | 318 | 4 | M | A | P | P | Retain | No obvious old termite track was found, damage of wood tissue was observed. Peeling off of bark and sign of split of internal wood tissue was observed. Trunk wound significantly decayed. High trunk failure risk. | Located closed to cut slope. The crack on trunk was found slightly larger since late March 2024. Peeling off of bark and split of internal wood tissue was observed in July 2024. Abnormal bark crack was found in December 2024. Additional guying for tree no. U041 has been installed as an enhanced stabilization measure alongside the bamboo staking in May 2025. Adjustment of guying and application of insecticide and fungicide was conducted on 18 September 2025. Adjustment of trunk protection pad was conducted on 18 September 2025 and 25 September 2025. |

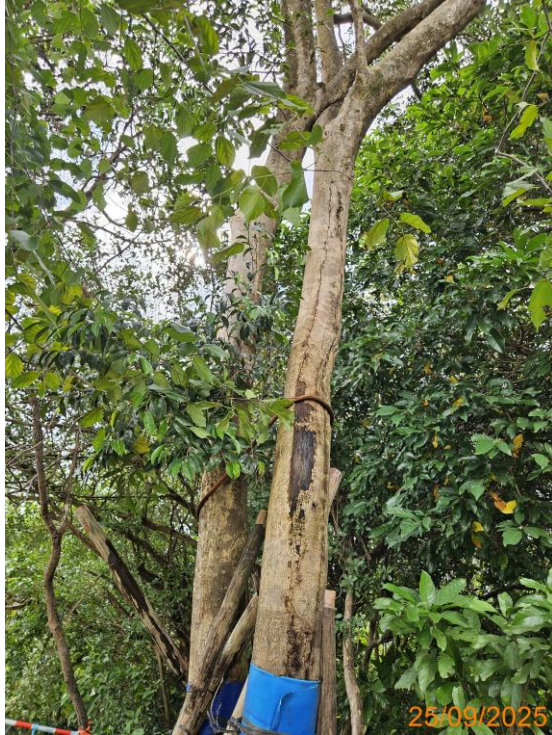
9: U041\_Abnormal bark crack on trunk

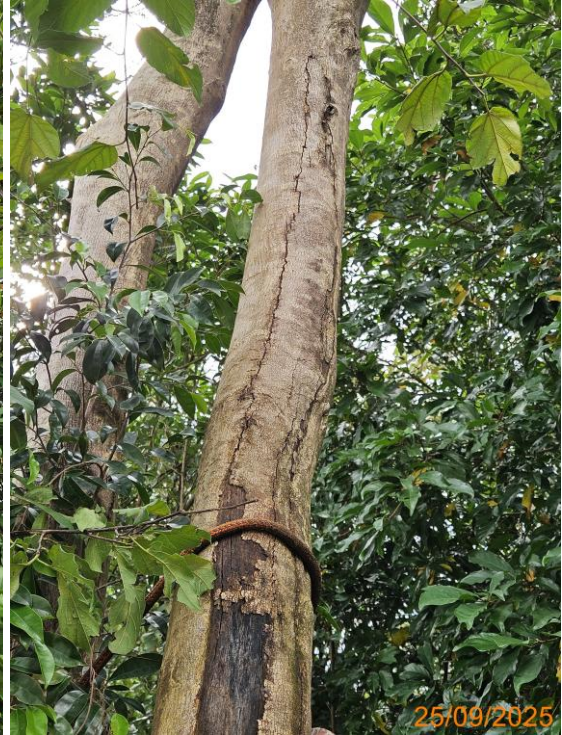
10: U041\_Abnormal bark crack on trunk\_Close up

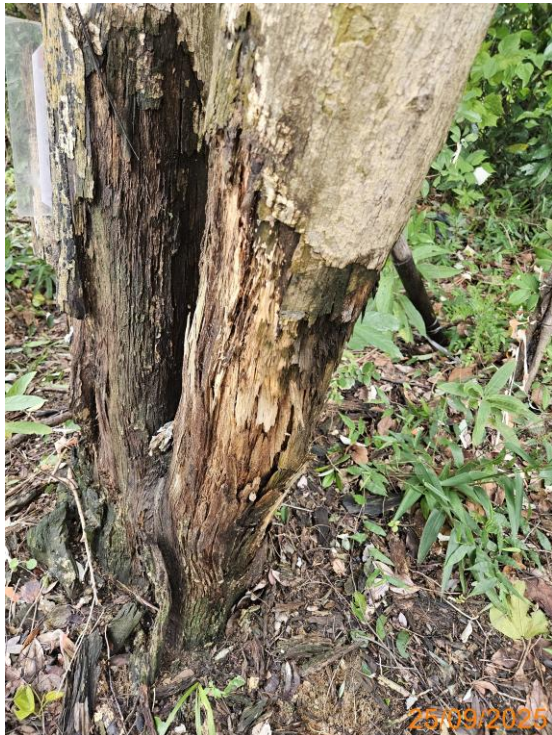
11: U041\_Crack on trunk

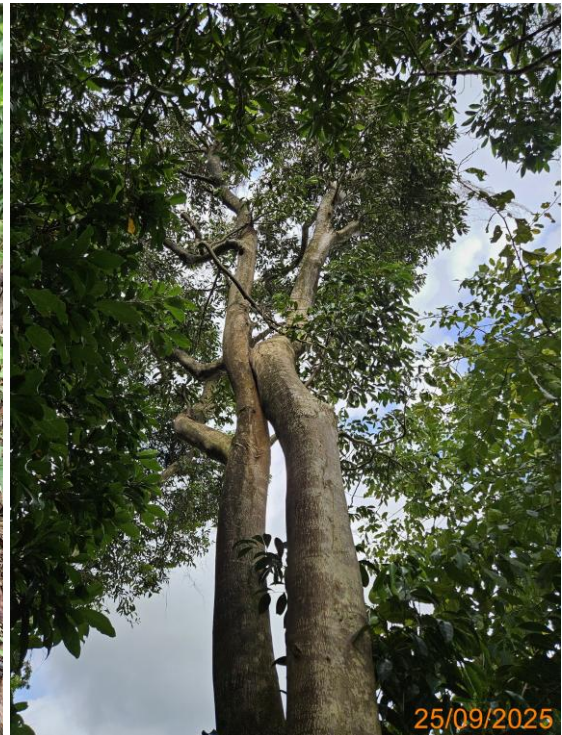
12: U041\_Crown

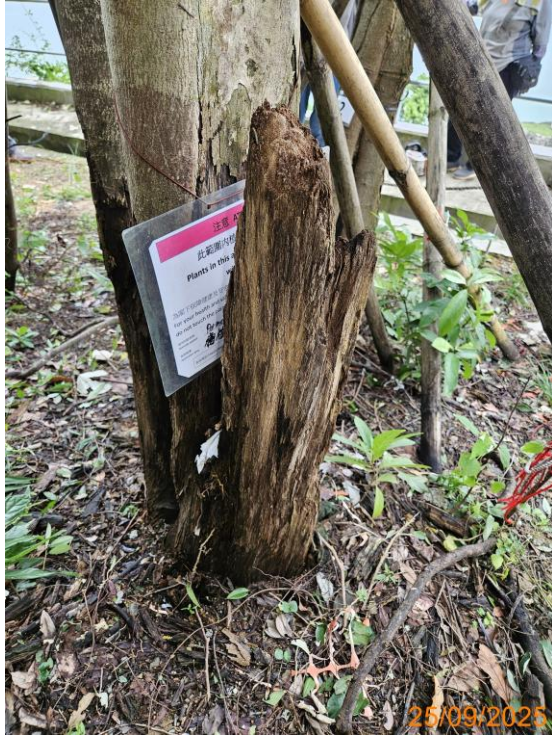
13: U041\_Wood damage at trunk union#1

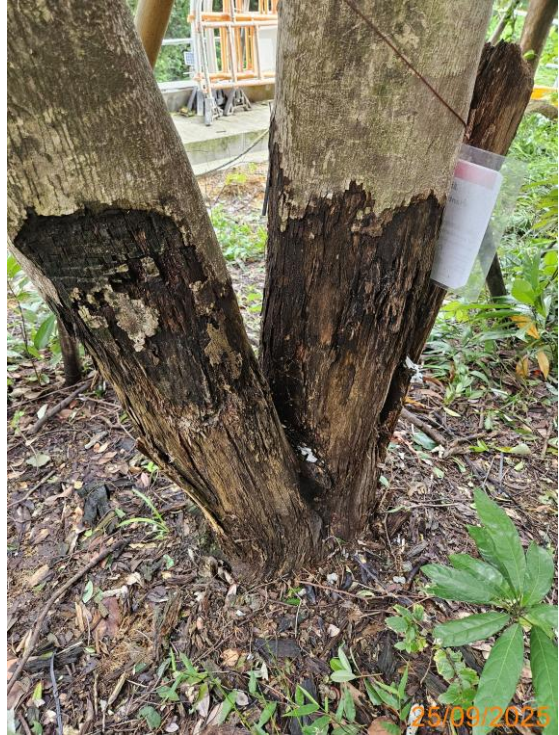
14: U041\_Wood damage at trunk union#2

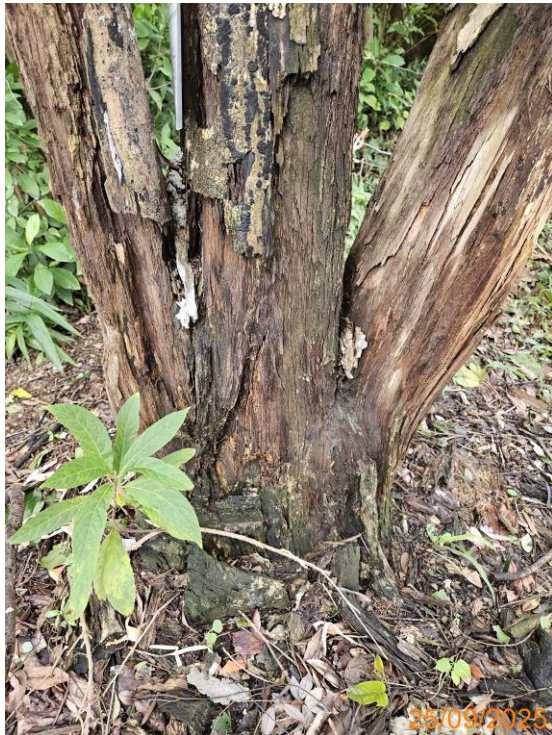
15: U041\_Wood damage at trunk union#3

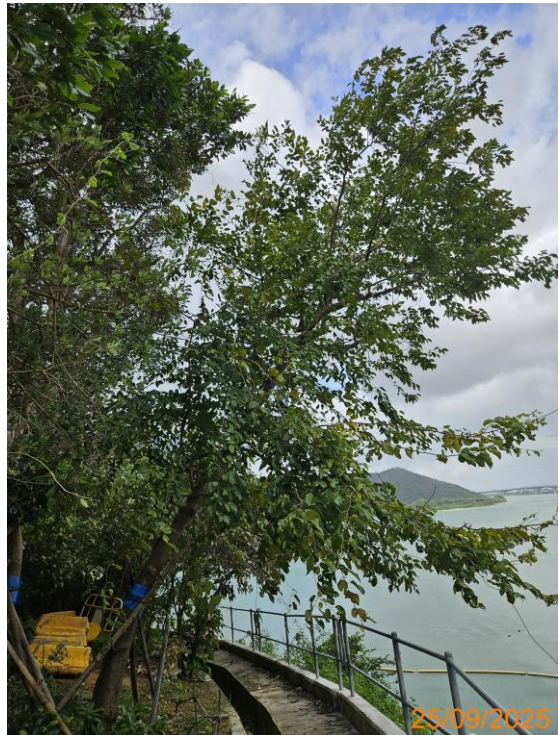
16: U042

| Tree No. | Species | | | Measurements | | | Amenity Value<br>(High(H) / Medium (M) / Low(L) | Tree Condition (Good(G) / Average(A) / Poor(P)) | | | Recommendation<br>(Retain / Transplant / Remove) | Findings | Remark |
|---|---|---|---|---|---|---|---|---|---|---|---|---|---|
| U042 | <i>Gmelina chinensis</i> | 石梓 | RPPHK | 6 | 150 | 2 | M | A | P | A | Retain | Large wound near trunk base with wound wood development. Trunk wound is decaying. | Located closed to cut slope. Application of insecticide and fungicide as preventive measure was conducted on 18 September 2025. Adjustment of trunk protection pad was conducted on 18 September 2025 and 25 September 2025. |

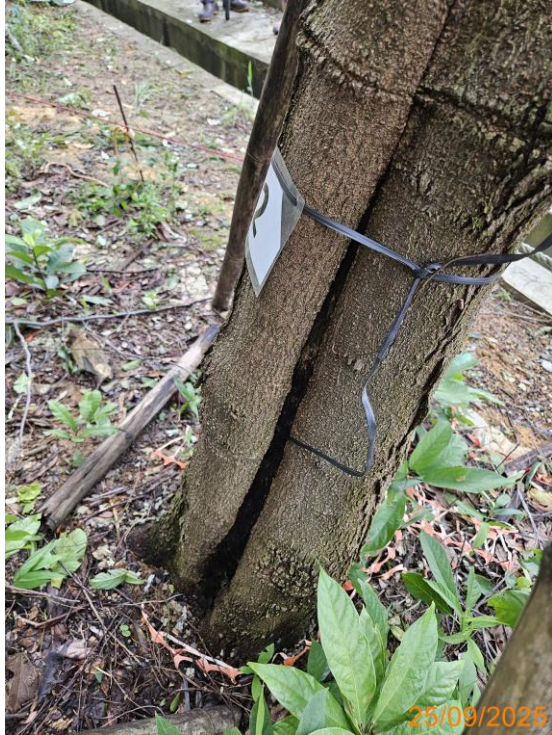
17: U042\_Wound on trunk base

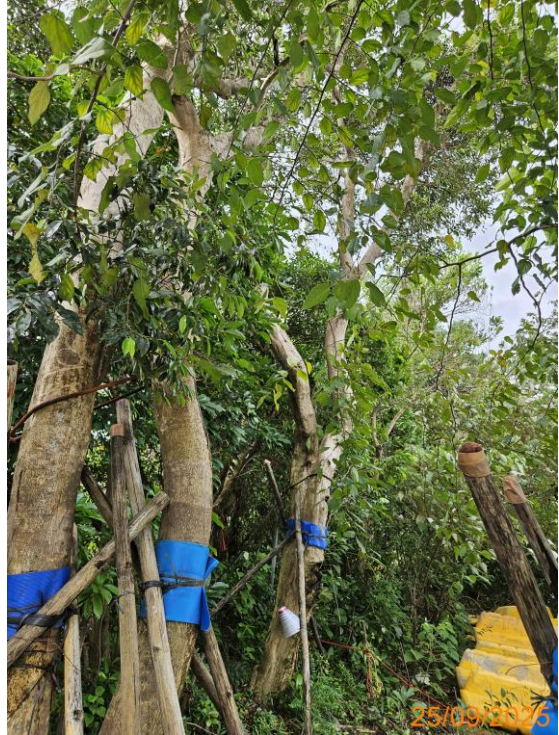
18: U043

| Tree No. | Species | | | Measurements | | | Amenity Value<br>(High(H) / Medium (M) / Low(L) | Tree Condition (Good(G) / Average(A) / Poor(P)) | | | Recommendation<br>(Retain / Transplant / Remove) | Findings | Remark |
|---|---|---|---|---|---|---|---|---|---|---|---|---|---|
| U043 | <i>Aquilaria sinensis</i> | 土沉香 | RPPHK;<br>Cap.586;<br>IUCN:VU | 9 | 310 | 4 | M | A | P | P | Retain | Crack on trunk base. Trunk wound significantly decayed. High trunk failure risk. | Located closed to cut slope and fenced off by 2m high barrier. Application of insecticide and fungicide was conducted on 18 September 2025. Adjustment of trunk protection pad was conducted on 18 September 2025 and 25 September 2025. |

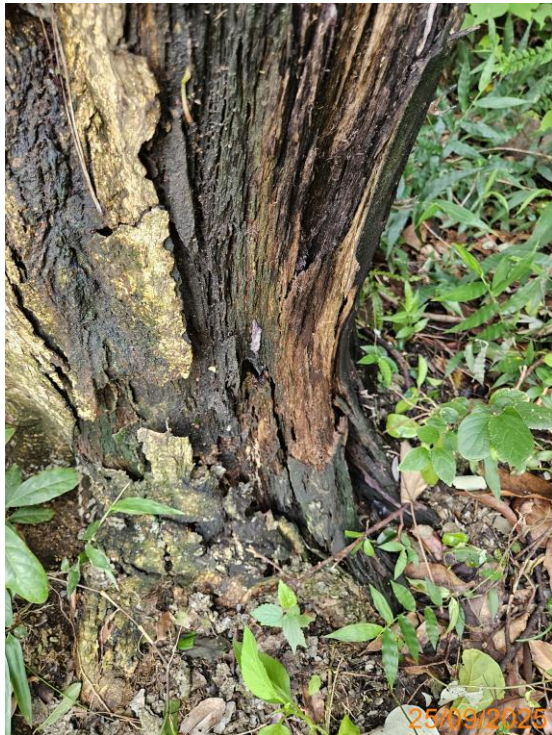
19: U043\_Crack on trunk

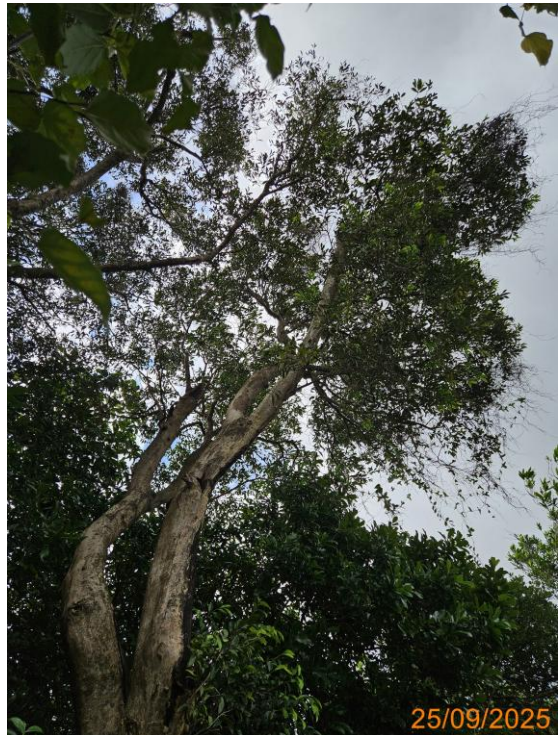
20: U043\_Crown

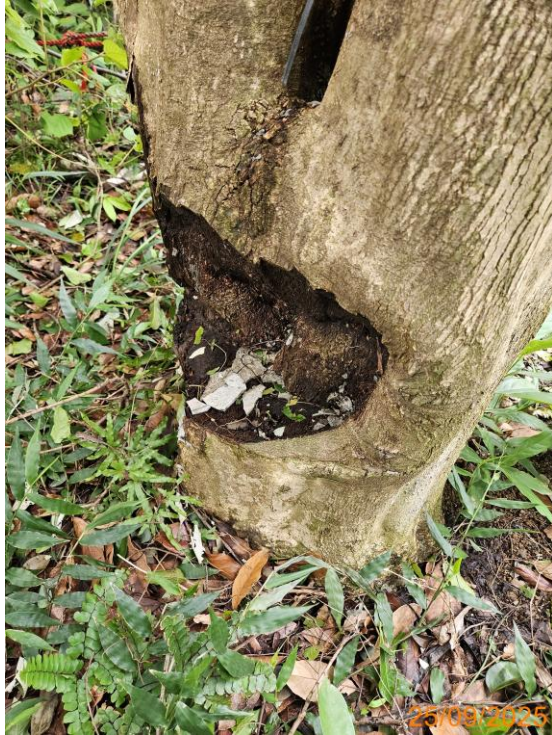
21: U043\_Wound on trunk#1

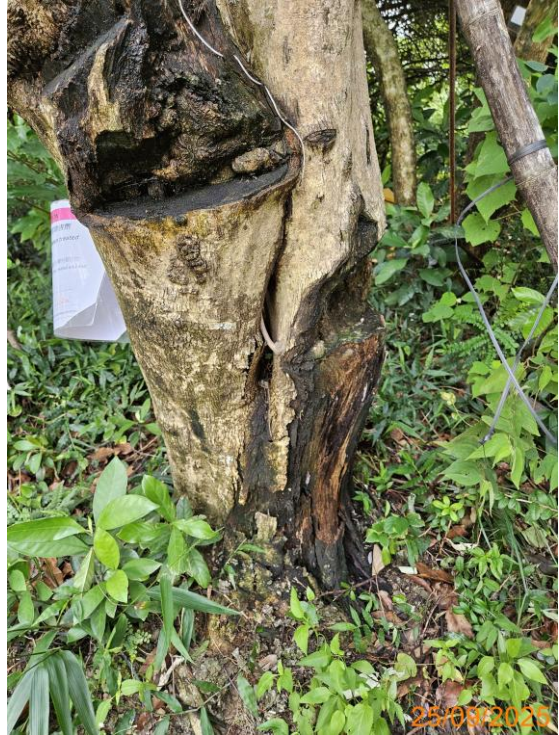
22: U043\_Wound on trunk#2

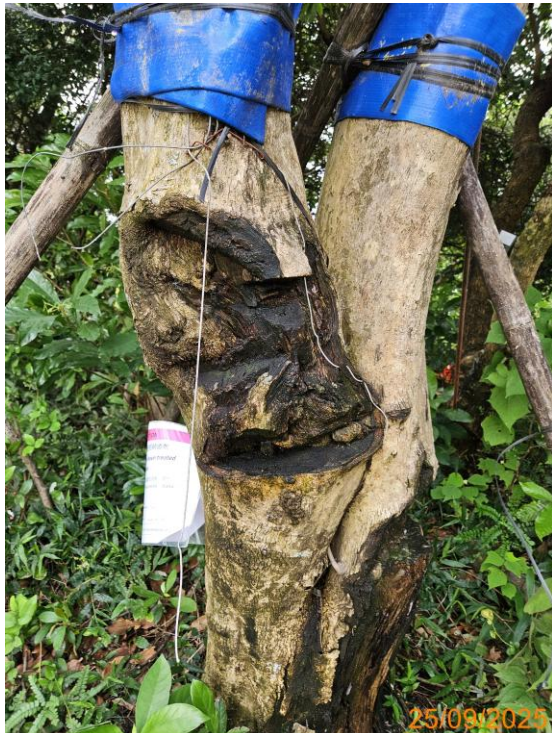
23: U043\_Wound on trunk#3
