**Tree Schedule for Survey of Plant Species of Conservation Importance**

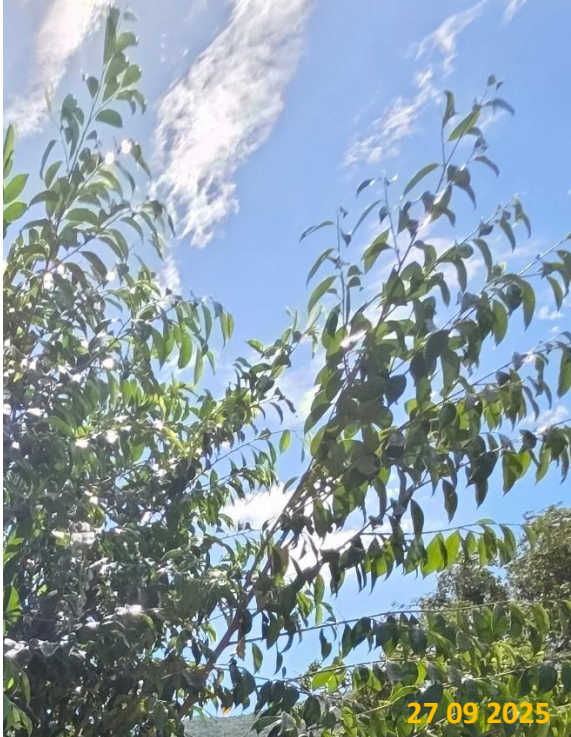
| A11 – Overall view | A11 – Crown condition. |

| No. | Species | | Conservation Status | Measurements | | | Tree Condition (Good(G) / Average(A) / Poor(P)) | | | Recommendation (Retain / Transplant / Remove) | Findings | Remark |
|---|---|---|---|---|---|---|---|---|---|---|---|---|
| A11 (T7521) | <i>Aquilaria sinensis</i> | 土沉香 | RPPHK; Cap.586; IUCN:VU | 190 | 3.5 | 1 | P | A | P | Retain | Insect infestation is not significant. | Root-plate movement (mentioned in previous monitoring report). Topped tree due to illegal felling on Aug 2023 (reported to police on 21 Aug 2023). Large decaying trunk wound. Foliage density reduced after Typhoon T10 event on Sep 2025. |

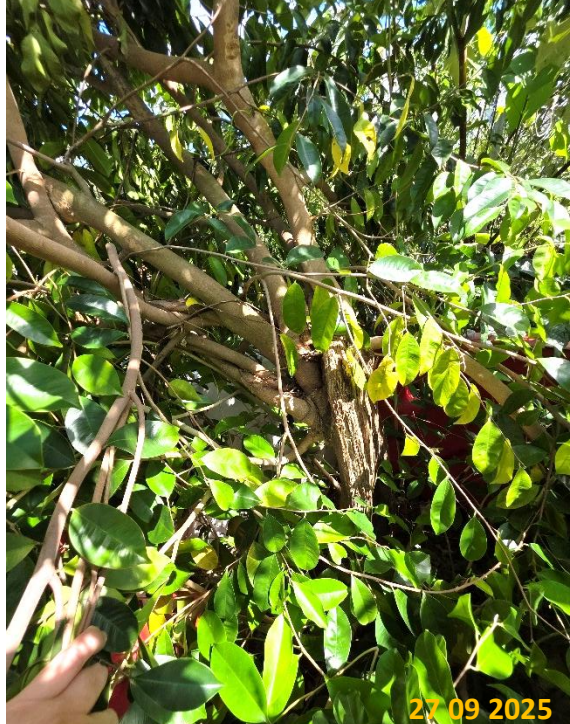
| A11 – Shoots are epicormic generated from cut trunk which is decaying severely | A11 - Soil condition |

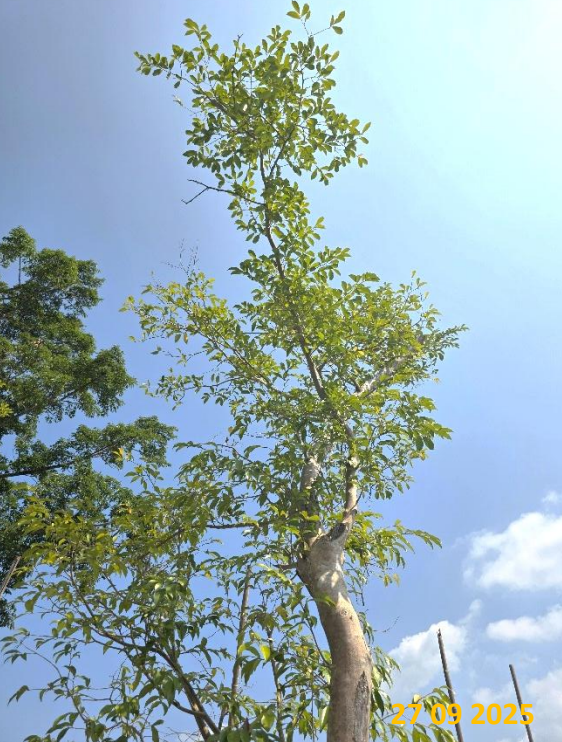
| A8 – Overall view | A8 – Crown condition. Foliage density reduced significantly after Super Typhoon. |

| No. | Species | | Conservation Status | Measurements | | | Tree Condition (Good(G) / Average(A) / Poor(P)) | | | Recommendation (Retain / Transplant / Remove) | Findings | Remark |
|---|---|---|---|---|---|---|---|---|---|---|---|---|
| A8<br>(T8996) | <i>Aquilaria sinensis</i> | 土沉香 | RPPHK;<br>Cap.586;<br>IUCN:VU | 110 | 5 | 4 | P | P | P | Transplant | The foliage density is low and further reduced after recent inclement weather events. No obvious wound wood production. Severity of the insect feeding was low. | Trunk wounds were observed before transplant operation. Shallow root. Sudden defoliation happened in May 2023 but recovered in Aug 2023. It was translocated to the temporary holding nursery on 29 Sep 2023. A branch (5cm) was broken due to typhoon in Oct 2023. Decaying wounds and exposed dead woods on trunk. |

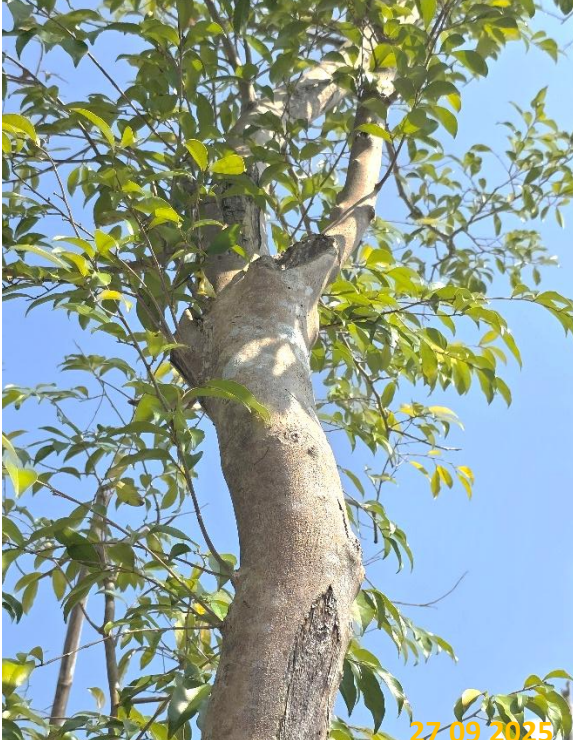
| A8 – Pruning wound previously damaged by typhoon KOINU (Oct 2023) | A8 – Trunk and root condition. |

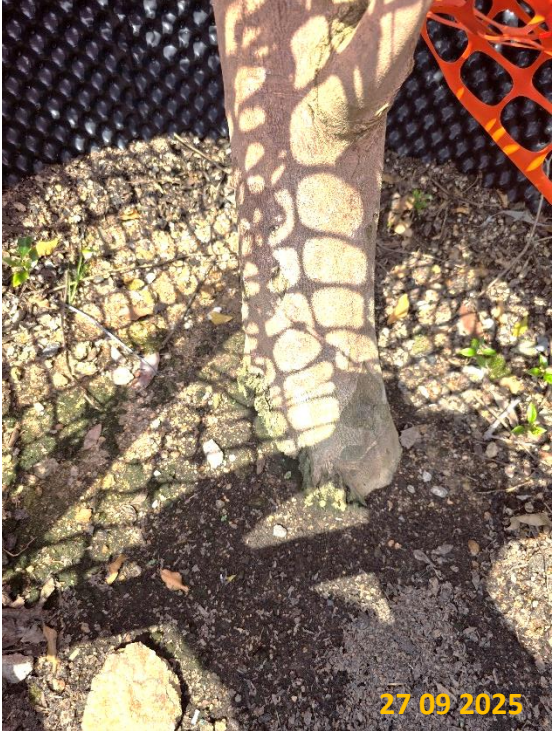
| A8 – Decaying wound at trunk base<br>(size: ~180mm x170mm) | A8 – Decaying wound on trunk |

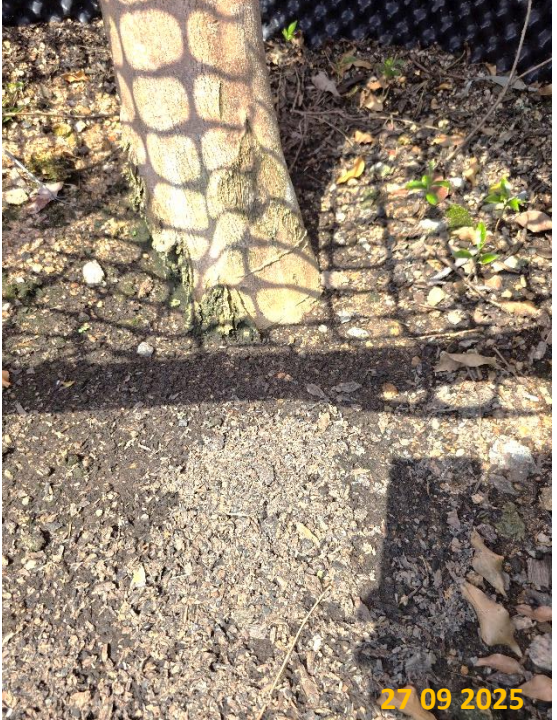
| A8 – Ant nest was not found | A8 – Leaves chlorosis and thin |

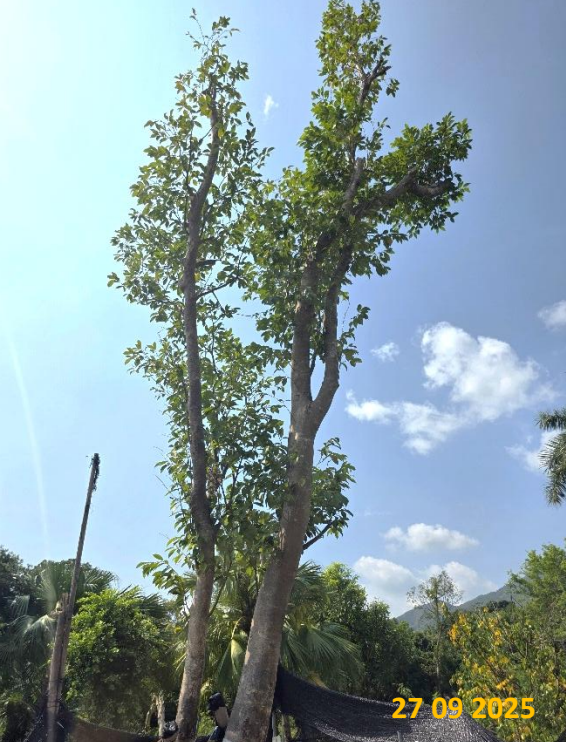
| A12 - Overall View | A12 - Dieback observed. |

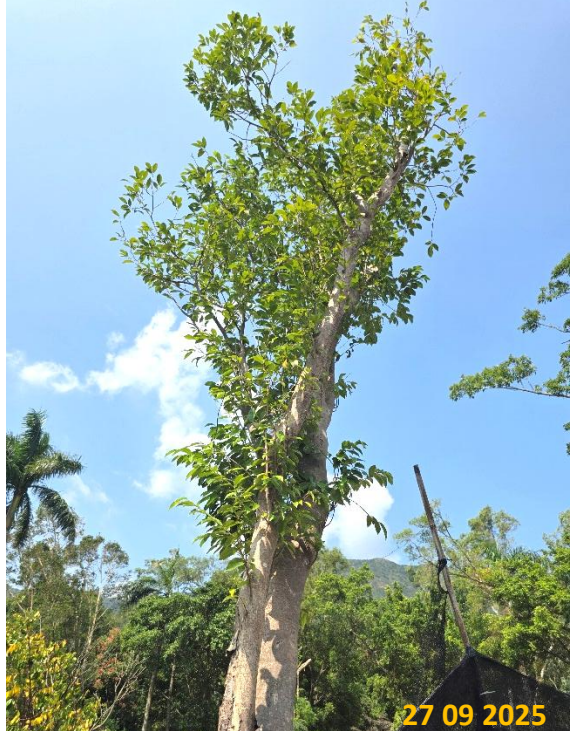
| A12 - Foliage density reduced significantly after Super Typhoon. | A12 – Trunk and root condition |

| No. | Species | | Conservation Status | Measurements | | | Tree Condition (Good(G) / Average(A) / Poor(P)) | | | Recommendation (Retain / Transplant / Remove) | Findings | Remark |
|---|---|---|---|---|---|---|---|---|---|---|---|---|
| A12<br>(T3537) | <i>Aquilaria sinensis</i> | 土沉香 | RPPHK;<br>Cap.586;<br>IUCN:VU | 185 | 8 | 3 | P | P | A | Transplant | The foliage density is low and further reduced after recent inclement weather events. No obvious wound wood production. Severity of the insect feeding was low. | Trunk wounds were observed before transplant operation. Shallow root. Original root ball was full of stones which were removed partially during the translocation. It was translocated to the temporary holding nursery on 29 Sep 2023. It collapsed during typhoon dated Oct 2023 resulted in largely reduction in foliage density. It was slightly lean after a typhoon event dated 13-14 Nov 2024 and reinstated. Decaying wounds and exposed dead woods on trunk. |

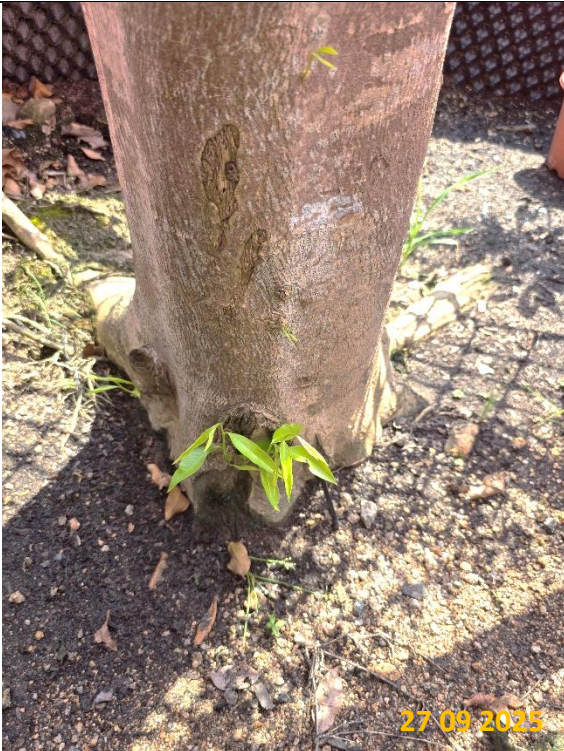
| <p>A12 –Wound at trunk base</p> <p>27 09 2025</p> | <p>A12 – Decaying wound on trunk</p> <p>27 09 2025</p> |

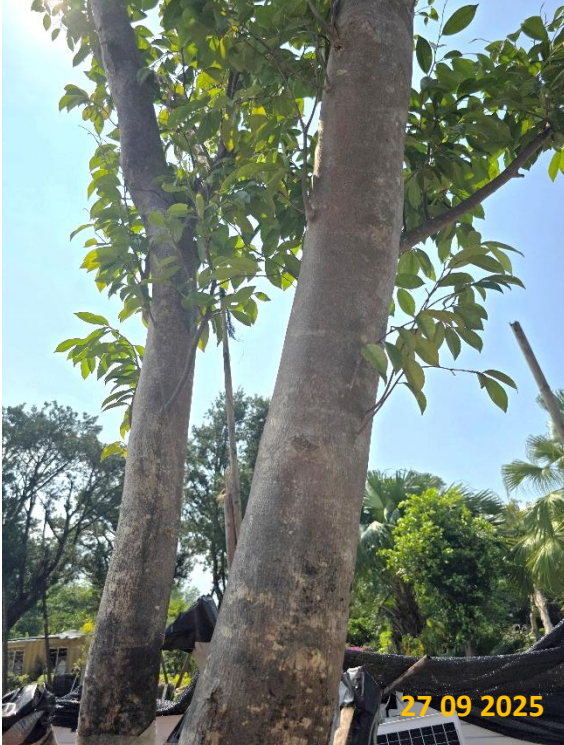
| <p>A12 – New epicormics on trunk</p> <p>27 09 2025</p> | <p>Fencing is in order during inspection</p> <p>27 09 2025</p> |
