Tree Schedule for Survey of Plant Species of Conservation Importance

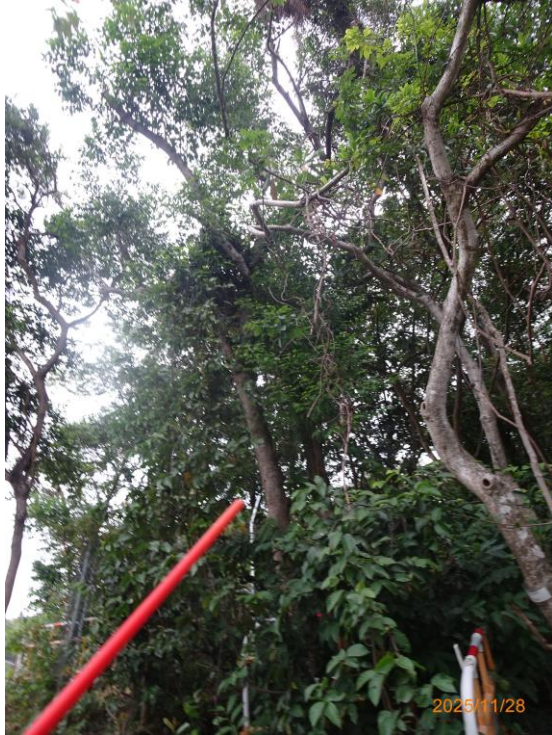
1: T8217

Tree No.	Species			Measurements			Amenity Value (High(H) / Medium (M) / Low(L)	Tree Condition (Good(G) / Average(A) / Poor(P))			Recommendation (Retain / Transplant / Remove)	Findings	Remark
	Scientific Name	Chinese Name	Conservation Status	Height (m)	DBH (mm)	Crown Spread (m)		Form	Health	Structure			
T8217	<i>Canthium dicoccum</i>	魚骨木	IUCN:VU	9	220	6	L	P	A	P	Retain	Branch failure of T8217 was found on 21 July 2025 due to Typhoon signal No. 10. Overall condition of tree and its remaining part is fair.	There is no proper and safe assess towards T8231 & T8217, thus, plastics barriers were installed in lieu of 2m high barrier. Branch failure of T8217 was found on 21 July 2025. It was identified that the fallen part was one of the branches on upper position of tree. No decay was observed on the tearing position. No other collapsed part was observed due to adverse weather during time of inspection. Overall condition of tree and its remaining part is fair. Pruning of jagged wound to provide a clean cut is recommended. The pruning work the completed on 21 July 2025. Application of insecticides and fungicides on wound was conducted to prevent infection of wound on 16 November 2025.

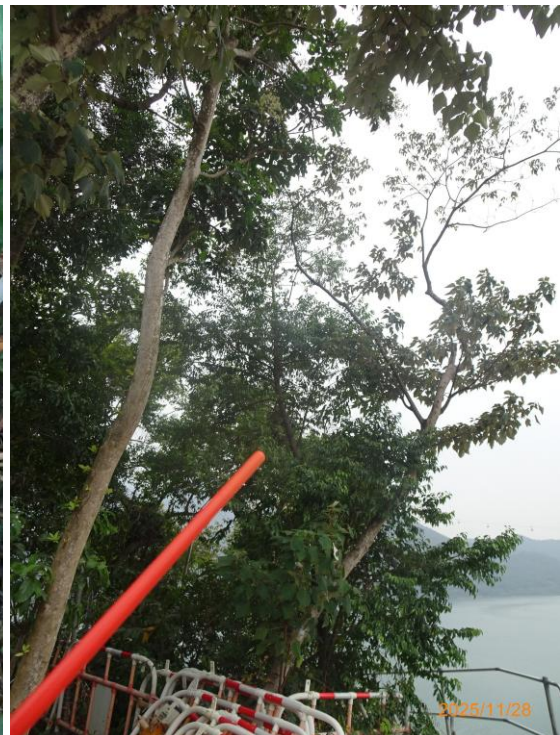
4: T8231

T8231	<i>Canthium dicoccum</i>	魚骨木	IUCN:VU	7	190	6	L	P	A	P	Retain	Second epicormic failure was found on 21 July 2025 due to Typhoon signal No. 10, Overall condition of tree and its remaining part is fair	There is no proper and safe assess towards T8231 & T8217, thus, plastics barriers were installed in lieu of 2m high barrier. Epicormic branch failure was found on 03 May 2024. Staking to provide extra support and pruning of jagged wound to provide a clean cut was conducted on 16 May 2024. Application of insecticide and fungicide on wound was conducted on 16 November 2025. Adjustment of trunk protection pad was conducted on 16 November 2025. The Staking was in normal condition during the time of inspection. No further significant defects were observed. Second epicormic failure was found on 21 July 2025, Overall condition of tree and its remaining part is fair. Pruning of jagged wound to provide a clean cut is recommended. Pruning works was completed on 21 July 2025.

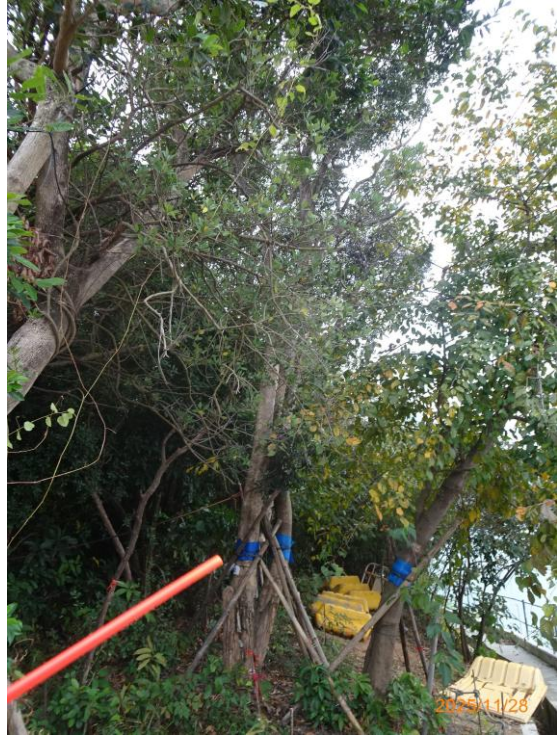
6: U041

U041	<i>Aquilaria sinensis</i>	土沉香	RPPHK; Cap.586; IUCN:VU	10	318	4	M	A	P	P	Retain	No obvious old termite track was found, damage of wood tissue was observed. Peeling off of bark and sign of split of internal wood tissue was observed. Trunk wound significantly decayed. High trunk failure risk.	Located closed to cut slope. The crack on trunk was found slightly larger since late March 2024. Peeling off of bark and split of internal wood tissue was observed in July 2024. Abnormal bark crack was found in December 2024. Additional guying for tree no. U041 has been installed as an enhanced stabilization measure alongside the bamboo staking in May 2025. Adjustment of guying and application of insecticide and fungicide was conducted on 16 November. Adjustment of trunk protection pad was conducted on 16 November 2025.
U042	<i>Gmelina chinensis</i>	石梓	RPPHK	6	150	2	M	A	P	A	Retain	Large wound near trunk base with wound wood development. Trunk wound is decaying.	Located closed to cut slope. Application of insecticide and fungicide as preventive measure was conducted on 16 November 2025. Adjustment of trunk protection pad was conducted on 16 November 2025.

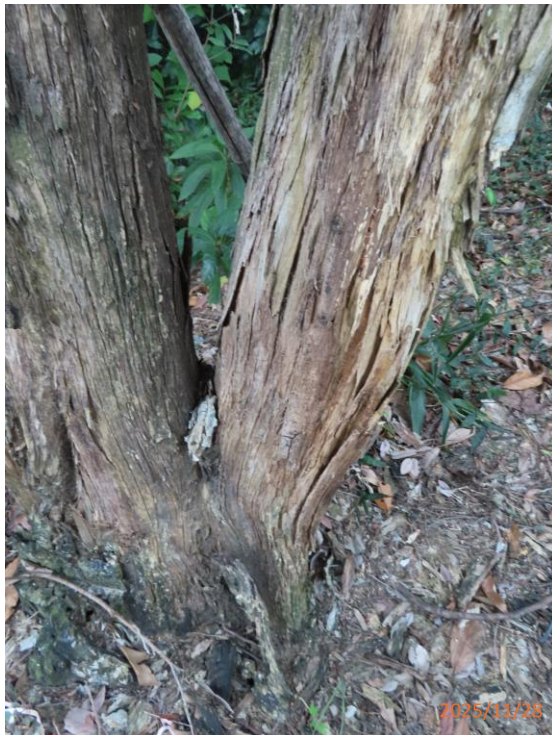
7: U041_Crack on trunk

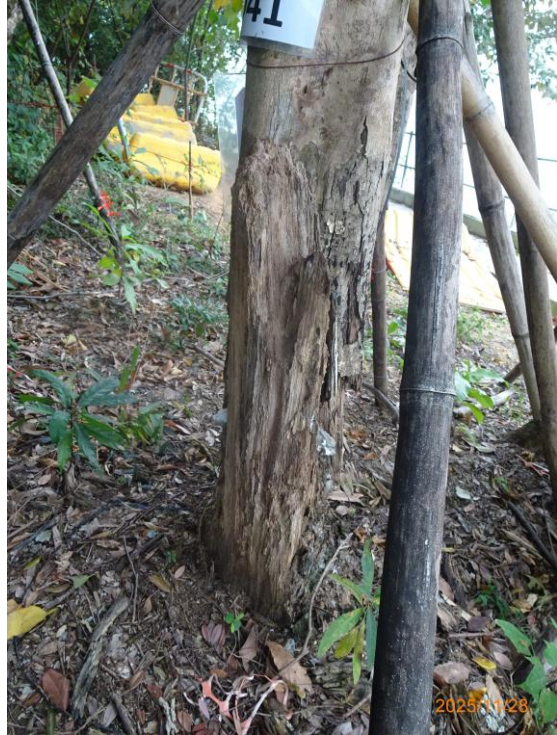
10: U041_Wood damage at trunk union#1

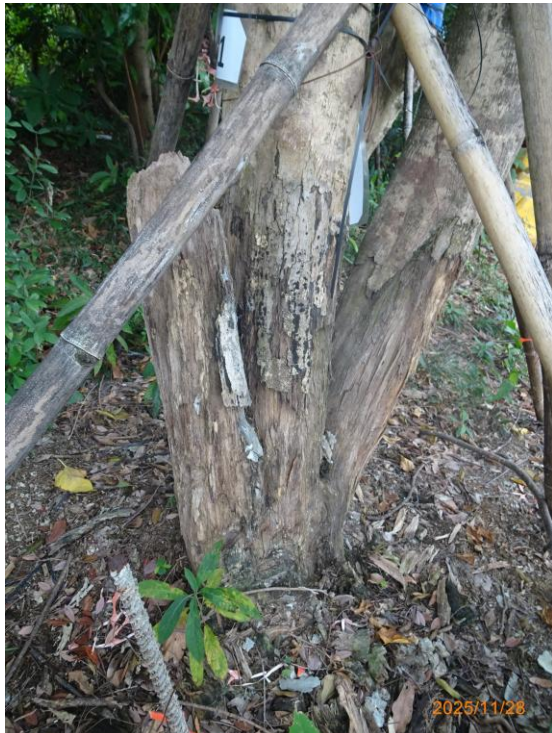
11: U041_Wood damage at trunk union#2

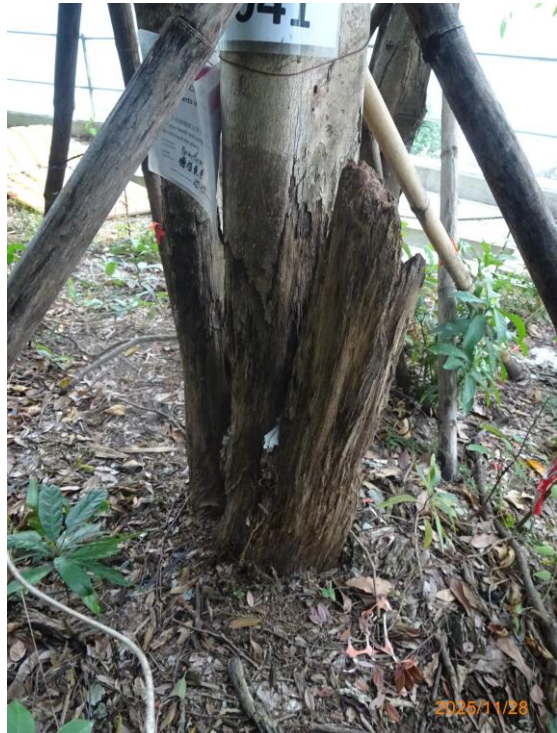
12: U041_Wood damage at trunk union#3

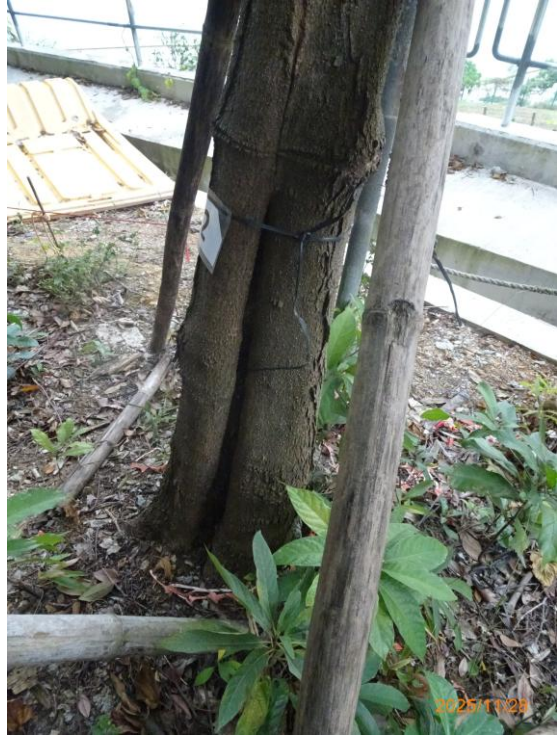
14: U042_Wound on trunk base

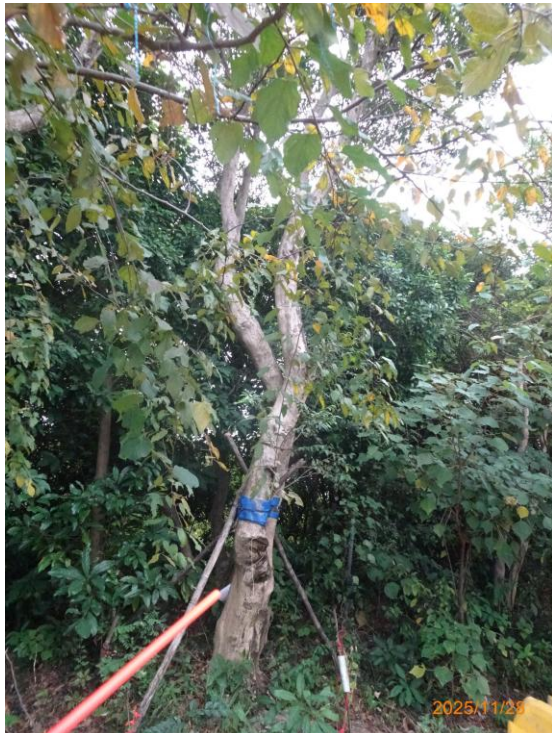
15: U043

U043	<i>Aquilaria sinensis</i>	土沉香	RPPHK; Cap.586; IUCN:VU	9	310	4	M	A	P	P	Retain	Crack on trunk base. Trunk wound significantly decayed. High trunk failure risk.	Located closed to cut slope and fenced off by 2m high barrier. Application of insecticide and fungicide was conducted on 16 November 2025. Adjustment of trunk protection pad was conducted on 16 November 2025.

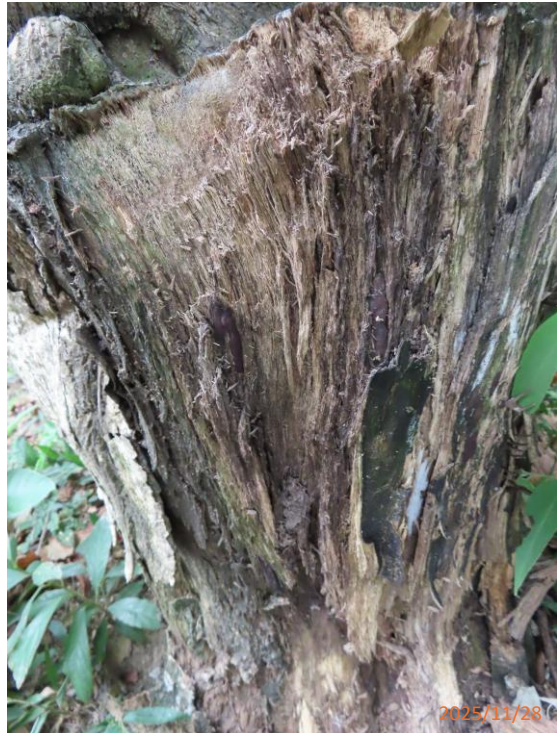
16: U043_Crack on trunk

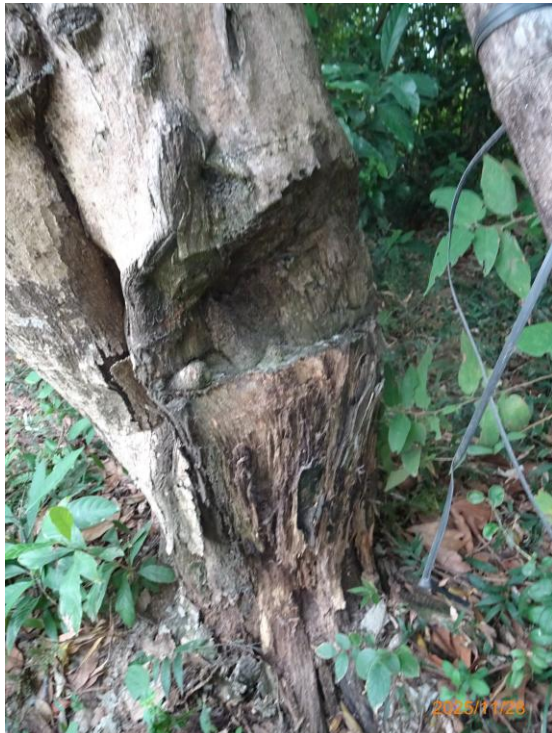
19: U043_Wound on trunk#1

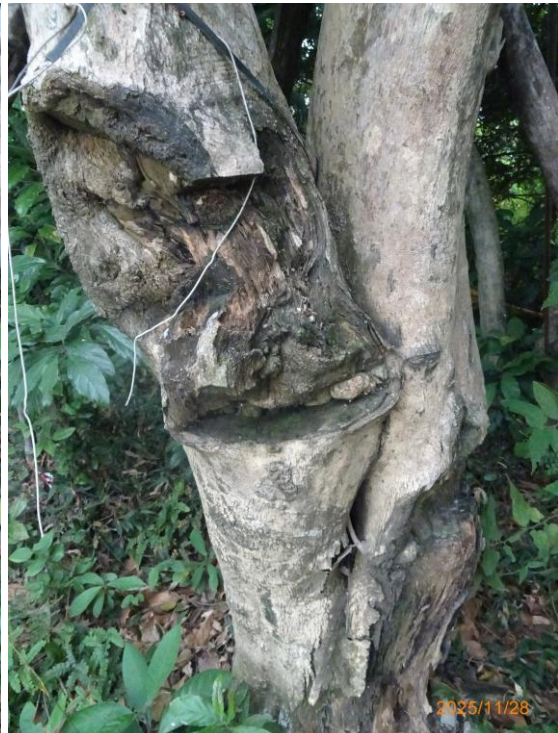
20: U043_Wound on trunk#2
