Tree Schedule for Survey of Plant Species of Conservation Importance

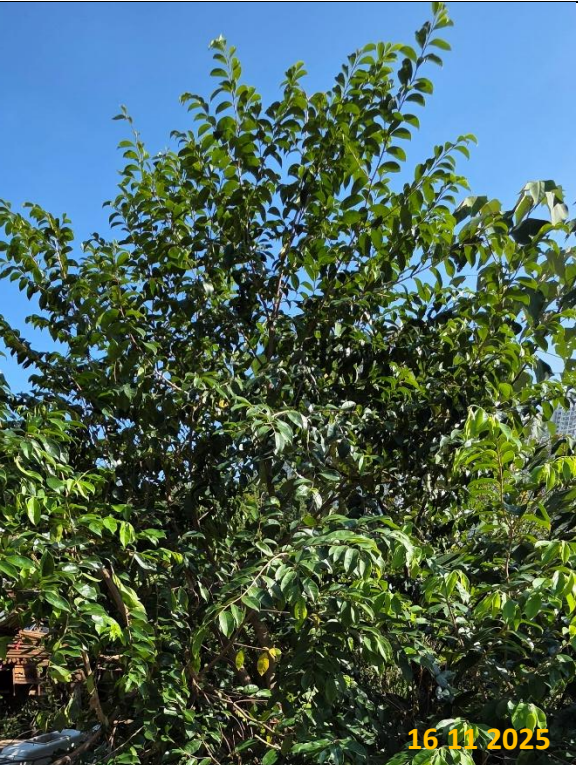
<p>06 12 2025</p>	<p>A11 – Crown condition.</p>

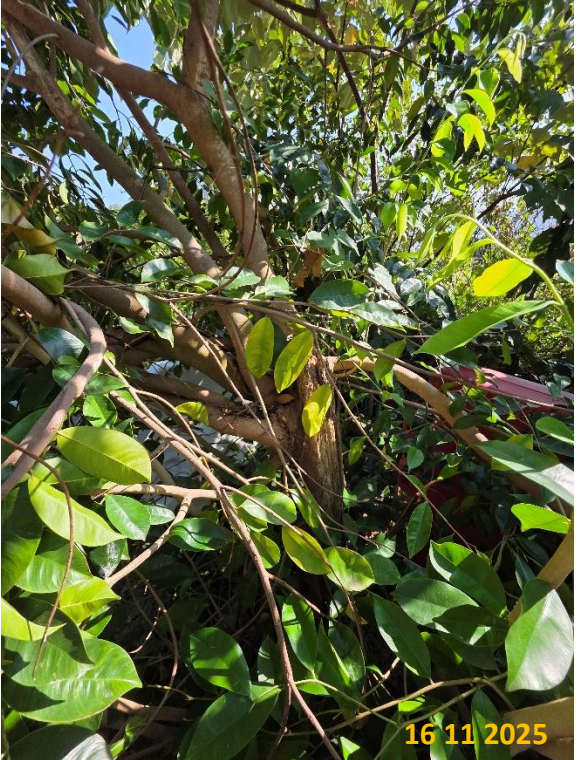
<p>16 11 2025</p>
<p>A11 – Shoots are epicormic generated from cut trunk which is decaying severely</p>

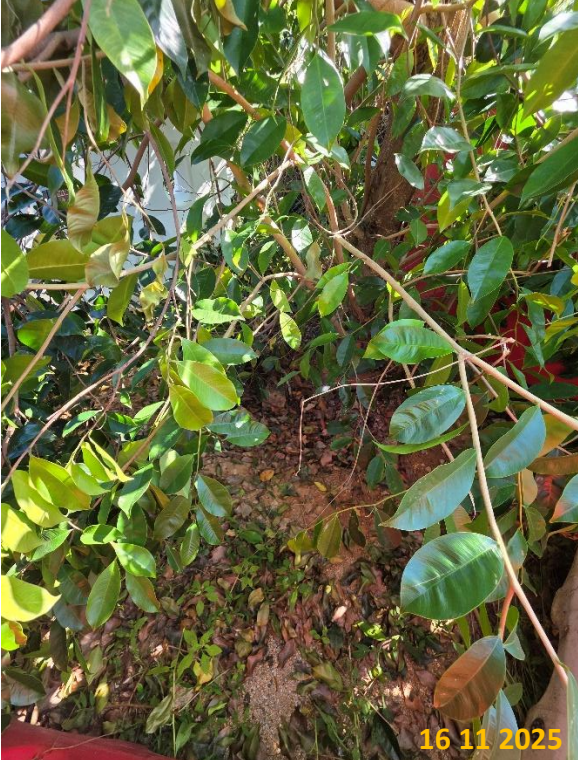
<p>16 11 2025</p>	<p>A11 - Soil condition</p>

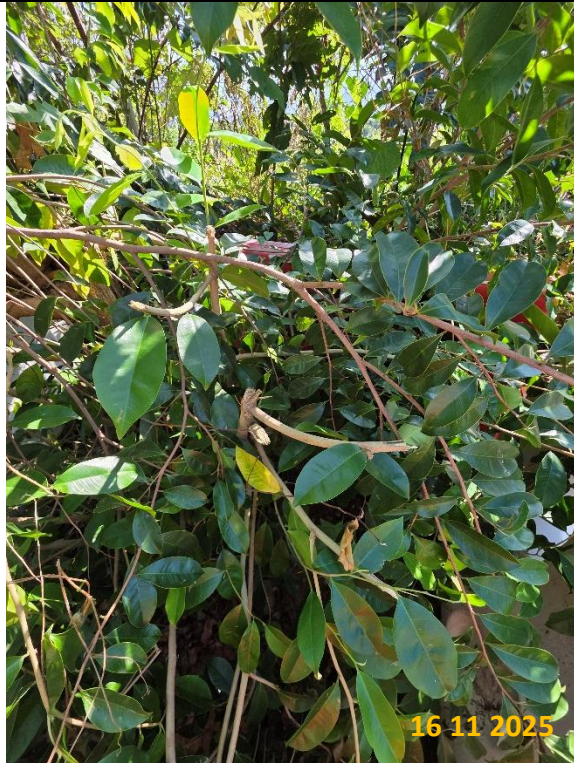
Unknown physical damage is observed resulting in the breaking of some epicormic shoots.

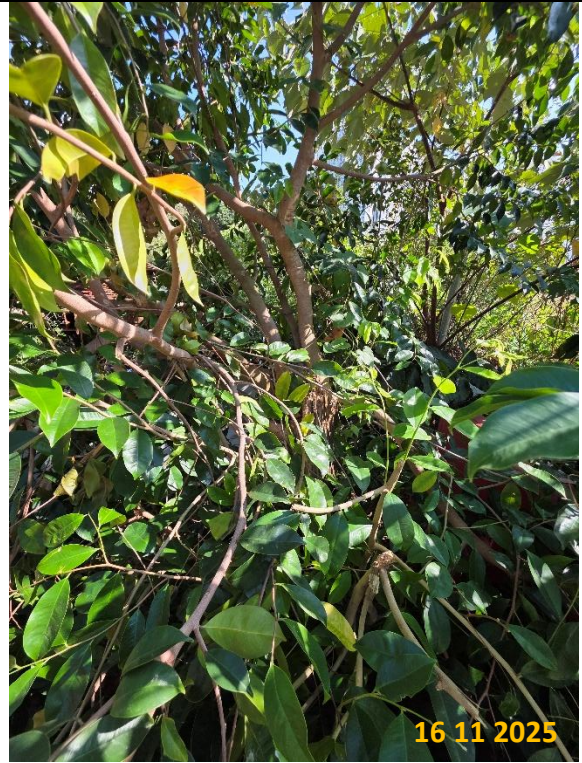
Unknown physical damage is observed resulting in the breaking of some epicormic shoots.

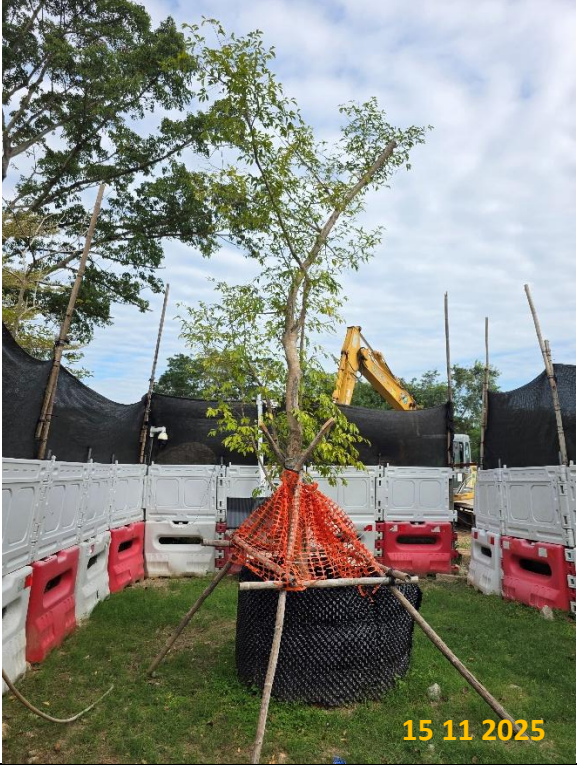
A8 – Overall view	A8 – Crown condition. Foliage density is low since Super Typhoon dated Sep 2025.

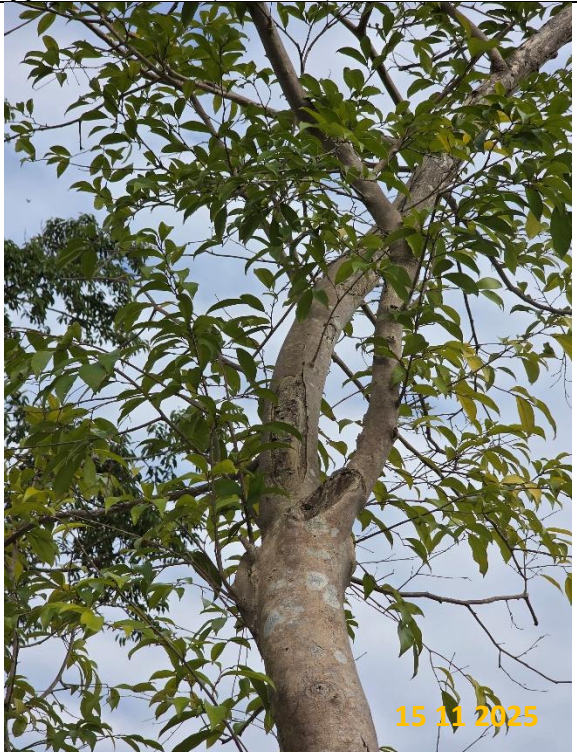
<p>A close-up photograph of the crown of tree A8, showing sparse green foliage against a cloudy sky. The date '15 11 2025' is printed in yellow at the bottom right.</p>
A8 – Pruning wound previously damaged by typhoon KOINU (Oct 2023)	A8 – Trunk and root condition.

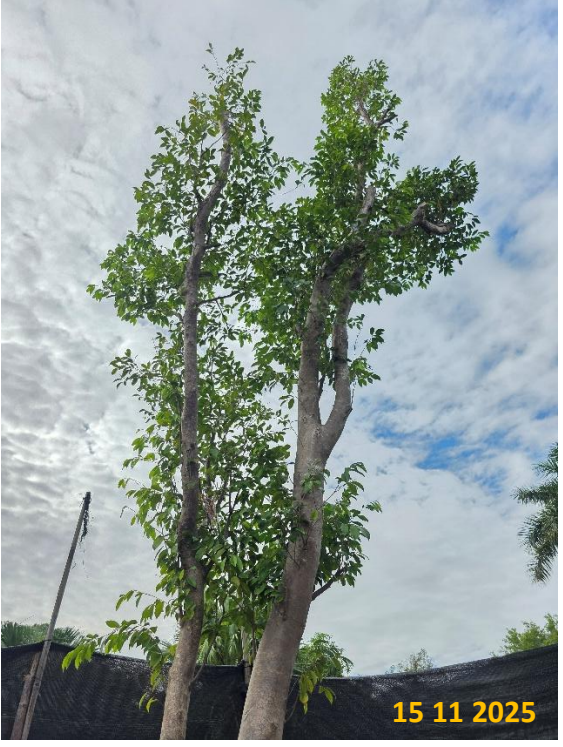
A photograph showing the full height of tree A12. The tree has a slender trunk and a canopy of green leaves. It is situated behind a row of grey and red plastic safety barriers. A black protective net is draped over the base of the tree. A yellow date stamp '15 11 2025' is visible in the bottom right corner of the image. <p>15 11 2025</p>	<p>A12 - Dieback observed.</p>

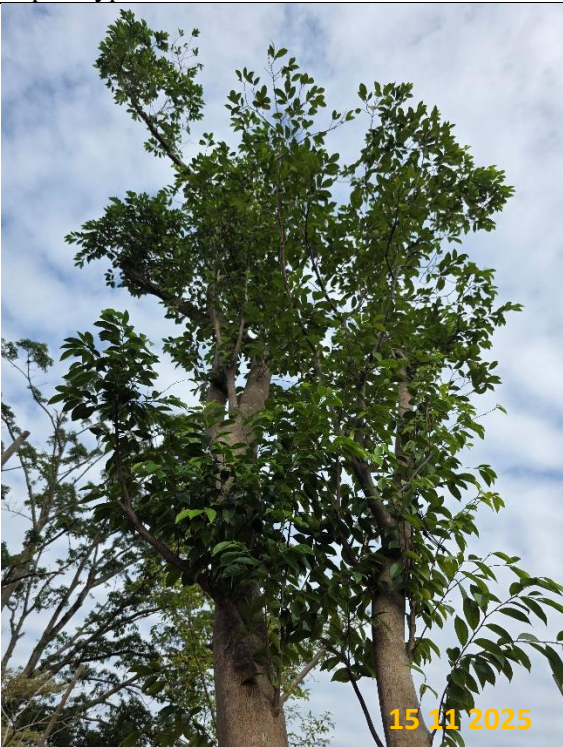
A close-up photograph of the upper part of tree A12, focusing on the canopy. Some branches appear thin and have sparse foliage, indicating dieback. The background shows a cloudy sky. A yellow date stamp '15 11 2025' is visible in the bottom right corner of the image. <p>15 11 2025</p>
<p>A12 - Foliage density reduced significantly after Super Typhoon.</p>

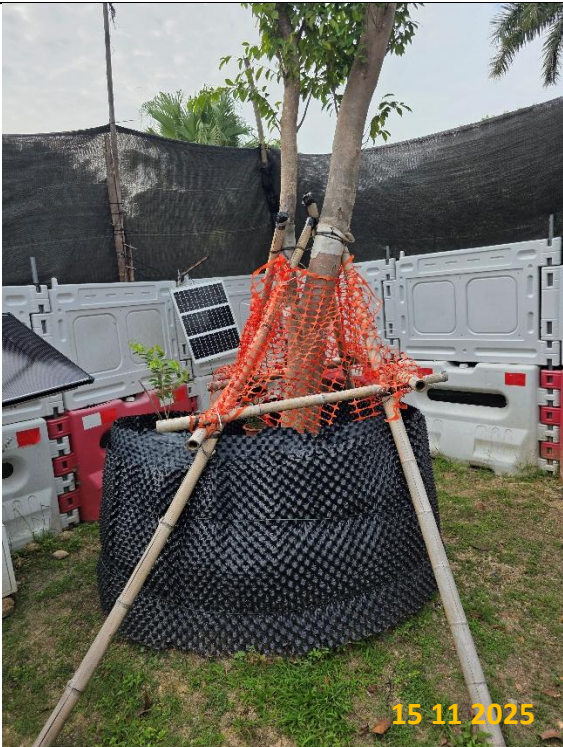
A close-up photograph of the foliage of tree A12. The leaves are green but appear somewhat sparse and thin, consistent with the caption's claim of reduced density after a typhoon. A yellow date stamp '15 11 2025' is visible in the bottom right corner of the image. <p>15 11 2025</p>	<p>A12 – Trunk and root condition</p>

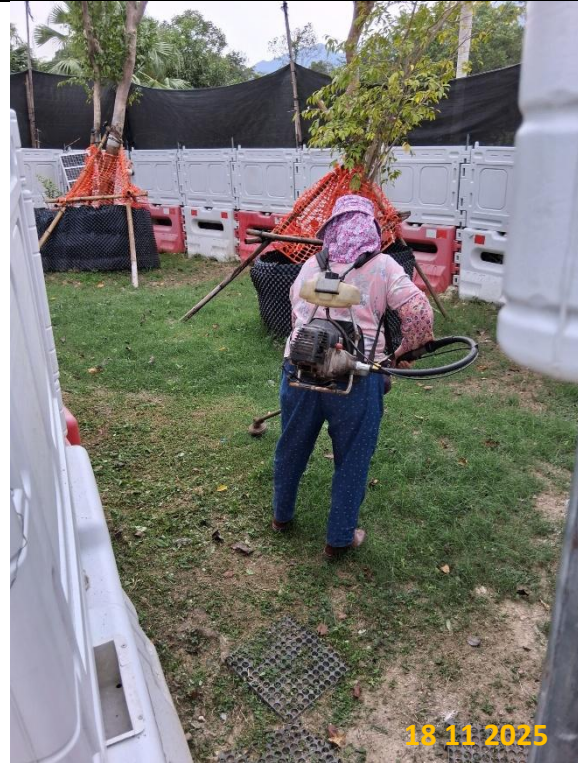
Weeding and grass cutting on 18 November 2025.

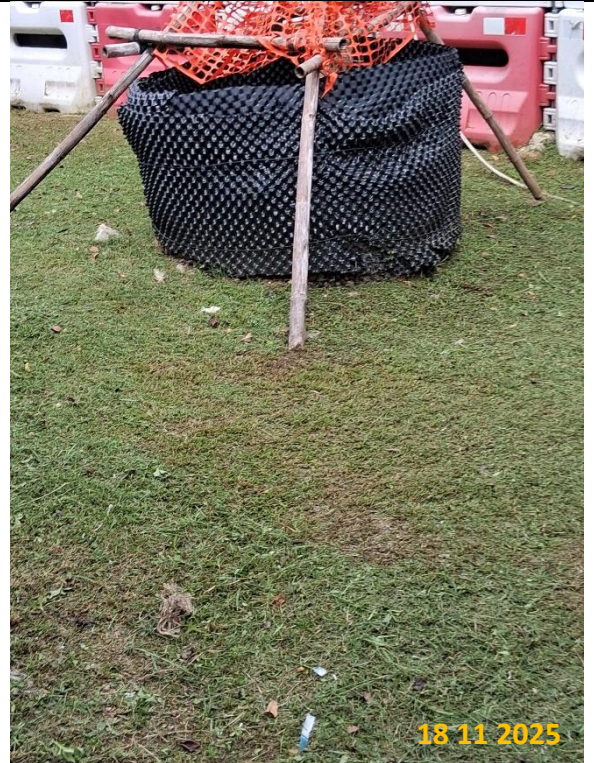
Weeding and grass cutting on 18 November 2025.

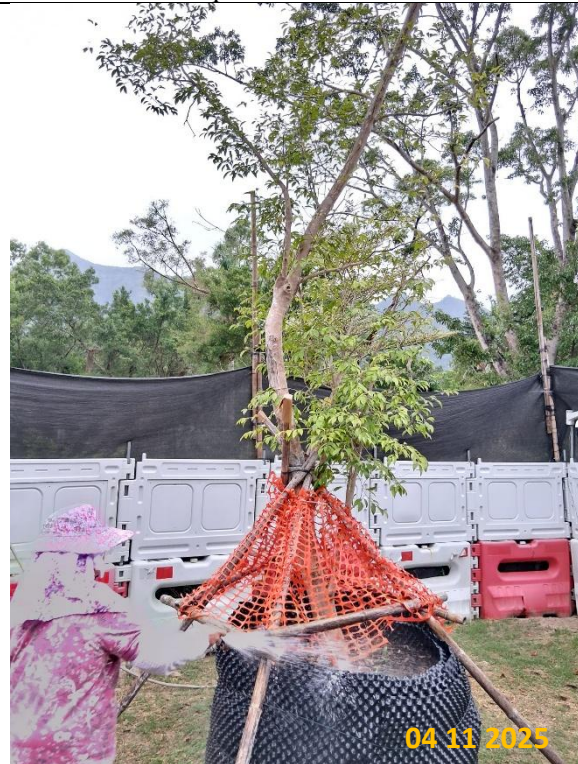
Manual watering was carried out for A8 during the reporting period. The watering frequency is one to two times per week.

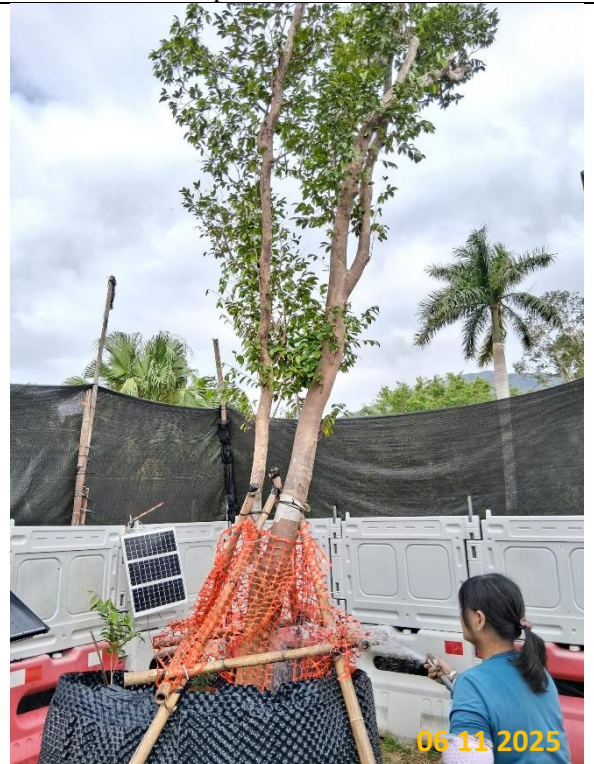
Manual watering was carried out for A12 during the reporting period. The watering frequency is one to two times per week.
