Tree Schedule for Survey of Plant Species of Conservation Importance

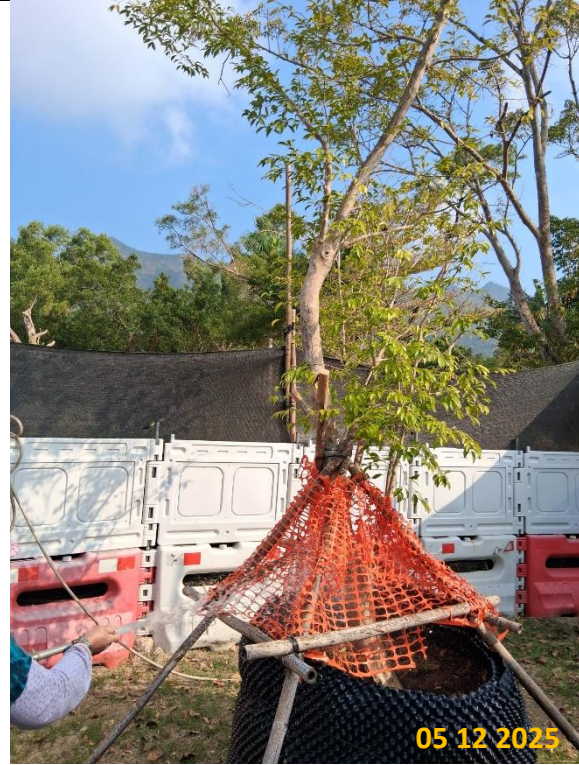
<p>A8 – Decaying wound at trunk base (size: ~180mm x170mm)</p>   <p>07 12 2025</p>	<p>A8 – Decaying wound on trunk</p>   <p>07 12 2025</p>
<p>A8 – Ant nest was not found</p>   <p>07 12 2025</p>	<p>A8 – Leaves chlorosis and thin</p>   <p>07 12 2025</p>

Manual watering was carried out for A8 during the reporting period. The watering frequency is one to two times per week.

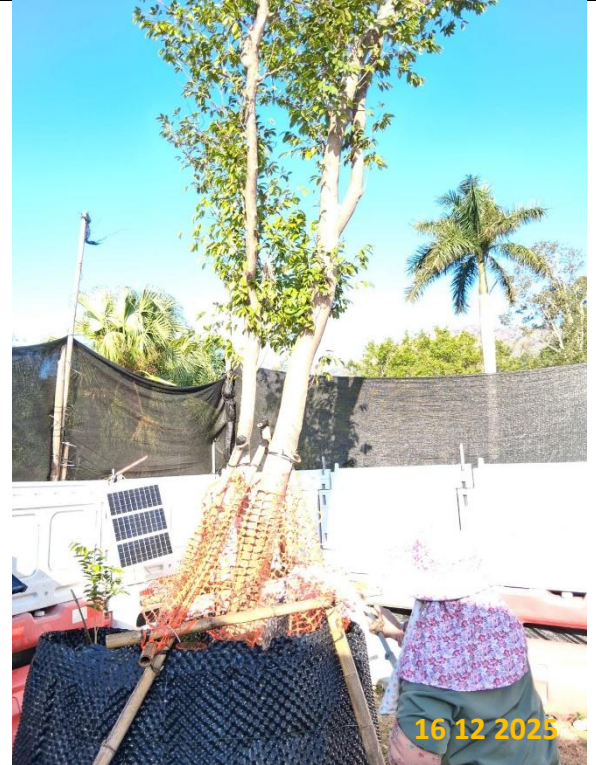
<p>A12 –Wound at trunk base</p>   <p>07 12 2025</p>	<p>A12 – Decaying wound on trunk</p>   <p>07 12 2025</p>
<p>A12 – Epicormics on trunk. Decaying wound on Trnnk.</p>   <p>07 12 2025</p>	<p>Fencing is in order during inspection</p>   <p>07 12 2025</p>

Manual watering was carried out for A12 during the reporting period. The watering frequency is one to two times per week.
