**Tree Schedule for Survey of Plant Species of Conservation Importance**

Tung Chung New Town Extension – Site Formation and Infrastructure Works at Tung Chung Valley, Phase 1

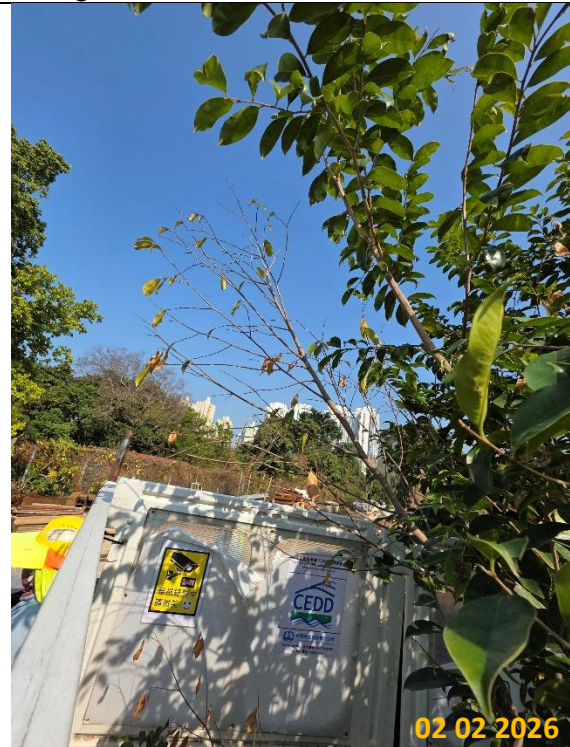
A11 – Wilting twigs due to previous physical damage on Nov 2025

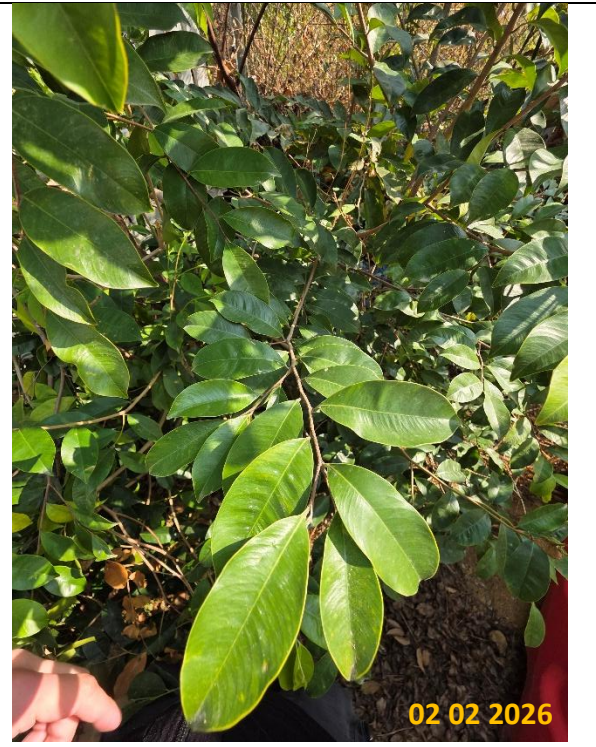
A11 – Foliage condition

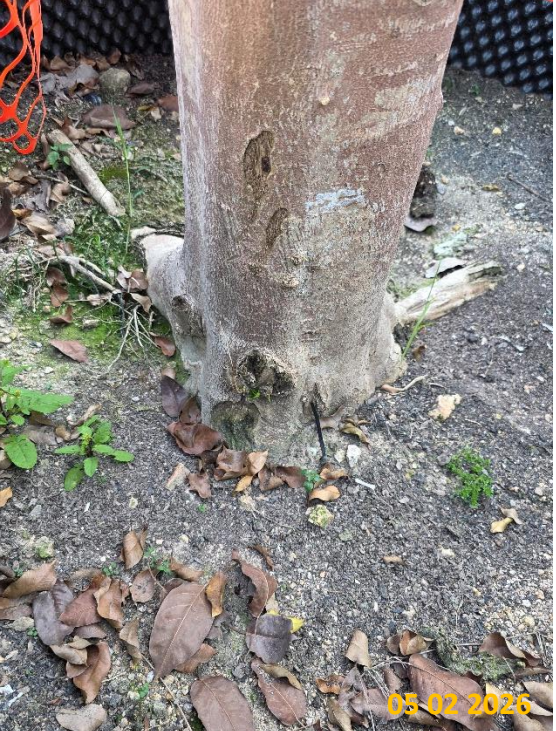
<p>A12 –Wound at trunk base</p>

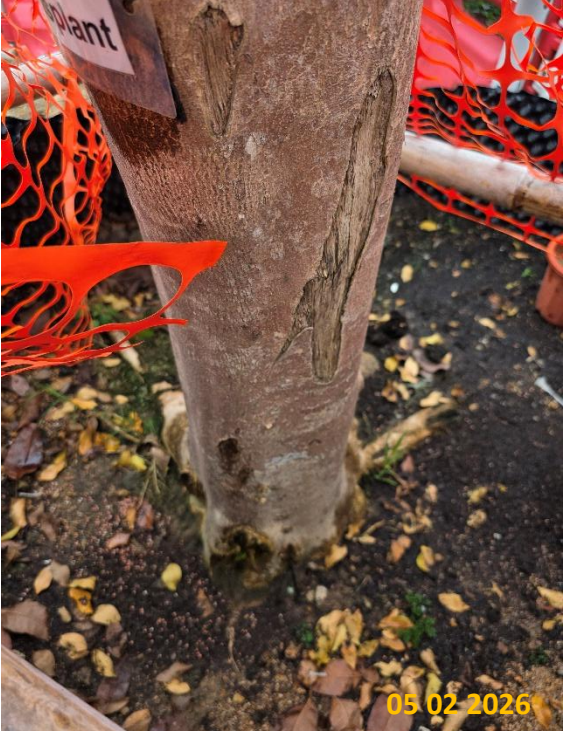
<p>05 02 2026</p>	<p>A12 – Decaying wound on trunk</p>

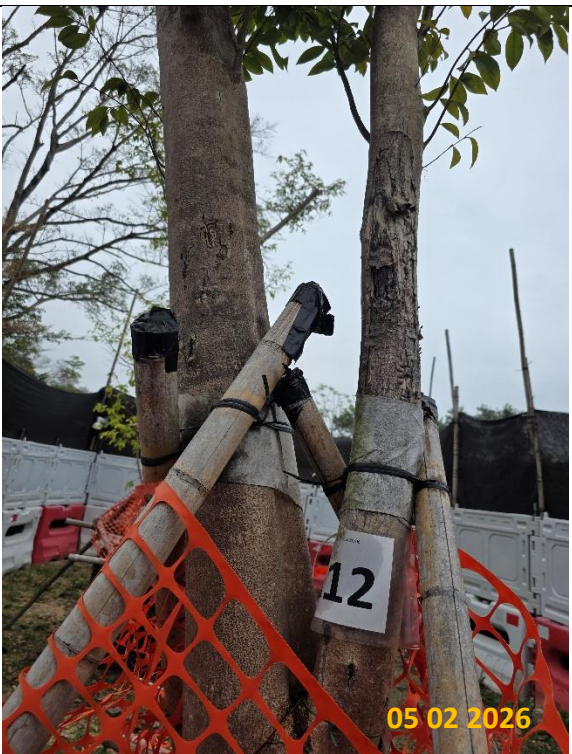
<p>05 02 2026</p>
<p>A12 – Epicormics on trunk. Decaying wound on Trnnk.</p>

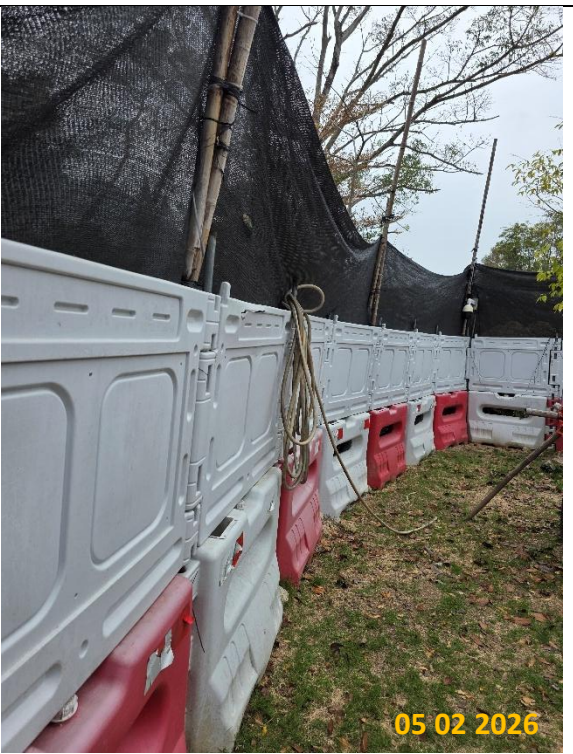
<p>05 02 2026</p>	<p>Fencing is in order during inspection</p>
