Tree Schedule for Survey of Plant Species of Conservation Importance

Tung Chung New Town Extension – Site Formation and Infrastructure Works at Tung Chung Valley, Phase 1

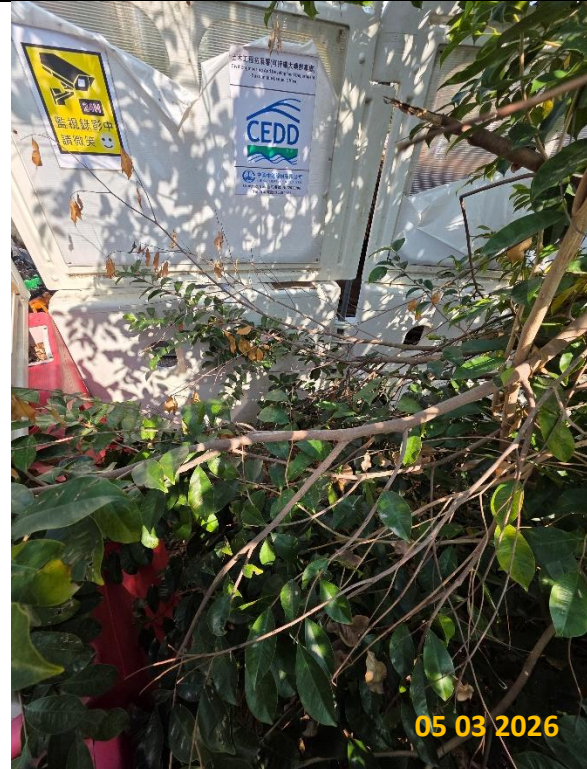
A11 – Wilting twigs due to previous physical damage on Nov 2025

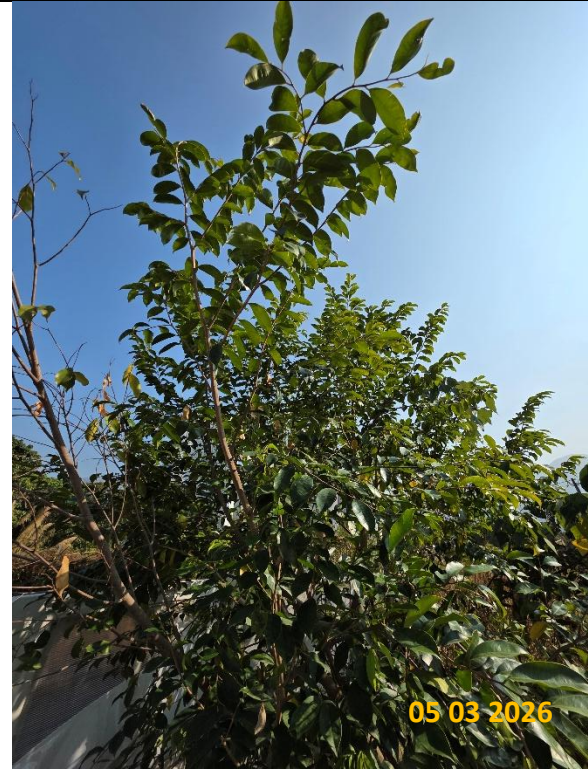
A11 – Foliage condition

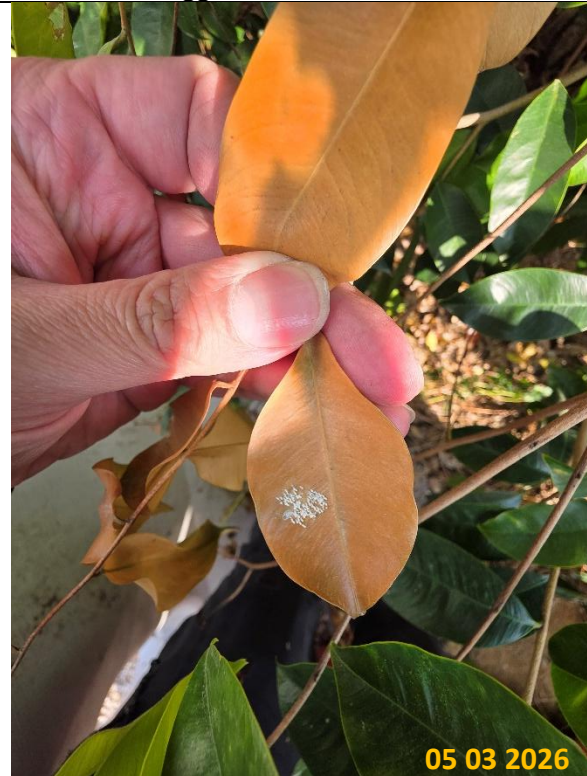
A11 – Insect eggs are observed

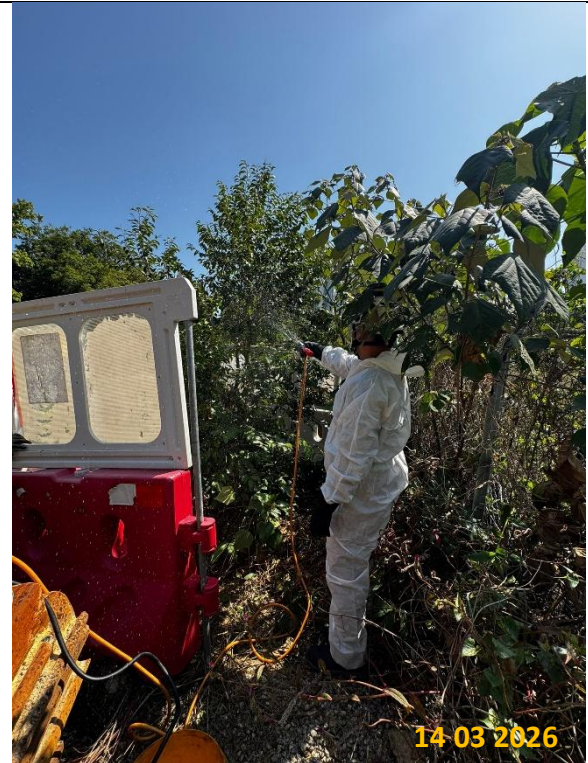
A11 – Pest control

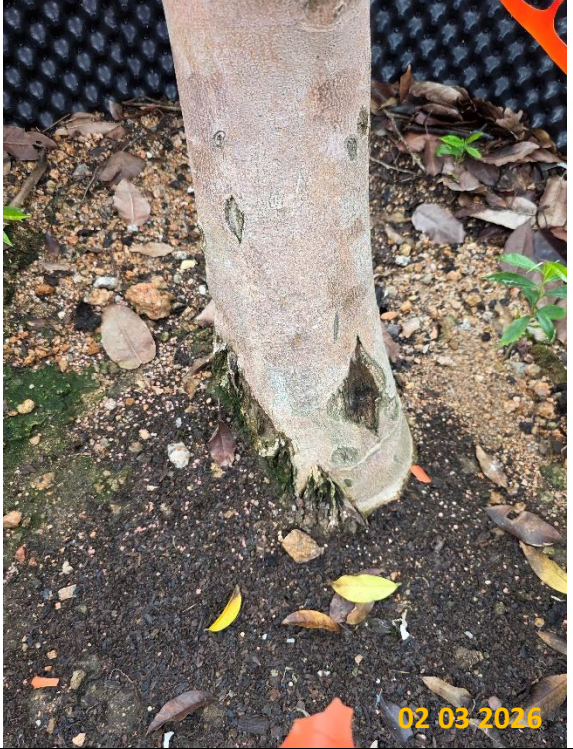
<p>A8 – Decaying wound at trunk base (size: ~180mm x170mm)</p>	<p>A8 – Decaying wound on trunk</p>

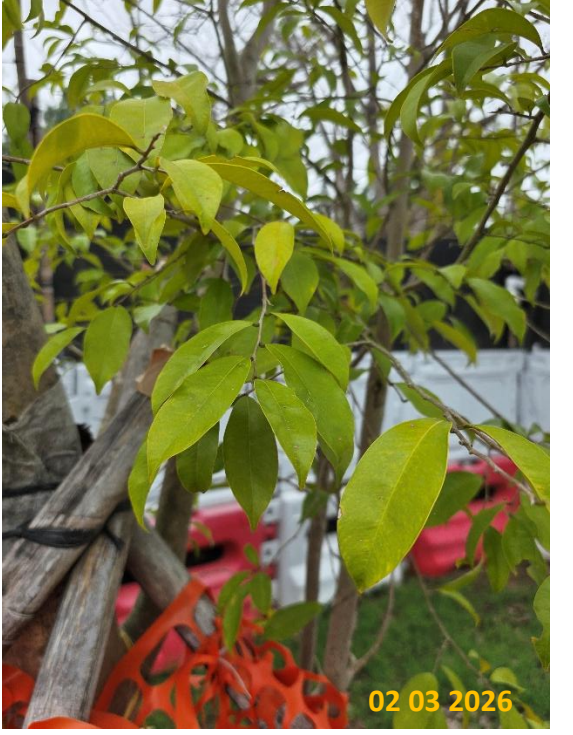
<p>02 03 2026</p>
<p>A8 – Leaves chlorosis and thin</p>	<p>A8 – insect eggs were observed</p>

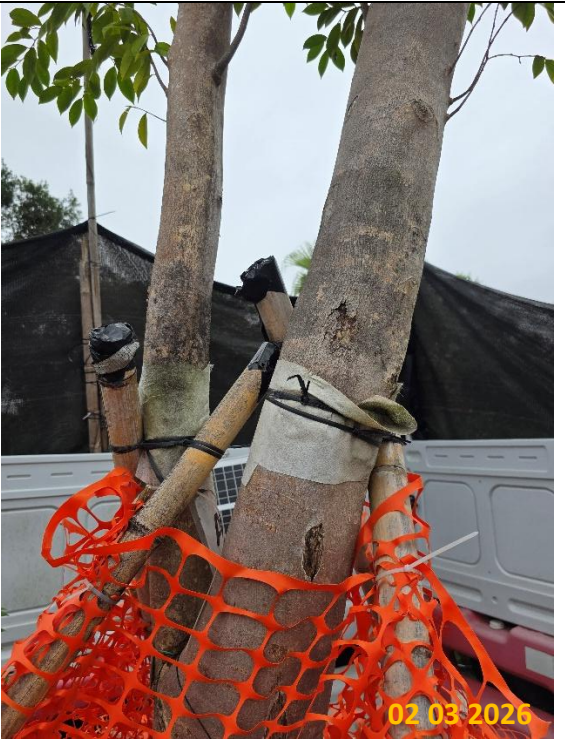
<p>A12 – Wound at trunk base</p>   <p>02 03 2026</p>	<p>A12 – Decaying wound on trunk</p>   <p>02 03 2026</p>
<p>A12 – Epicormics on trunk. Decaying wound on Trnk.</p>
