**Tree Schedule for Survey of Plant Species of Conservation Importance**

Tung Chung New Town Extension – Site Formation and Infrastructure Works at Tung Chung Valley, Phase 1

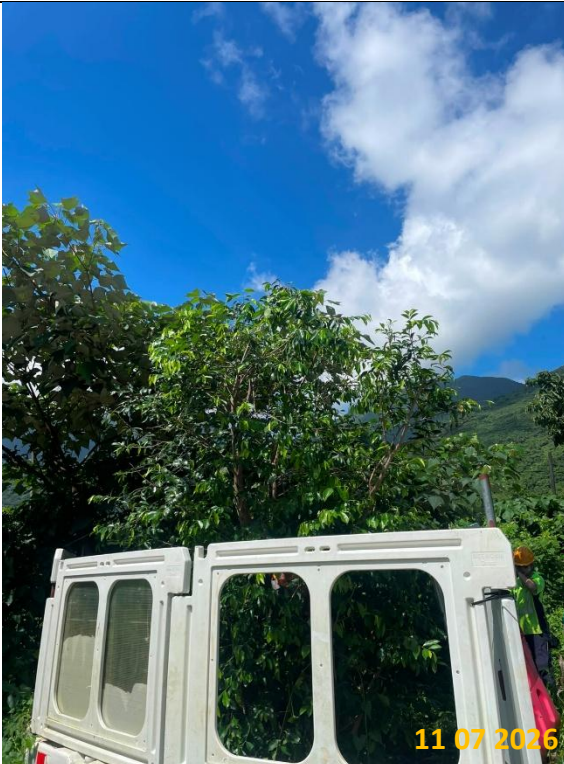
| A11 – Overall view | A11 – Crown condition. |

| No. | Species | | Conservation Status | Measurements | | | Tree Condition (Good(G) / Average(A) / Poor(P)) | | | Recommendation (Retain / Transplant / Remove) | Findings | Remark |
|---|---|---|---|---|---|---|---|---|---|---|---|---|
| A11 (T7521) | <i>Aquilaria sinensis</i> | 土沉香 | RPPHK; Cap.586; IUCN:VU | 190 | 3.5 | 1 | P | A | P | Retain | <p>Insect infestation is low.</p> <p>Since climbing weeds were observed, crown cleaning was carried out on 11 July 2026.</p> <p>Adjacent undersized trees within the tree protection zone were removed on 11 July 2026.</p> | Root-plate movement (mentioned in previous monitoring report). Topped tree due to illegal felling on Aug 2023 (reported to police on 21 Aug 2023). Large decaying trunk wound. Foliage density reduced after inclement weather events on Aug and Sep 2025. Unknown physical damage is observed resulting in the breaking of some epicormic shoots on Nov 2025 (Cleaned). |

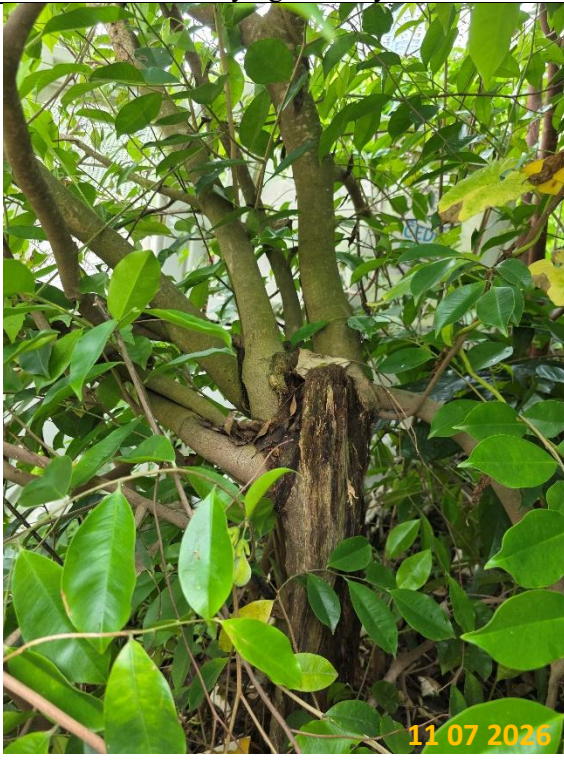
| A11 – Shoots are epicormic generated from cut trunk which is decaying severely | A11 - Soil condition |

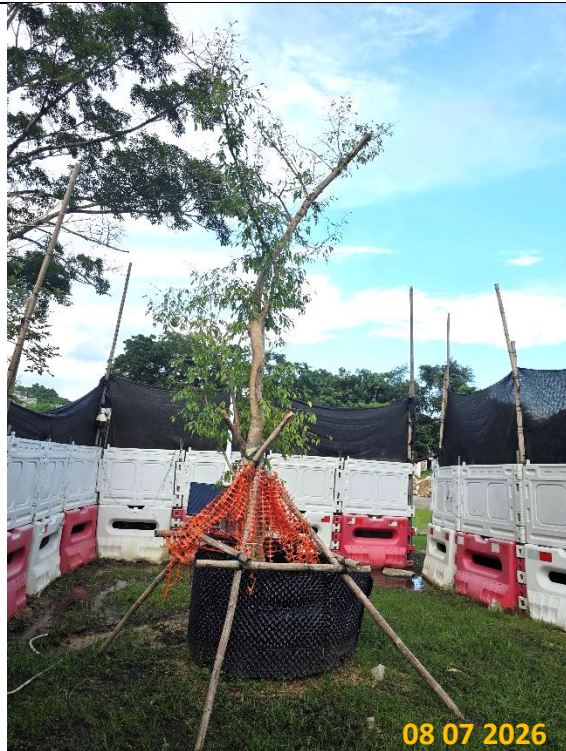
A8 – Overall view

| No. | Species | | Conservation Status | Measurements | | | Tree Condition (Good(G) / Average(A) / Poor(P)) | | | Recommendation (Retain / Transplant / Remove) | Findings | Remark |
|---|---|---|---|---|---|---|---|---|---|---|---|---|
| A8<br>(T8996) | <i>Aquilaria sinensis</i> | 土沉香 | RPPHK;<br>Cap.586;<br>IUCN:VU | 110 | 5 | 4 | P | P | P | Transplant | No obvious wound wood production. Severity of the insect feeding was low. Pest control was done on 8 July and 21 July 2026. Adjustment of tree supportive system and crown cleaning were done on 21 July 2026. Fruiting completed. | Trunk wounds were observed before transplant operation. Shallow root. Sudden defoliation happened in May 2023 but recovered in Aug 2023. It was translocated to the temporary holding nursery on 29 Sep 2023. A branch (5cm) was broken due to typhoon in Oct 2023. Decaying wounds and exposed dead woods on trunk. The foliage density is low especially after inclement weather events on Aug/Sep 2025. The tree recovered partially on Spring 2026. However recent heavy raining on June and July resulted in the reduction in foliage density again. |

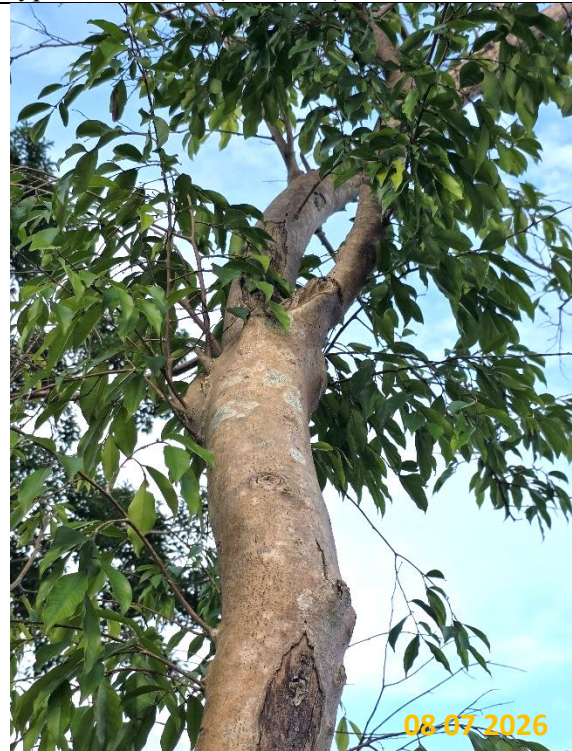
A8 – Pruning wound previously damaged by typhoon KOINU (Oct 2023)

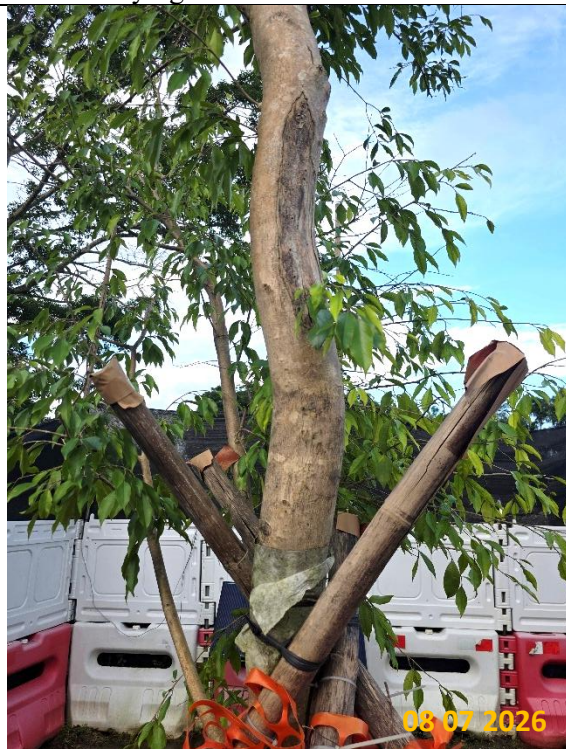
A8 – Decaying wound on trunk

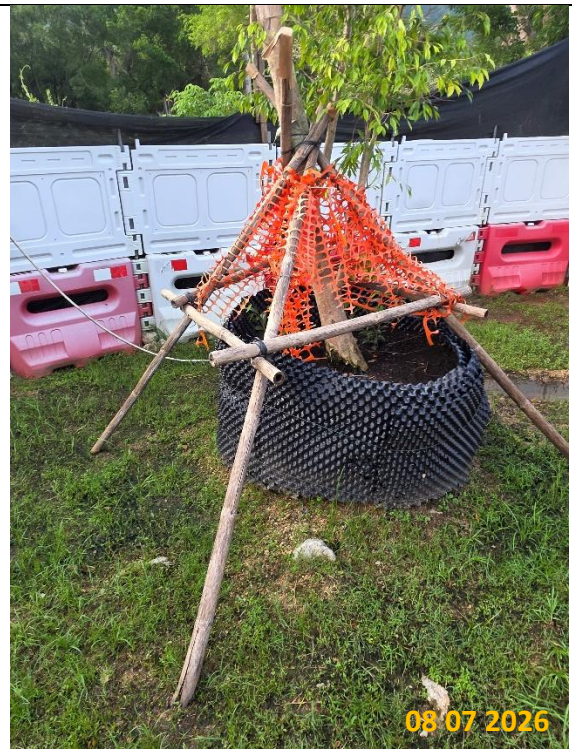
A8 – Trunk and root condition.

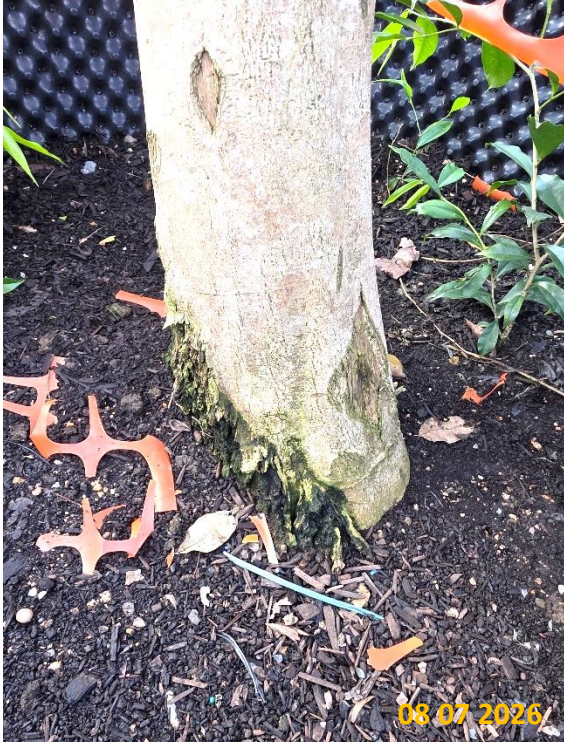
| <p>A8 – Decaying wound at trunk base<br/>(size: ~180mm x170mm)</p> | <p>A8 –Leaves chlorosis and thin.</p> |

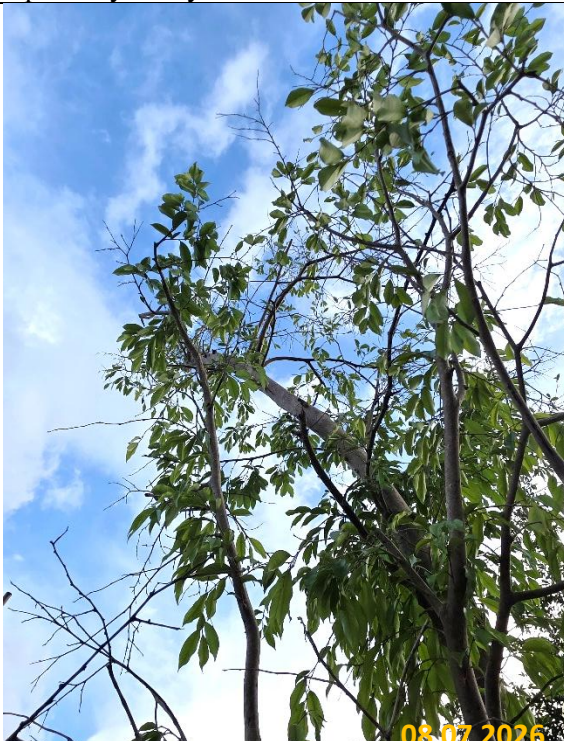
| <p>A8 – Foliage density reduced after fruiting and repeatedly heavy rains</p> | <p>A8 – Fruits were dropped</p> |

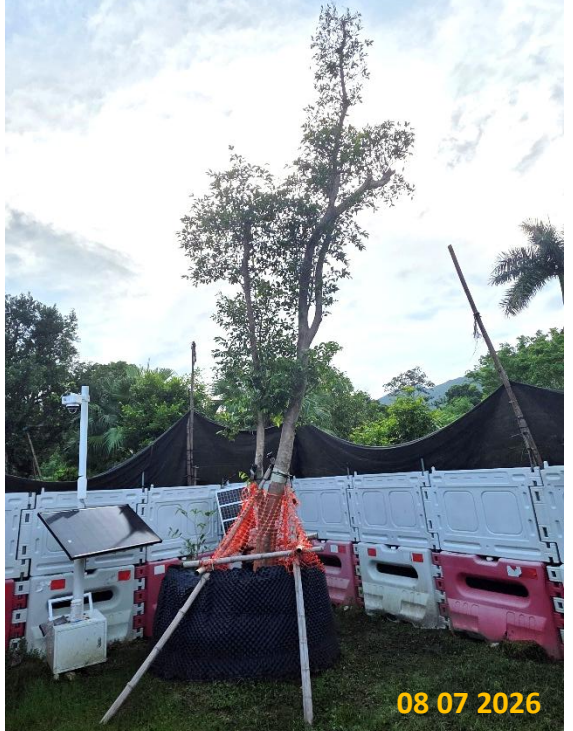
| No. | Species | | Conservation Status | Measurements | | | Tree Condition (Good(G) / Average(A) / Poor(P)) | | | Recommendation (Retain / Transplant / Remove) | Findings | Remark |
|---|---|---|---|---|---|---|---|---|---|---|---|---|
| A12<br>(T3537) | <i>Aquilaria sinensis</i> | 土沉香 | RPPHK;<br>Cap.586;<br>IUCN:VU | 185 | 8 | 3 | P | P | A | Transplant | No obvious wound wood production. Fruiting. Severity of the insect feeding was low. Pest control was done on 8 July and 21 July 2026. Adjustment of tree supportive system and crown cleaning were done on 21 July 2026. It is still fruiting. | Trunk wounds were observed before transplant operation. Shallow root. Original root ball was full of stones which were removed partially during the translocation. It was translocated to the temporary holding nursery on 29 Sep 2023. It collapsed during typhoon dated Oct 2023 resulted in largely reduction in foliage density. It was slightly lean after a typhoon event dated 13-14 Nov 2024 and reinstated. Decaying wounds and exposed dead woods on trunk. The foliage density is low especially after inclement weather events on Aug/Sep 2025. The tree recovered partially on Spring 2026. However recent heavy raining on June and July resulted in the reduction in foliage density again. |

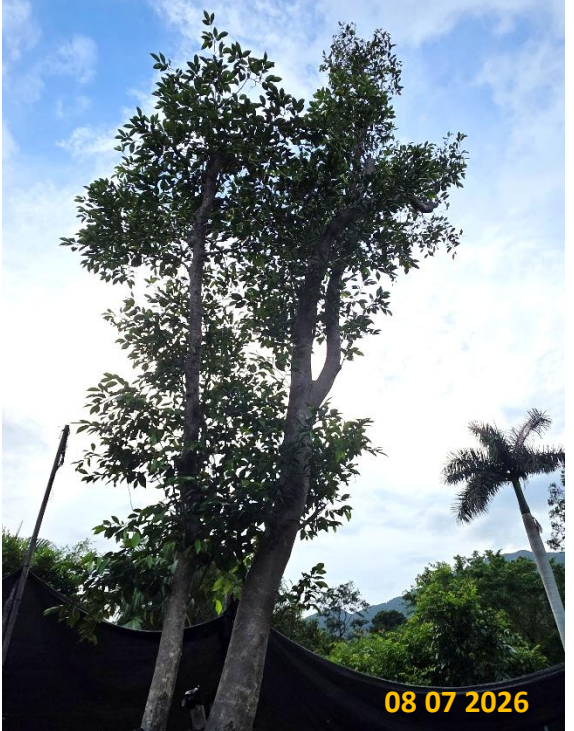
| A12 - Overall View | A12 - Dieback observed. |

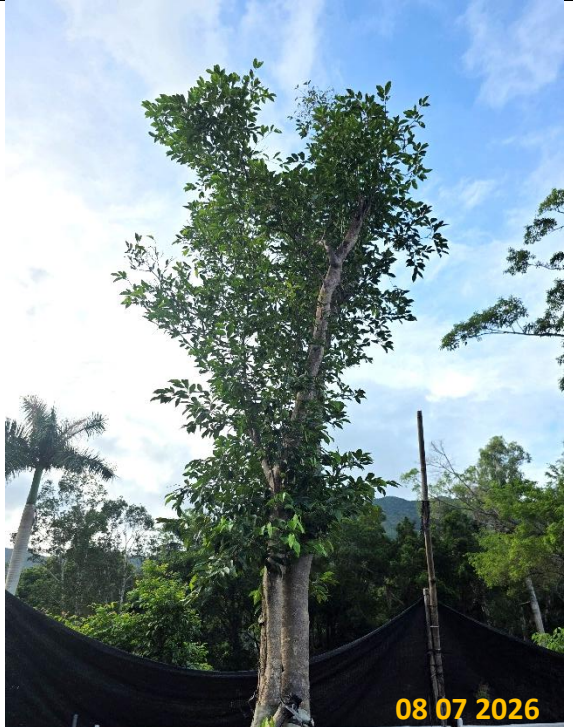
| A12 - Foliage density reduced after repeatedly heavy rains | A12 – Trunk and root condition |

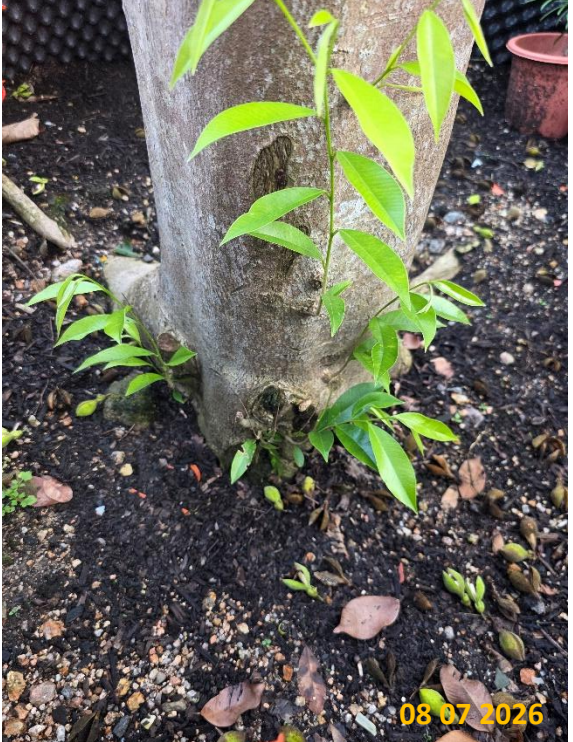
| <p>A12 –Wound at trunk base</p> <p>08 07 2026</p> | <p>A12 – Decaying wound on trunk</p> <p>08 07 2026</p> |

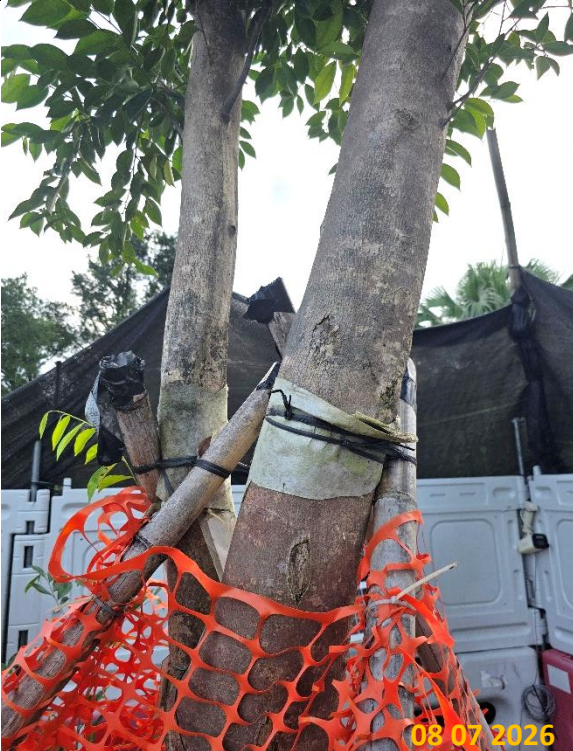
| <p>A12 – Epicormics on trunk. Decaying wound on Trnnk.</p> <p>08 07 2026</p> | <p>A12 – It is still fruiting</p> <p>08 07 2026</p> |

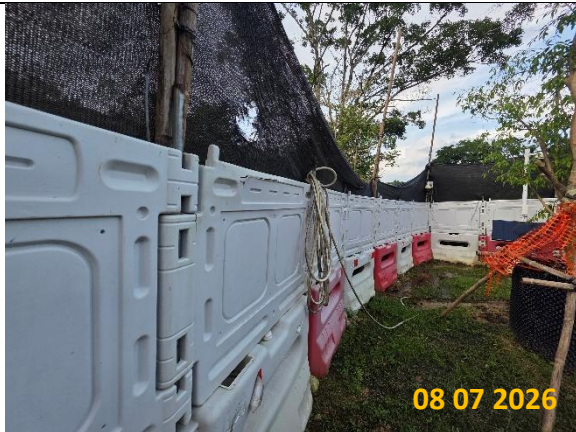
Fencing is in order during inspection
