Tree Schedule for Survey of Plant Species of Conservation Importance

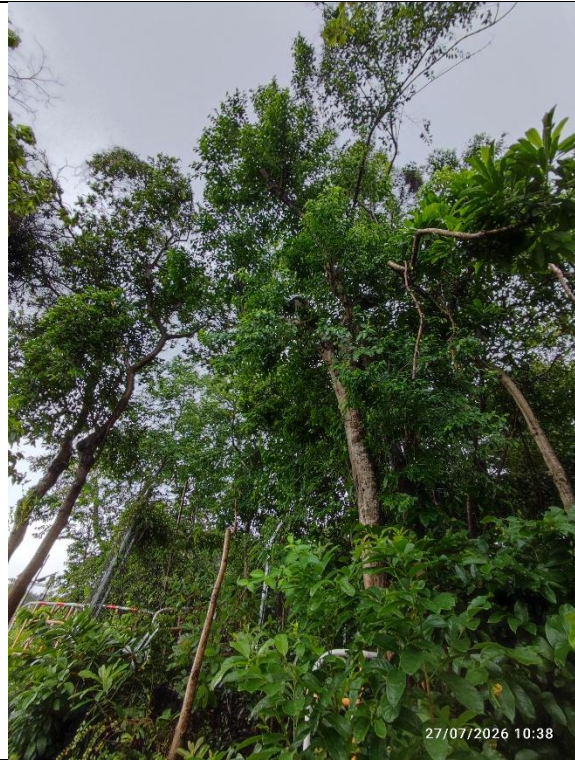
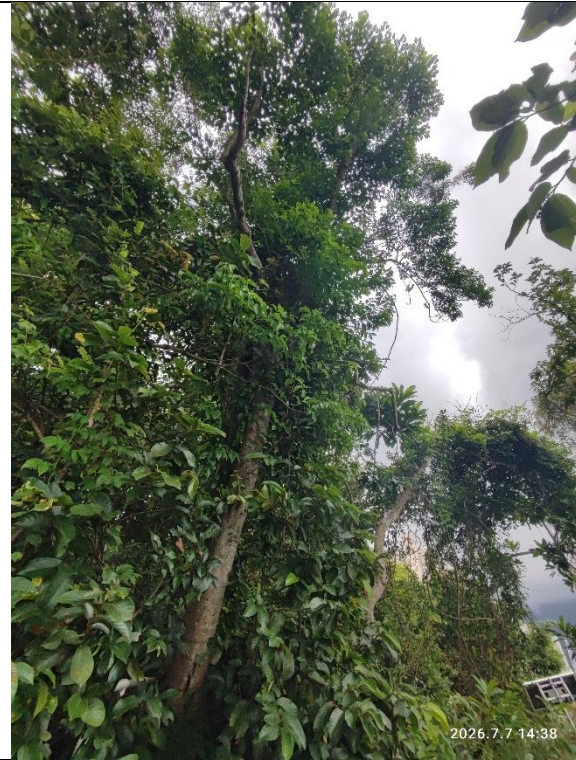
**T8217 – General view**

| Tree No. | Species | | | Measurements | | | Amenity Value<br>(High(H) /<br>Medium (M) /<br>Low(L) | Tree Condition (Good(G) /<br>Average(A) / Poor(P)) | | | Recommendation<br>(Retain / Transplant /<br>Remove) | Findings | Remark |
|---|---|---|---|---|---|---|---|---|---|---|---|---|---|
| T8217 | <i>Canthium dicoccum</i> | 魚骨木 | IUCN:VU | 9 | 220 | 6 | L | P | A | P | Retain | Branch failure of T8217 was found on 21 July 2025 due to Typhoon signal No. 10. Overall condition of tree and its remaining part is fair. | There is no proper and safe assess towards T8231 & T8217, thus, plastics barriers were installed in lieu of 2m high barrier. Branch failure of T8217 was found on 21 July 2025. It was identified that the fallen part was one of the branches on upper position of tree. No decay was observed on the tearing position. No other collapsed part was observed due to adverse weather during time of inspection. Overall condition of tree and its remaining part is fair. Pruning of jagged wound to provide a clean cut is recommended. The pruning work the completed on 21 July 2025. |

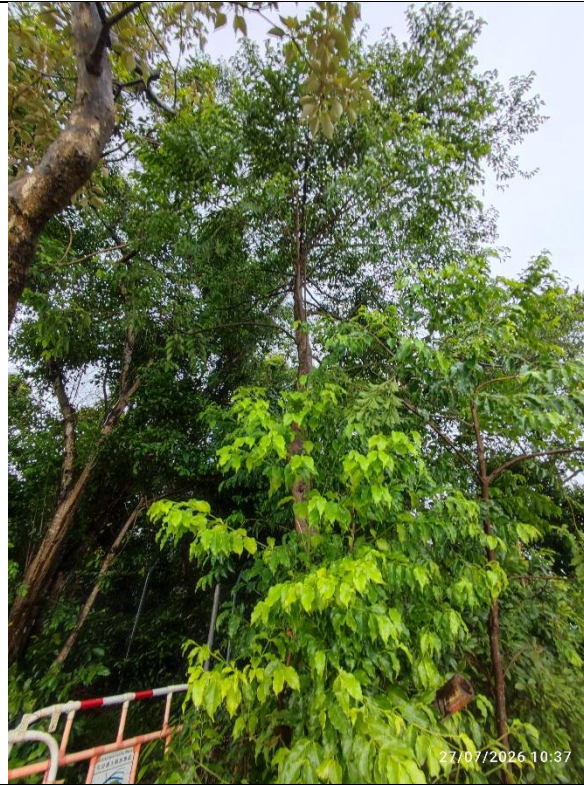
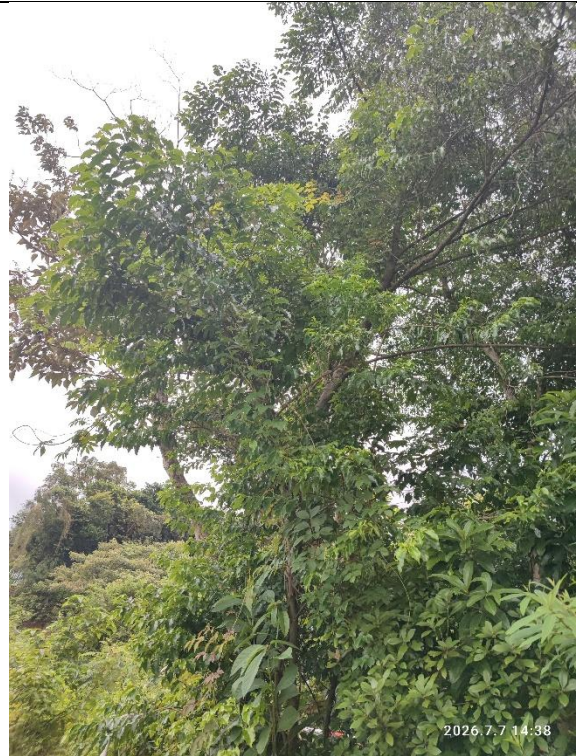
**T8231– General view**

| Tree No. | Species | | | Measurements | | | Amenity Value<br>(High(H) /<br>Medium (M) /<br>Low(L) | Tree Condition (Good(G) /<br>Average(A) / Poor(P)) | | | Recommendation<br>(Retain / Transplant /<br>Remove) | Findings | Remark |
|---|---|---|---|---|---|---|---|---|---|---|---|---|---|
| T8231 | <i>Canthium dicoccum</i> | 魚骨木 | IUCN:VU | 7 | 190 | 6 | L | P | A | P | Retain | Second epicormic failure was found on 21 July 2025 due to Typhoon signal No. 10, third epicormics failure was found on 21 May 2026 due to Amber Rainstorm Warning signal, Overall condition of tree and its remaining part is fair | There is no proper and safe assess towards T8231 & T8217, thus, plastics barriers were installed in lieu of 2m high barrier. Epicormic branch failure was found on 03 May 2024. Staking to provide extra support and pruning of jagged wound to provide a clean cut was conducted on 16 May 2024. The Staking was in normal condition during the time of inspection. No further significant defects were observed. Second epicormic failure was found on 21 July 2025, Overall condition of tree and its remaining part is fair. Pruning of jagged wound to provide a clean cut is recommended. Pruning works was completed on 21 July 2025. Third epicormic failure was found on 21 May 2026. Pruning of jagged wound to provide a clean cut was conducted on 29 May 2026. |

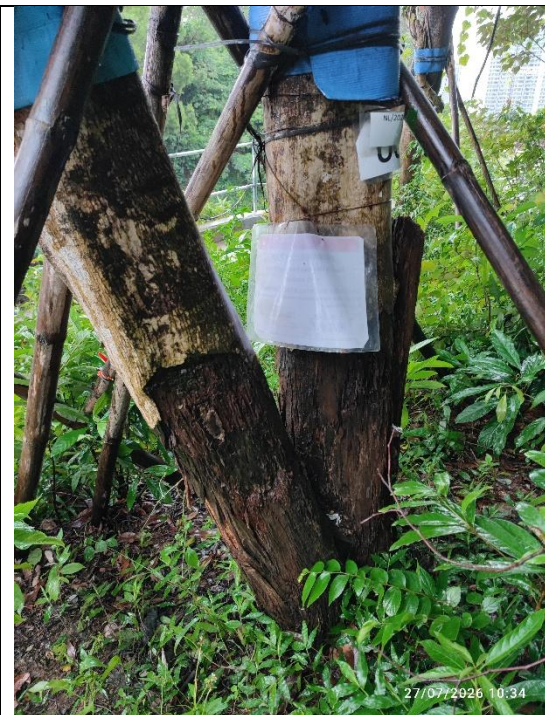
**U041 – Trunk condition**

| Tree No. | Species | | | Measurements | | | Amenity Value<br>(High(H) /<br>Medium (M) /<br>Low(L) | Tree Condition (Good(G) /<br>Average(A) / Poor(P)) | | | Recommendation<br>(Retain / Transplant /<br>Remove) | Findings | Remark |
|---|---|---|---|---|---|---|---|---|---|---|---|---|---|
| U041 | <i>Aquilaria sinensis</i> | 土沉香 | RPPHK;<br>Cap.586;<br>IUCN:VU | 10 | 318 | 4 | M | A | P | P | Retain | No obvious old termite track was found, damage of wood tissue was observed. Peeling off of bark and sign of split of internal wood tissue was observed. Trunk wound significantly decayed. High trunk failure risk. | Located closed to cut slope. The crack on trunk was found slightly larger since late March 2024. Peeling off of bark and split of internal wood tissue was observed in July 2024. Abnormal bark crack was found in December 2024. Additional guying for tree no. U041 has been installed as an enhanced stabilization measure alongside the bamboo staking in May 2025. |

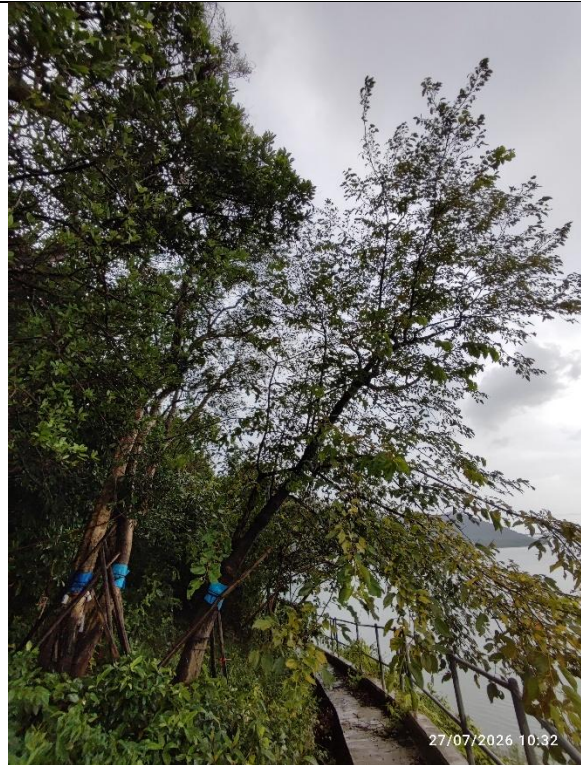
**U042 – General view**

| Tree No. | Species | | | Measurements | | | Amenity Value<br>(High(H) /<br>Medium (M) /<br>Low(L) | Tree Condition (Good(G) /<br>Average(A) / Poor(P)) | | | Recommendation<br>(Retain / Transplant /<br>Remove) | Findings | Remark |
|---|---|---|---|---|---|---|---|---|---|---|---|---|---|
| U042 | <i>Gmelina chinensis</i> | 石梓 | RPPHK | 6 | 150 | 2 | M | A | P | A | Retain | Large wound near trunk base with wound wood development. Trunk wound is decaying. | Located closed to cut slope. |

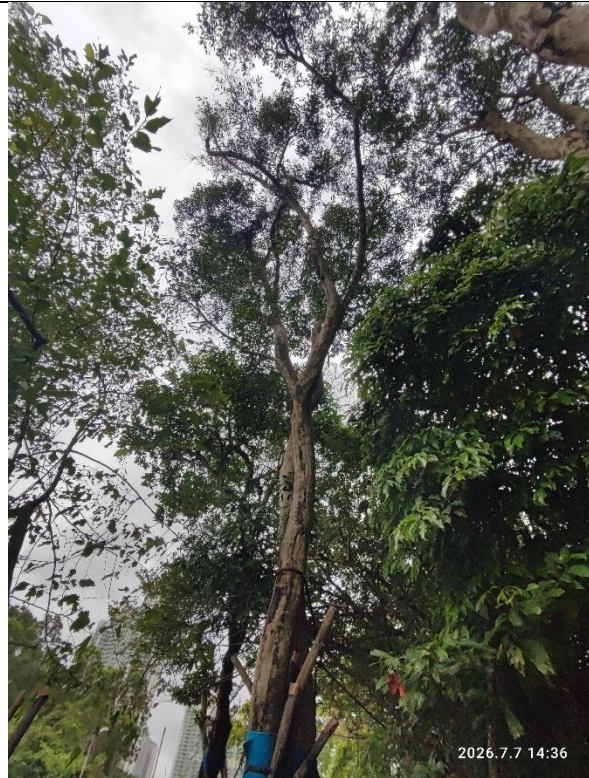
**U043– General view**

| Tree No. | Species | | | Measurements | | | Amenity Value<br>(High(H) /<br>Medium (M) /<br>Low(L) | Tree Condition (Good(G) /<br>Average(A) / Poor(P)) | | | Recommendation<br>(Retain / Transplant /<br>Remove) | Findings | Remark |
|---|---|---|---|---|---|---|---|---|---|---|---|---|---|
| U043 | <i>Aquilaria sinensis</i> | 土沉香 | RPPHK;<br>Cap.586;<br>IUCN:VU | 9 | 310 | 4 | M | A | P | P | Retain | Crack on trunk base. Trunk wound significantly decayed. High trunk failure risk. | Located closed to cut slope. |

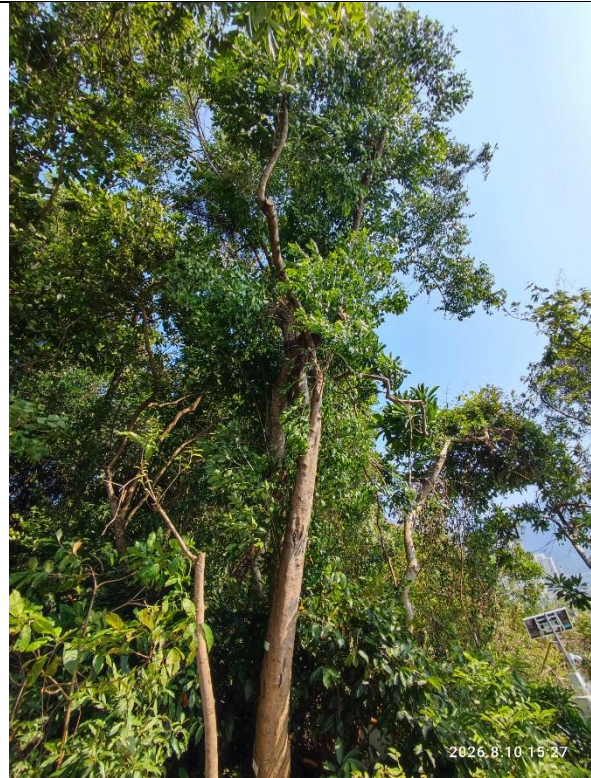
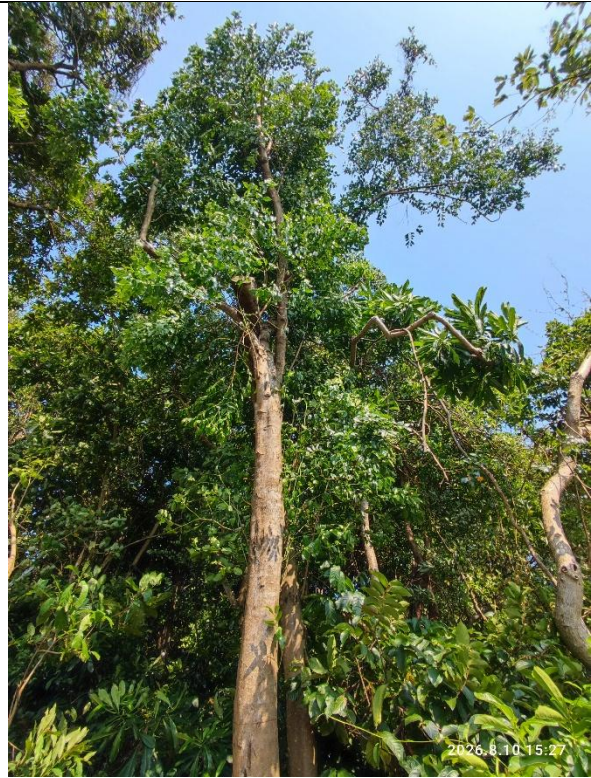
**T8217 – General view**

| Tree No. | Species | | | Measurements | | | Amenity Value<br>(High(H) / Medium (M) / Low(L) | Tree Condition (Good(G) / Average(A) / Poor(P)) | | | Recommendation<br>(Retain / Transplant / Remove) | Findings | Remark |
|---|---|---|---|---|---|---|---|---|---|---|---|---|---|
| T8217 | <i>Canthium dicoccum</i> | 魚骨木 | IUCN:VU | 9 | 220 | 6 | L | P | A | P | Retain | Branch failure of T8217 was found on 21 July 2025 due to Typhoon signal No. 10. Overall condition of tree and its remaining part is fair. | There is no proper and safe assess towards T8231 & T8217, thus, plastics barriers were installed in lieu of 2m high barrier. Branch failure of T8217 was found on 21 July 2025. It was identified that the fallen part was one of the branches on upper position of tree. No decay was observed on the tearing position. No other collapsed part was observed due to adverse weather during time of inspection. Overall condition of tree and its remaining part is fair. Pruning of jagged wound to provide a clean cut is recommended. The pruning work the completed on 21 July 2025. |

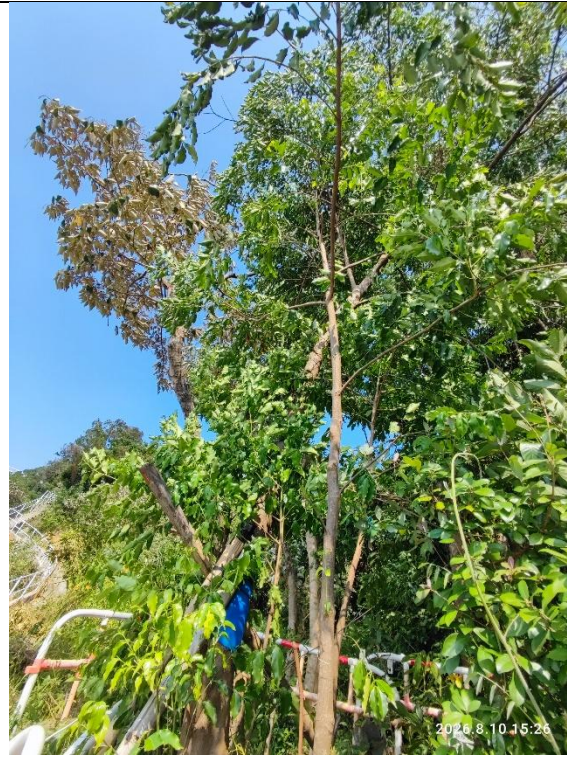
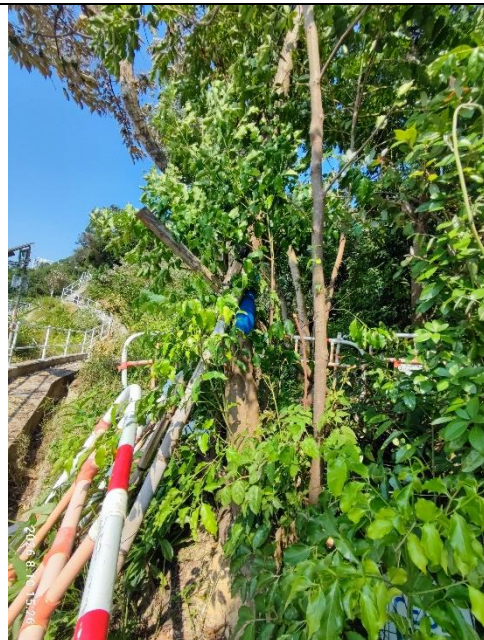
**T8231– General view**

| Tree No. | Species | | | Measurements | | | Amenity Value<br>(High(H) / Medium (M) / Low(L) | Tree Condition (Good(G) / Average(A) / Poor(P)) | | | Recommendation<br>(Retain / Transplant / Remove) | Findings | Remark |
|---|---|---|---|---|---|---|---|---|---|---|---|---|---|
| T8231 | <i>Canthium dicoccum</i> | 魚骨木 | IUCN:VU | 7 | 190 | 6 | L | P | A | P | Retain | Second epicormic failure was found on 21 July 2025 due to Typhoon signal No. 10, third epicormics failure was found on 21 May 2026 due to Amber Rainstorm Warning signal, Overall condition of tree and its remaining part is fair | There is no proper and safe assess towards T8231 & T8217, thus, plastics barriers were installed in lieu of 2m high barrier. Epicormic branch failure was found on 03 May 2024. Staking to provide extra support and pruning of jagged wound to provide a clean cut was conducted on 16 May 2024. The Staking was in normal condition during the time of inspection. No further significant defects were observed. Second epicormic failure was found on 21 July 2025, Overall condition of tree and its remaining part is fair. Pruning of jagged wound to provide a clean cut is recommended. Pruning works was completed on 21 July 2025. Third epicormic failure was found on 21 May 2026. Pruning of jagged wound to provide a clean cut was conducted on 29 May 2026. |

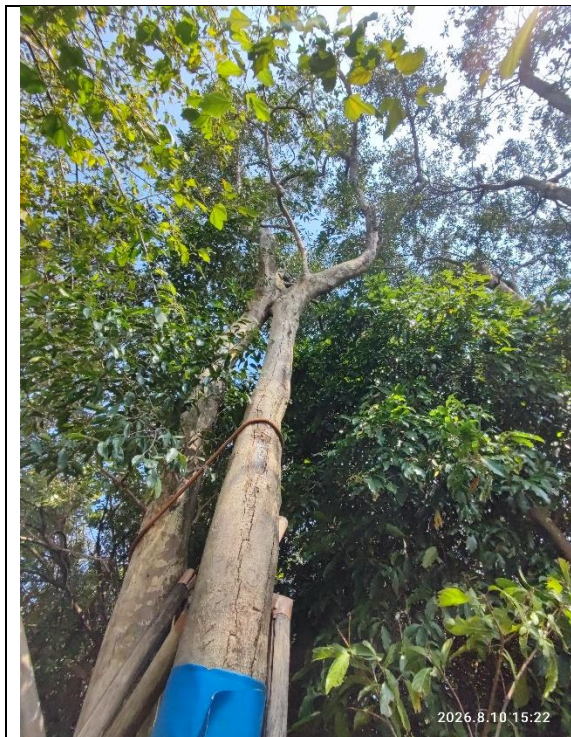
**U041 – General view**

| Tree No. | Species | | | Measurements | | | Amenity Value<br>(High(H) / Medium (M) / Low(L) | Tree Condition (Good(G) / Average(A) / Poor(P)) | | | Recommendation<br>(Retain / Transplant / Remove) | Findings | Remark |
|---|---|---|---|---|---|---|---|---|---|---|---|---|---|
| U041 | <i>Aquilaria sinensis</i> | 土沉香 | RPPHK;<br>Cap.586;<br>IUCN:VU | 10 | 318 | 4 | M | A | P | P | Retain | No obvious old termite track was found, damage of wood tissue was observed. Peeling off of bark and sign of split of internal wood tissue was observed. Trunk wound significantly decayed. High trunk failure risk. | Located closed to cut slope. The crack on trunk was found slightly larger since late March 2024. Peeling off of bark and split of internal wood tissue was observed in July 2024. Abnormal bark crack was found in December 2024. Additional guying for tree no. U041 has been installed as an enhanced stabilization measure alongside the bamboo staking in May 2025. |

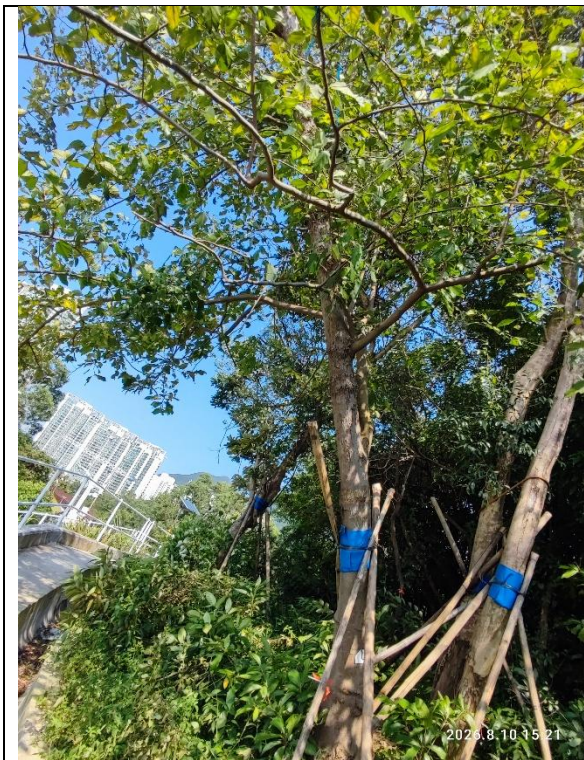
**U042 – General view**

| Tree No. | Species | | | Measurements | | | Amenity Value<br>(High(H) / Medium (M) / Low(L) | Tree Condition (Good(G) / Average(A) / Poor(P)) | | | Recommendation<br>(Retain / Transplant / Remove) | Findings | Remark |
|---|---|---|---|---|---|---|---|---|---|---|---|---|---|
| U042 | <i>Gmelina chinensis</i> | 石梓 | RPPHK | 6 | 150 | 2 | M | A | P | A | Retain | Large wound near trunk base with wound wood development. Trunk wound is decaying. | Located closed to cut slope. |

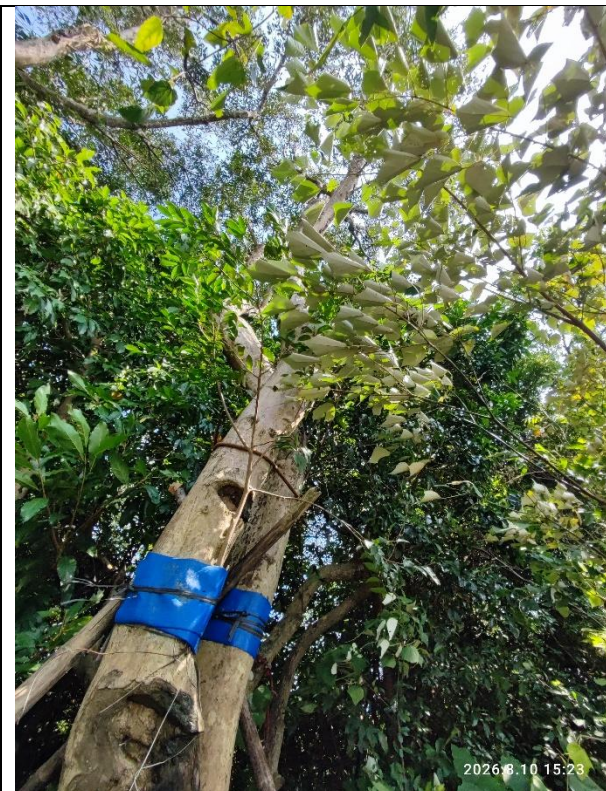
**U043– General view**

| Tree No. | Species | | | Measurements | | | Amenity Value<br>(High(H) / Medium (M) / Low(L) | Tree Condition (Good(G) / Average(A) / Poor(P)) | | | Recommendation<br>(Retain / Transplant / Remove) | Findings | Remark |
|---|---|---|---|---|---|---|---|---|---|---|---|---|---|
| U043 | <i>Aquilaria sinensis</i> | 土沉香 | RPPHK;<br>Cap.586;<br>IUCN:VU | 9 | 310 | 4 | M | A | P | P | Retain | Crack on trunk base. Trunk wound significantly decayed. High trunk failure risk. | Located closed to cut slope. |
