**Tree Schedule for Survey of Plant Species of Conservation Importance**

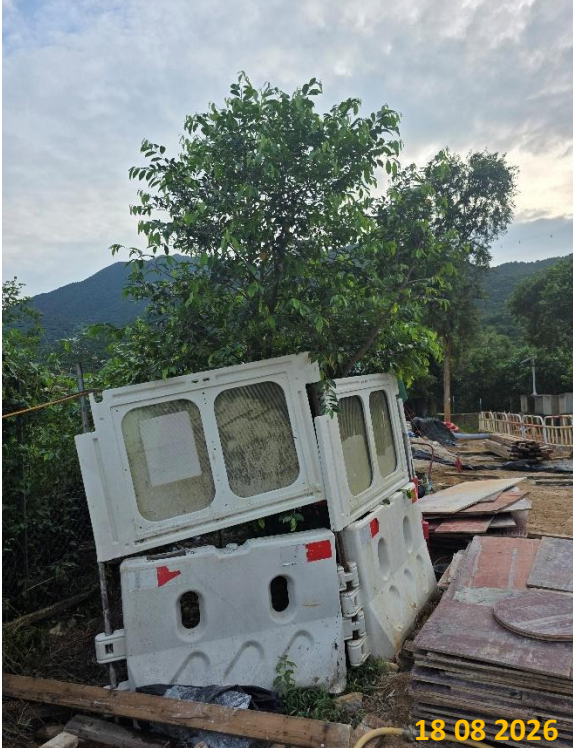
| A11 – Overall view | A11 – Crown condition. |

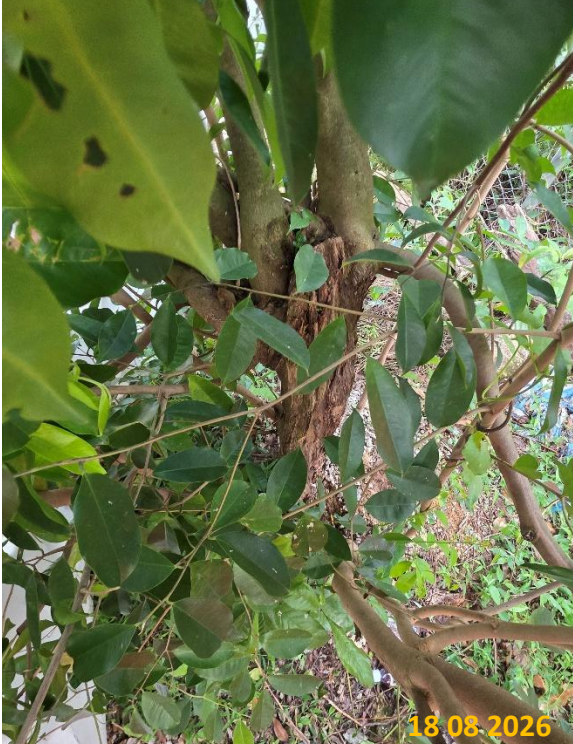
| A11 – Shoots are epicormic generated from cut trunk which is decaying severely | A11 - Soil condition |

| No. | Species | | Conservation Status | Measurements | | | Tree Condition (Good(G) / Average(A) / Poor(P)) | | | Recommendation (Retain / Transplant / Remove) | Findings | Remark |
|---|---|---|---|---|---|---|---|---|---|---|---|---|
| A11 (T7521) | <i>Aquilaria sinensis</i> | 土沉香 | RPPHK; Cap.586; IUCN:VU | 190 | 3.5 | 1 | P | A | P | Retain | Insect infestation is low. | Root-plate movement (mentioned in previous monitoring report). Topped tree due to illegal felling on Aug 2023 (reported to police on 21 Aug 2023). Large decaying trunk wound. Foliage density reduced after inclement weather events on Aug and Sep 2025. Unknown physical damage is observed resulting in the breaking of some epicormic shoots on Nov 2025 (Cleaned). |

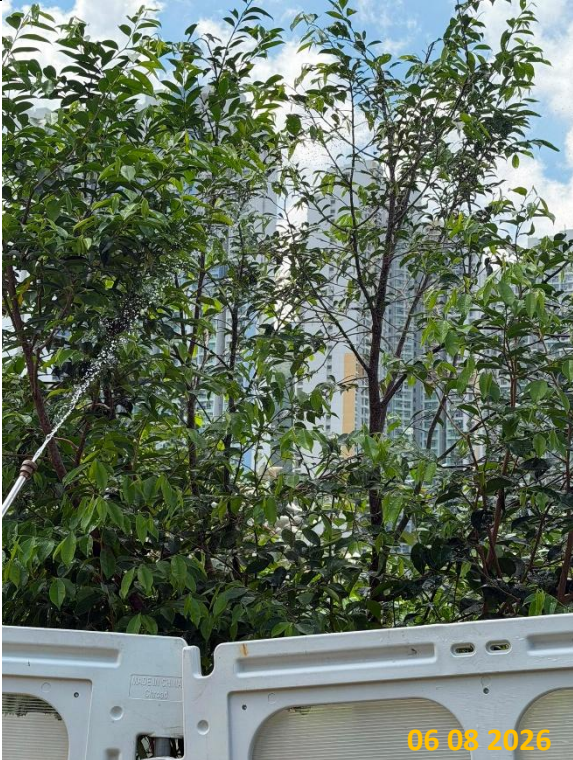
| Pest control done on 06/08/2026 | CCTV Screen |

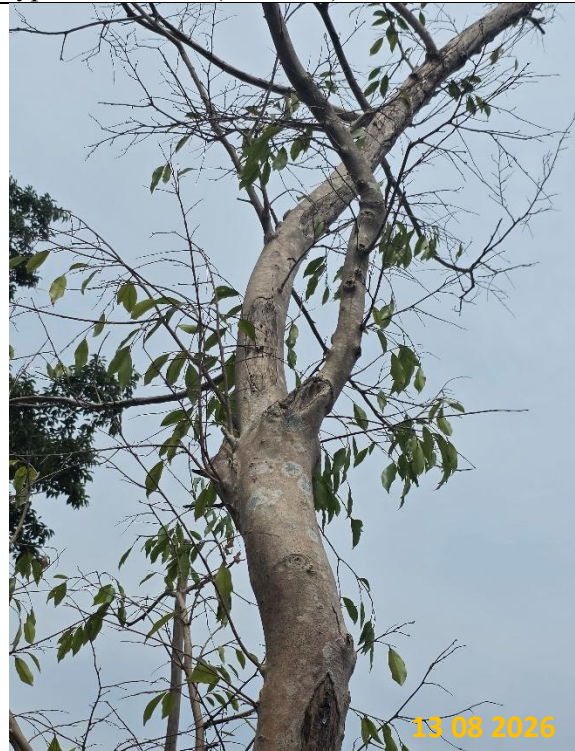
A8 – Pruning wound previously damaged by typhoon KOINU (Oct 2023)

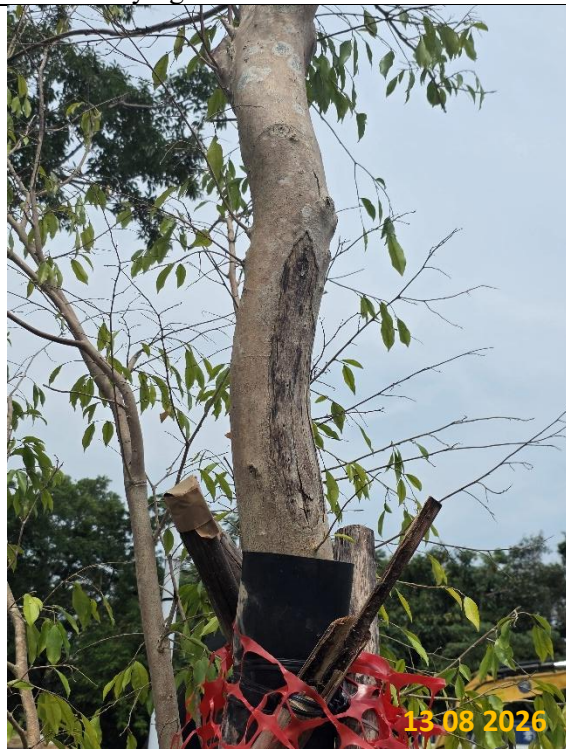
A8 – Decaying wound on trunk

| No. | Species | | Conservation Status | Measurements | | | Tree Condition (Good(G) / Average(A) / Poor(P)) | | | Recommendation (Retain / Transplant / Remove) | Findings | Remark |
|---|---|---|---|---|---|---|---|---|---|---|---|---|
| A8<br>(T8996) | <i>Aquilaria sinensis</i> | 土沉香 | RPPHK;<br>Cap.586;<br>IUCN:VU | 110 | 5 | 4 | P | P | P | Transplant | No obvious wound wood production.<br>Very low foliage density.<br>Dieback<br>Severity of the insect feeding was low. | Trunk wounds were observed before transplant operation. Shallow root. Sudden defoliation happened in May 2023 but recovered in Aug 2023. It was translocated to the temporary holding nursery on 29 Sep 2023. A branch (5cm) was broken due to typhoon in Oct 2023. Decaying wounds and exposed dead woods on trunk. The foliage density is low especially after inclement weather events on Aug/Sep 2025.<br>The tree recovered partially on Spring 2026. However recent heavy raining, hot weather on June and July resulted in the reduction in foliage density. Foliage density becomes very low after tropical cyclone warning signal No. 9 event. |

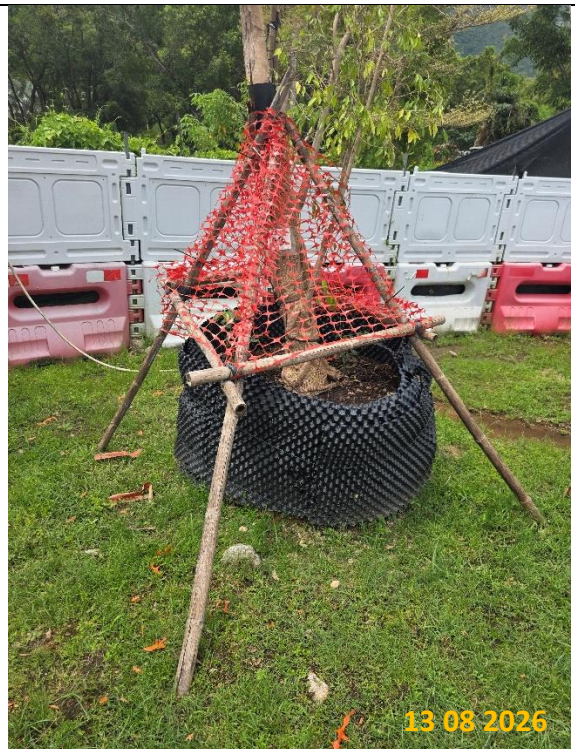
A8 – Trunk and root condition.

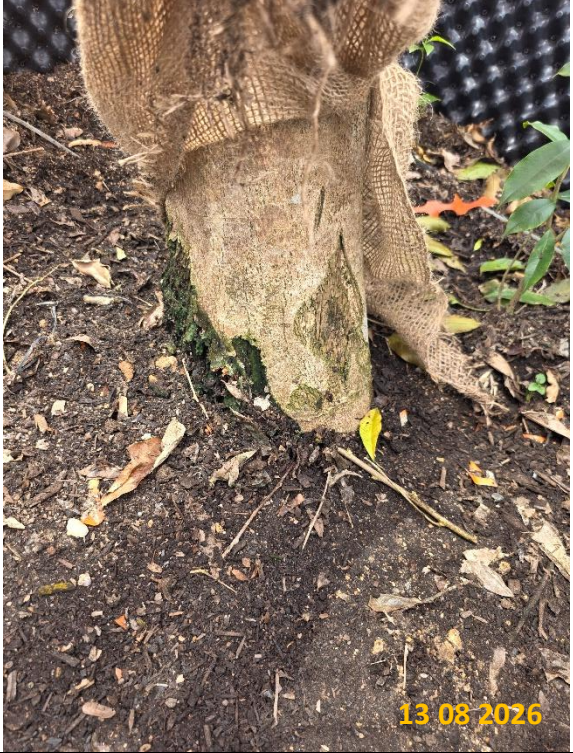
| <p>A8 – Decaying wound at trunk base<br/>(size: ~180mm x170mm)</p> | <p>A8 –Leaves chlorosis and thin.</p> |

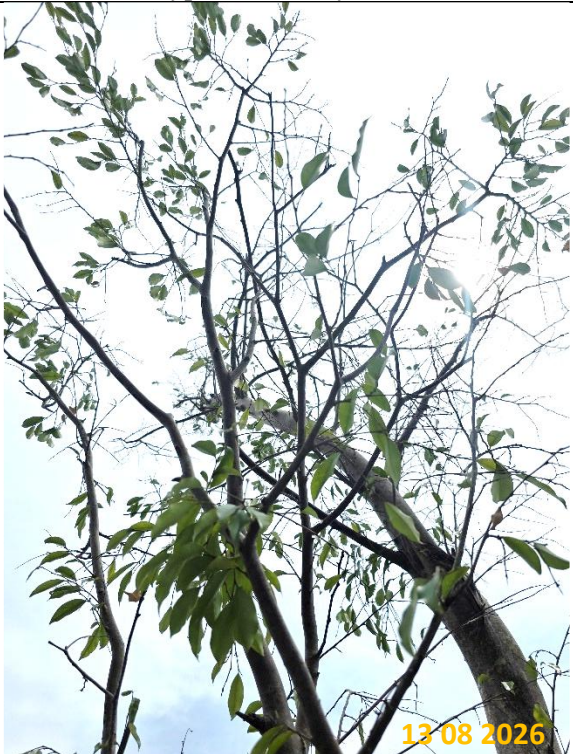
| <p>A8 – Foliage density reduced after fruiting, hot weather and Typhoon on July 2026</p> | <p>A8 – dieback</p> |

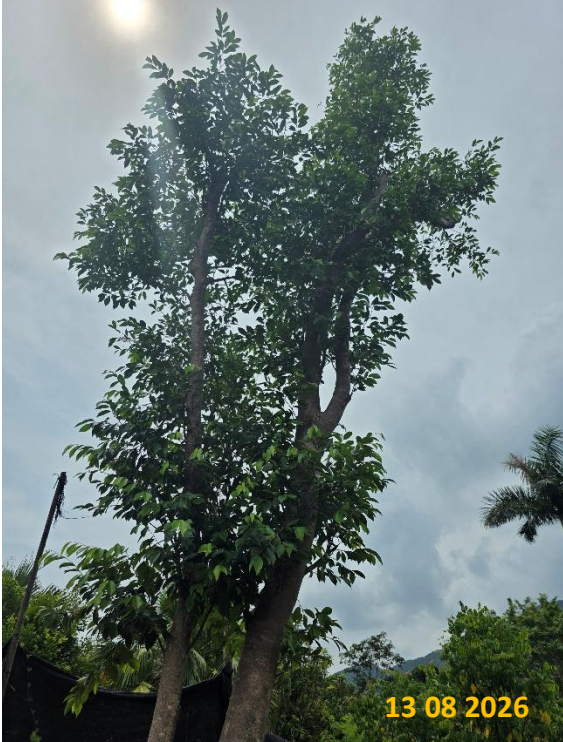
| <p>A12 - Overall View</p> <p>13 08 2026</p> | <p>A12 - Dieback observed.</p> <p>13 08 2026</p> |

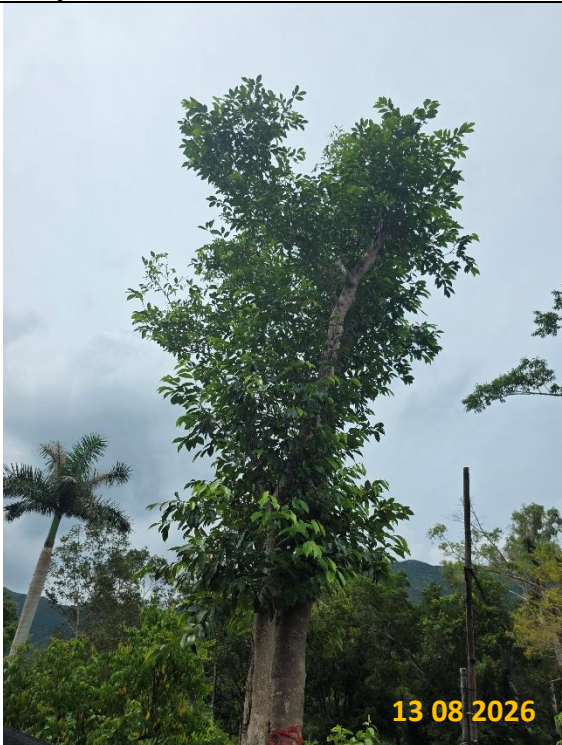
| <p>A12 - Foliage density reduced after repeatedly heavy rains</p> <p>13 08 2026</p> | <p>A12 – Trunk and root condition</p> <p>13 08 2026</p> |

| No. | Species | | Conservation Status | Measurements | | | Tree Condition (Good(G) / Average(A) / Poor(P)) | | | Recommendation (Retain / Transplant / Remove) | Findings | Remark |
|---|---|---|---|---|---|---|---|---|---|---|---|---|
| A12<br>(T3537) | <i>Aquilaria sinensis</i> | 土沉香 | RPPHK;<br>Cap.586;<br>IUCN:VU | 185 | 8 | 3 | P | P | A | Transplant | No obvious wound wood production.<br>Severity of the insect feeding was low. | Trunk wounds were observed before transplant operation. Shallow root. Original root ball was full of stones which were removed partially during the translocation.<br>It was translocated to the temporary holding nursery on 29 Sep 2023. It collapsed during typhoon dated Oct 2023 resulted in largely reduction in foliage density. It was slightly lean after a typhoon event dated 13-14 Nov 2024 and reinstated. Decaying wounds and exposed dead woods on trunk. The foliage density is low especially after inclement weather events on Aug/Sep 2025.<br>The tree recovered partially on Spring 2026. However recent heavy raining, hot weather on June and July resulted in the reduction in foliage density. |

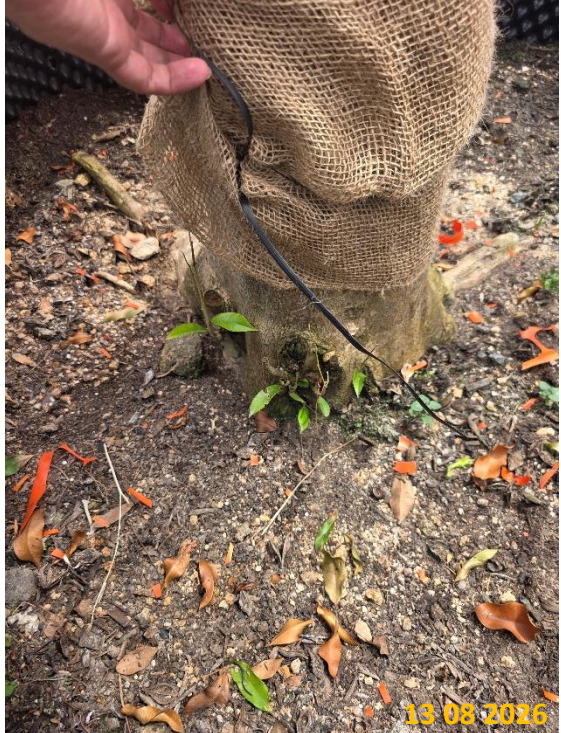
| <p>A12 –Wound at trunk base</p> | <p>A12 – Epicormics on trunk. Decaying wound on Trnnk.</p> |

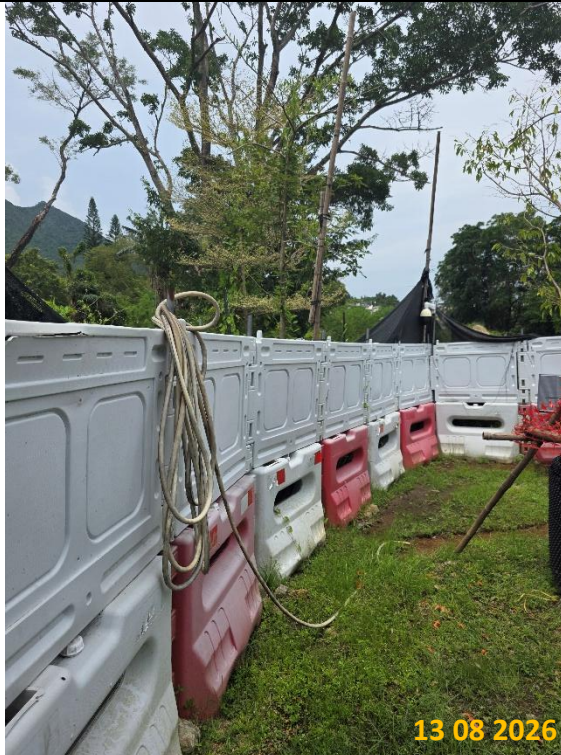
| <p>Fencing is in order during inspection</p> | <p>Grass cutting and weeding was conducted on 1 August 2026.</p> |
