Tung Chung New Town Extension – Site Formation and Infrastructure Works at Tung Chung Valley, Phase 1

**Tree Schedule for Survey of Plant Species of Conservation Importance**

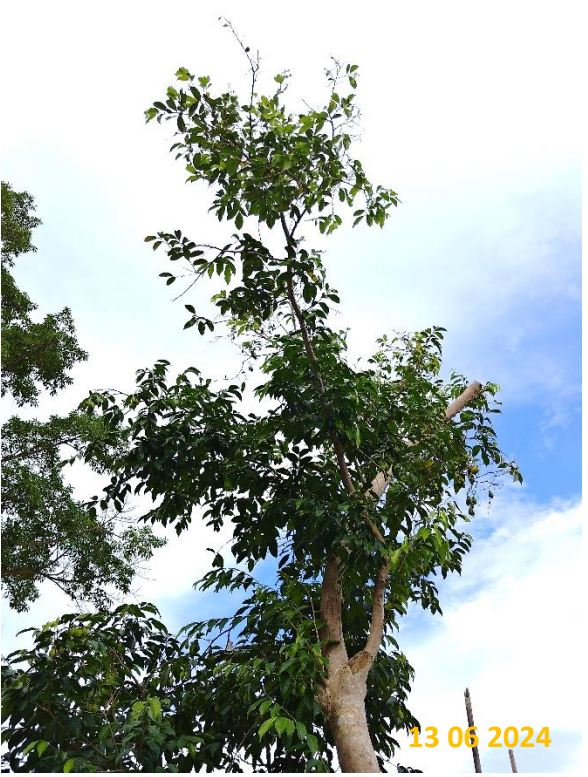
<p>13 06 2024</p> <p>This photograph shows a young tree, identified as A8, in a construction site. The tree is supported by a tripod of wooden stakes and has a protective structure around its base consisting of a black mesh cylinder and a burlap cone. The tree is situated on a patch of grass and soil, with white and red plastic safety barriers in the background. The sky is blue with some clouds.</p>	<p>A8 – Crown condition</p>

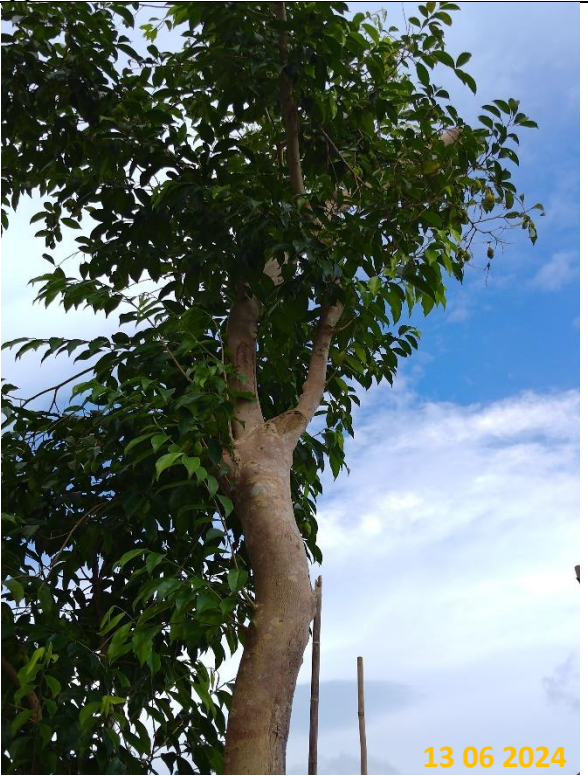
<p>13 06 2024</p> <p>This photograph provides a close-up view of the crown of tree A8. The tree has a dense canopy of green leaves. The trunk is visible at the bottom of the frame. The background shows a blue sky with light clouds.</p>
<p>A8 – Pruning wound previously damaged by typhoon KOINU (Oct 2023)</p>

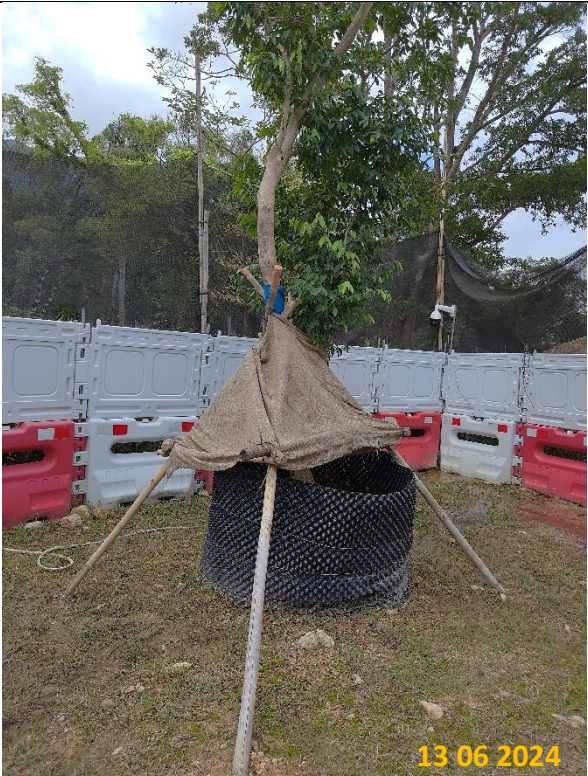
<p>13 06 2024</p> <p>This photograph shows a close-up of the trunk of tree A8, focusing on a pruning wound. The wound is a vertical cut in the bark, and the surrounding bark appears slightly damaged or healed. The background shows green foliage and a blue sky.</p>	<p>A8 – Trunk and root condition.</p>

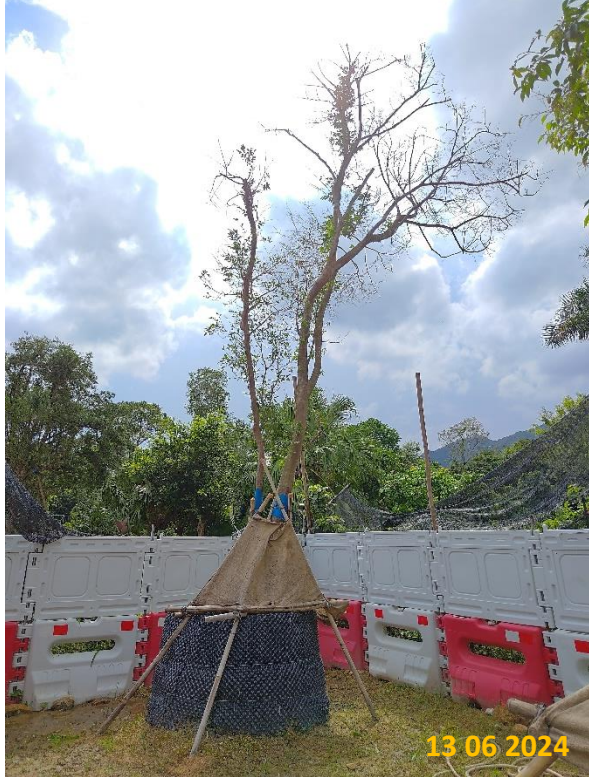
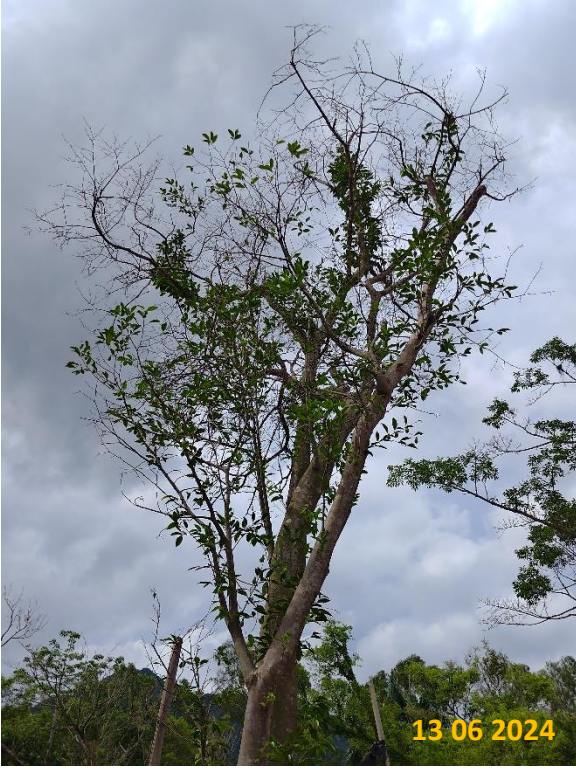
<p>A12 - Overall View</p>	<p>A12 – Foliage density is low since its collapse during Typhoon KOINU. Dieback observed.</p>

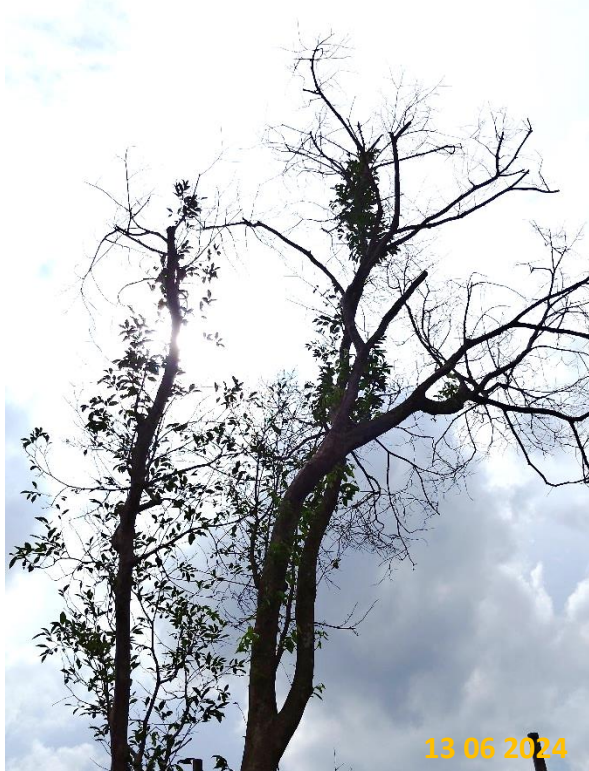
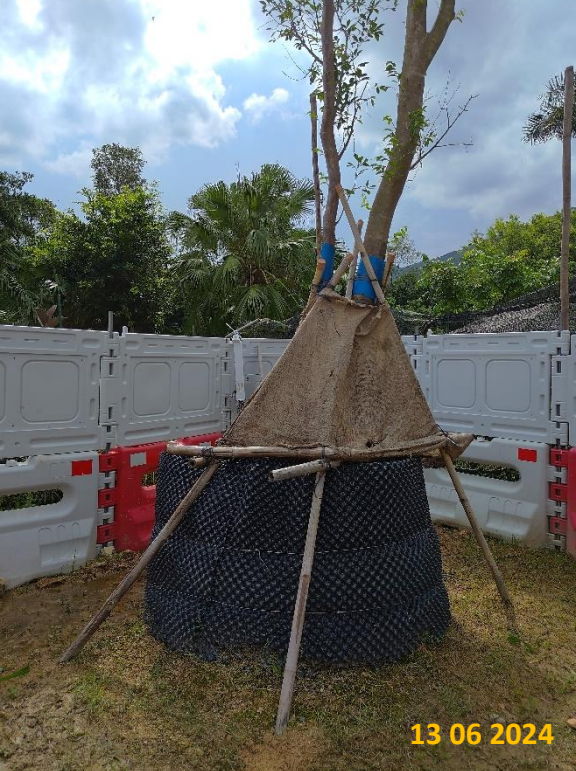
<p>13 06 2024</p>
<p>A12 – Codominant branch with included bark</p>	<p>A12 – Trunk and root condition</p>

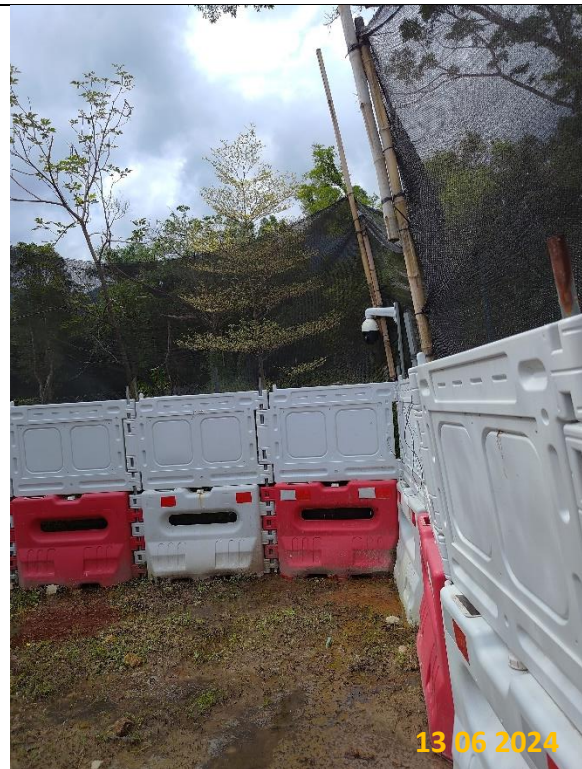
CCTV and fencing are in order
