Tung Chung New Town Extension – Site Formation and Infrastructure Works at Tung Chung Valley, Phase 1

Tree Schedule for Survey of Plant Species of Conservation Importance

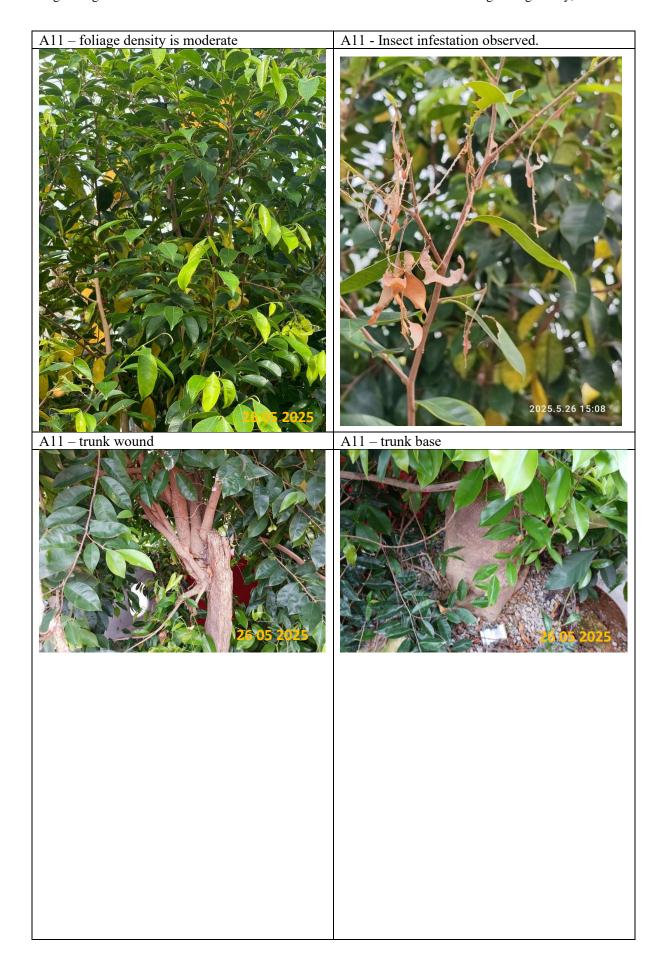
A11 – Application of insecticide was carried out in the reporting period

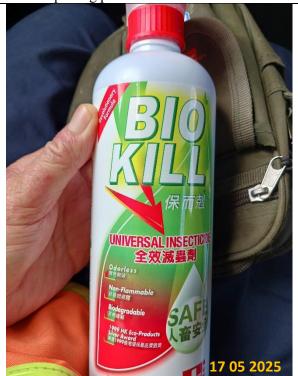
A11 – Application of insecticide was carried out in the reporting period

All - the larval stage of *Heortia vitessoides* (沉香黄野螟)

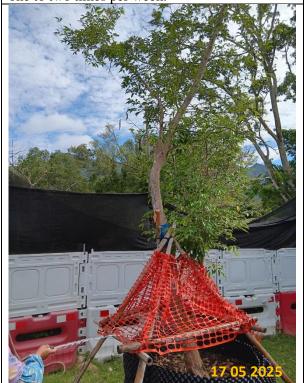
Manual watering was carried out for A8 during the reporting period. The watering frequency is one to two times per week.

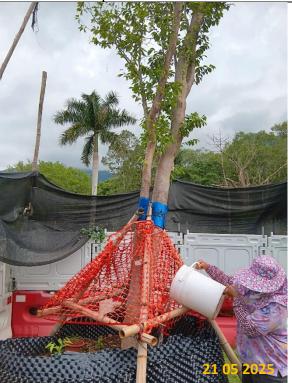
Manual watering was carried out for A12 during the reporting period. The watering frequency is one to two times per week.
