NL/2020/05 Photographic record (Monthly Monitoring Report for Preservation of Plant Species of Conservation Importance – December 2025)

Tree Schedule for Survey of Plant Species of Conservation Importance

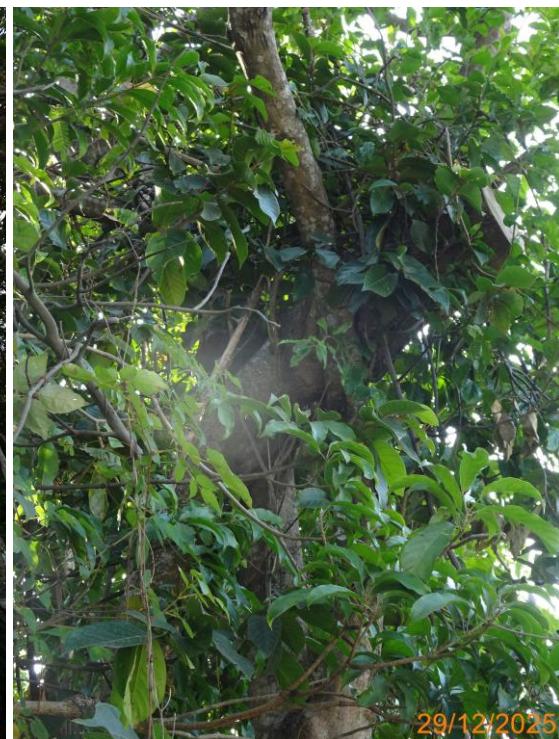
2: T8217_Cross branches

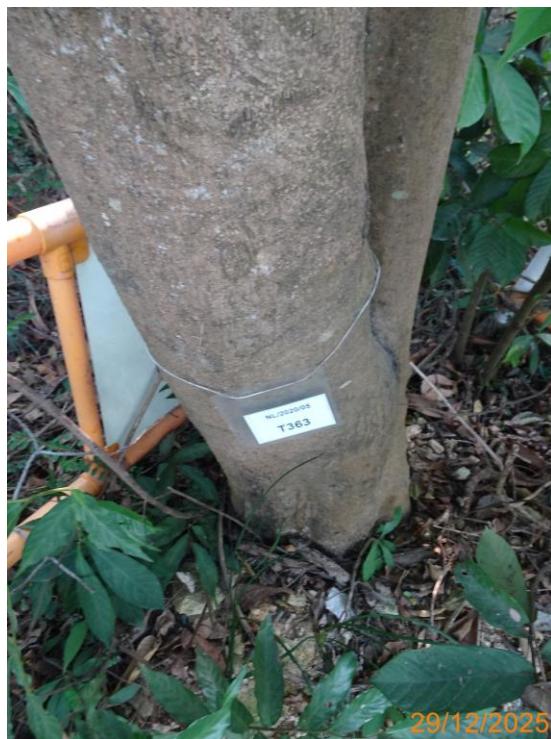
3: T8217_Trunk base

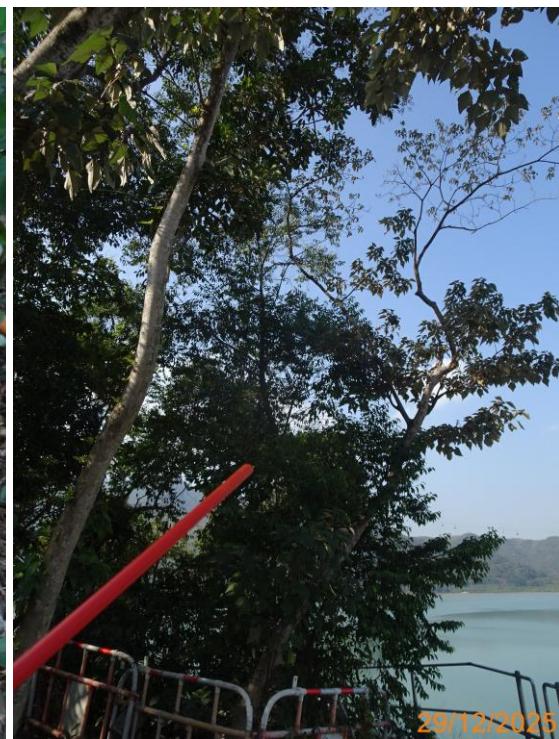
4: T8231

T8231	<i>Canthium dicoccum</i>	魚骨木	IUCN:VU	7	190	6	L	P	A	P	Retain	Second epicormic failure was found on 21 July 2025 due to Typhoon signal No. 10. Overall condition of tree and its remaining part is fair	There is no proper and safe assess towards T8231 & T8217, thus, plastics barriers were installed in lieu of 2m high barrier. Epicormic branch failure was found on 03 May 2024. Staking to provide extra support and pruning of jagged wound to provide a clean cut was conducted on 16 May 2024. Application of insecticide and fungicide on wound was conducted on 6 December 2025. Adjustment of trunk protection pad was conducted on 6 December 2025. The Staking was in normal condition during the time of inspection. No further significant defects were observed. Second epicormic failure was found on 21 July 2025. Overall condition of tree and its remaining part is fair. Pruning of jagged wound to provide a clean cut is recommended. Pruning works was completed on 21 July 2025.

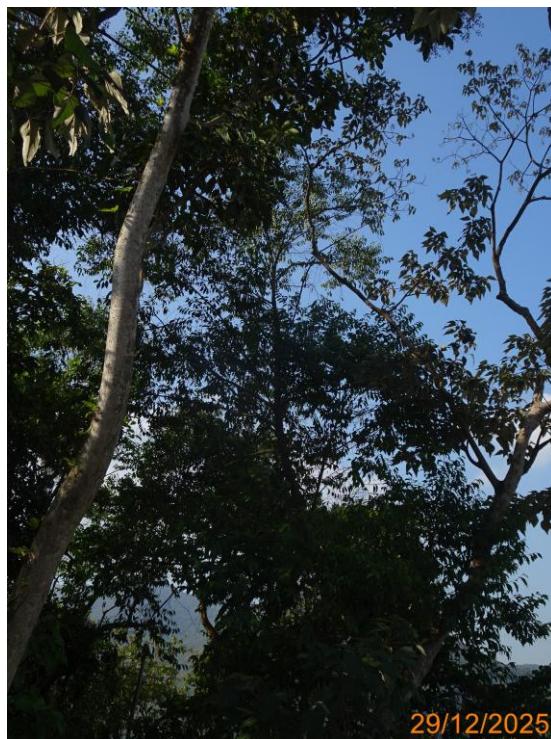
5: T8231_Crown

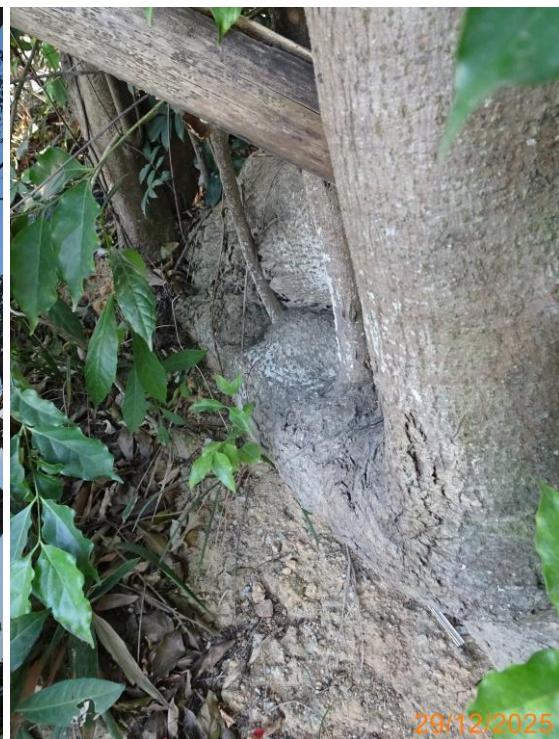
6: T8231_Trunk base

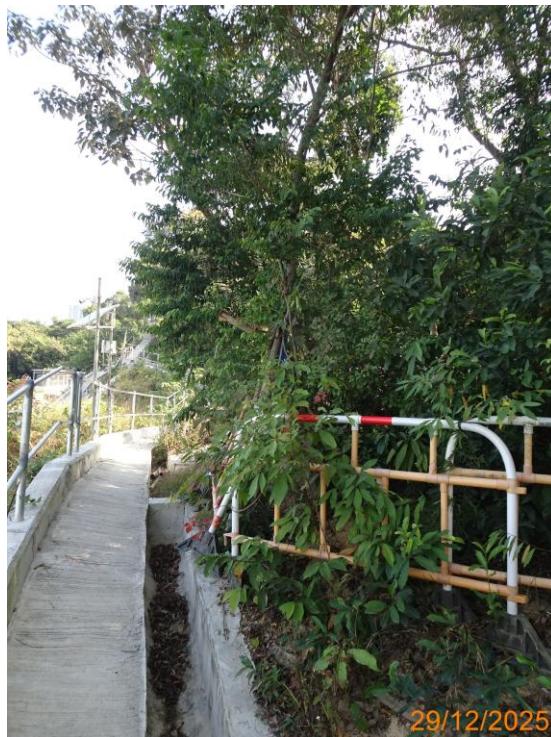
7: T8231_Trunk

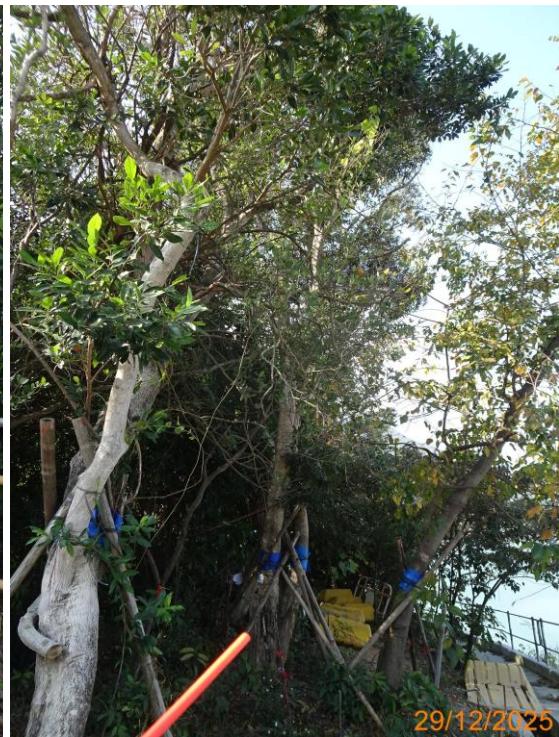
8: U041

U041	<i>Aquilaria sinensis</i>	土沉香	RPPHK; Cap.586; IUCN:VU	10	318	4	M	A	P	P	Retain	No obvious old termite track was found, damage of wood tissue was observed. Peeling off of bark and sign of split of internal wood tissue was observed. Trunk wound significantly decayed. High trunk failure risk.	Located closed to cut slope. The crack on trunk was found slightly larger since late March 2024. Peeling off of bark and split of internal wood tissue was observed in July 2024. Abnormal bark crack was found in December 2024. Additional guying for tree no. U041 has been installed as an enhanced stabilization measure alongside the bamboo staking in May 2025. Adjustment of guying and application of insecticide and fungicide was conducted on 6 December. Adjustment of trunk protection pad was conducted on 6 December 2025.
U042	<i>Gmelina chinensis</i>	石梓	RPPHK	6	150	2	M	A	P	A	Retain	Large wound near trunk base with wound wood development. Trunk wound is decaying.	Located closed to cut slope. Application of insecticide and fungicide as preventive measure was conducted on 6 December 2025. Adjustment of trunk protection pad was conducted on 6 December 2025.

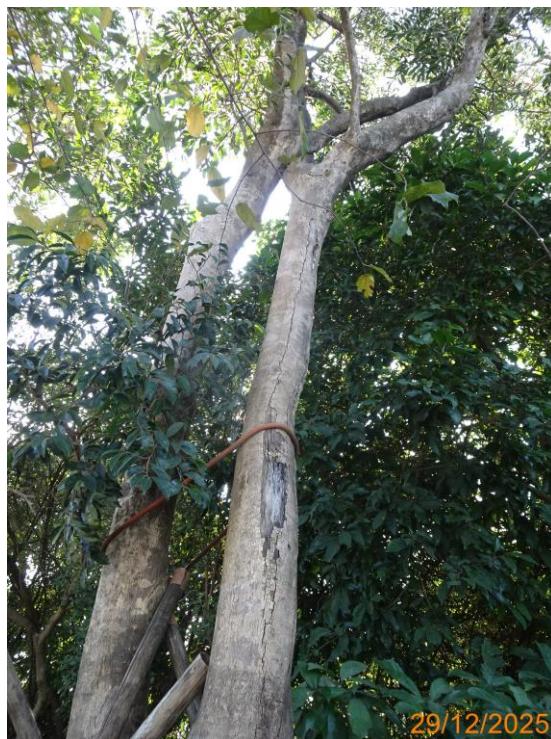
9: U041_Abnormal bark crack on trunk

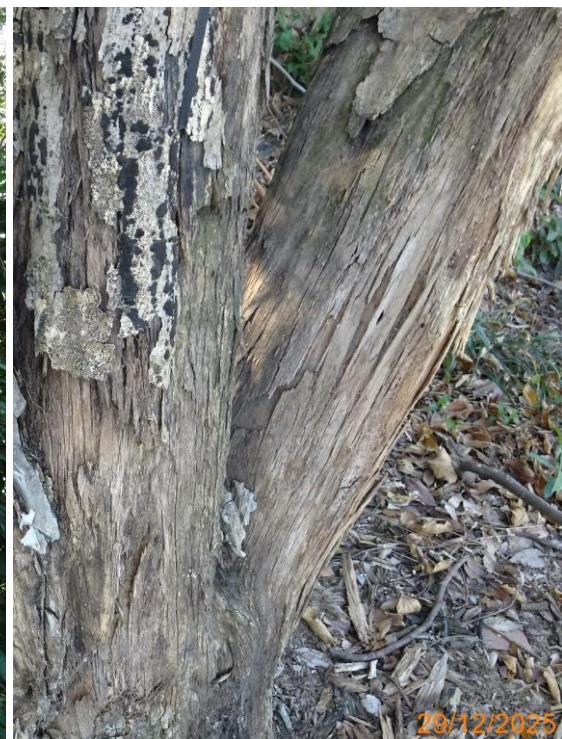
10: U041_Crack on trunk

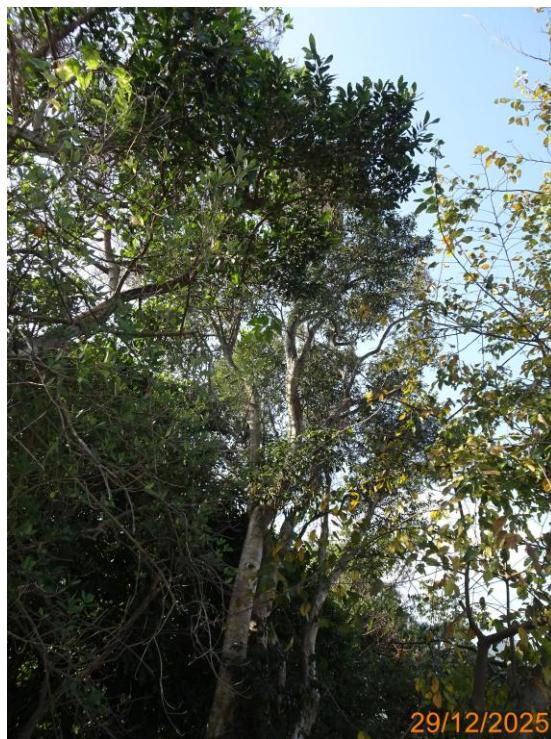
11: U041_Crown

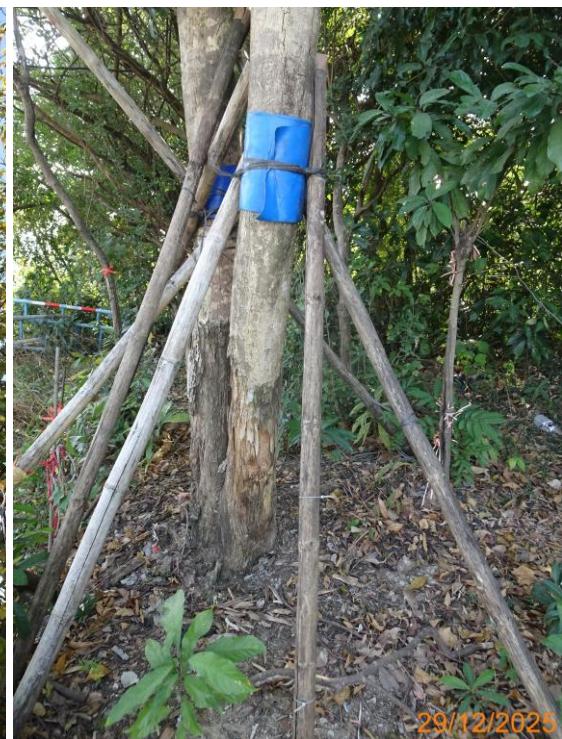
12: U041_Trunk base

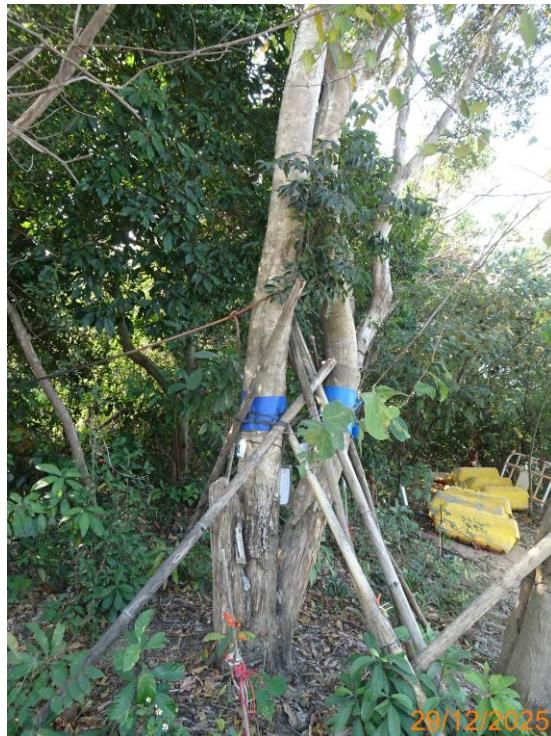
13: U041_Trunk

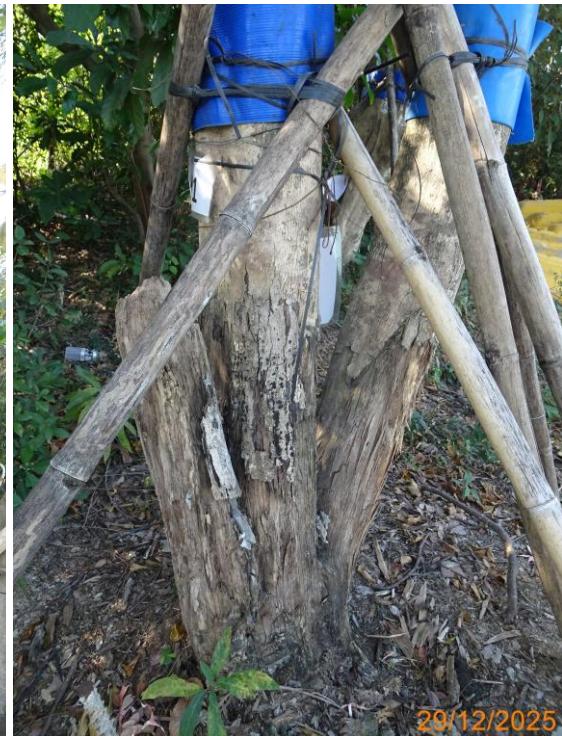
14: U041_Wood damage at trunk union#1

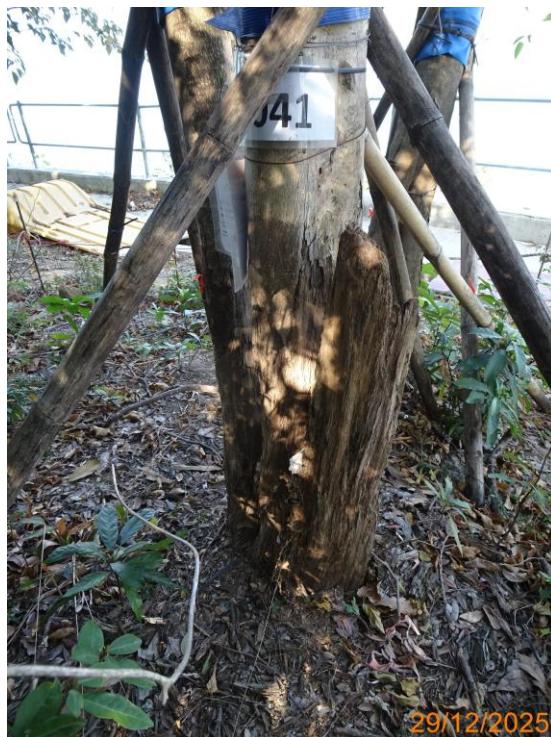
15: U041_Wood damage at trunk union#2

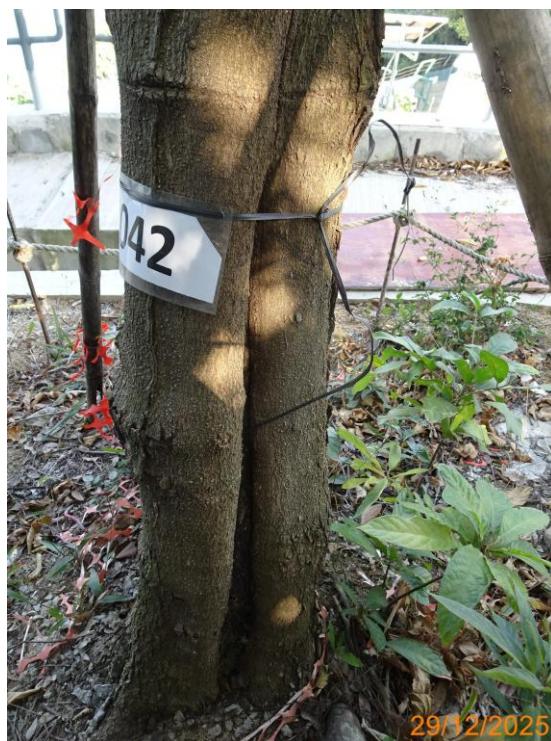
17: U042_Wound on trunk base

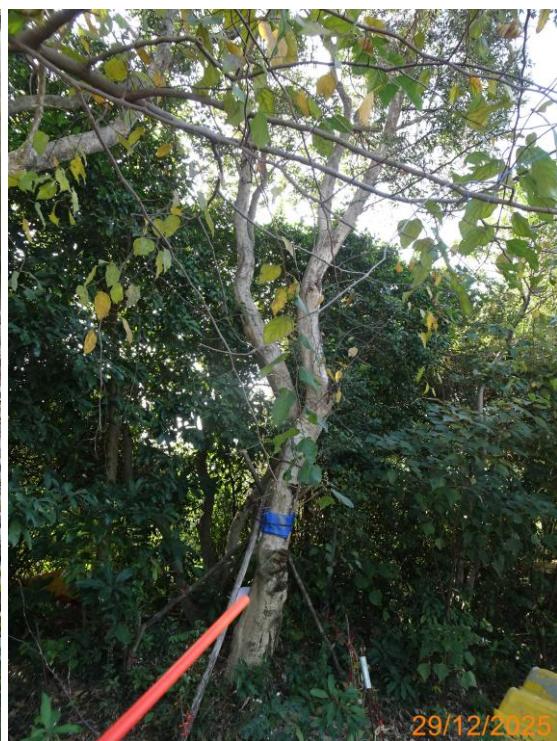
18: U043

U043	<i>Aquilaria sinensis</i>	土沉香	RPPHK; Cap.586; IUCN:VU	9	310	4	M	A	P	P	Retain	Crack on trunk base. Trunk wound significantly decayed. High trunk failure risk.	Located closed to cut slope and fenced off by 2m high barrier. Application of insecticide and fungicide was conducted on 6 December 2025. Adjustment of trunk protection pad was conducted on 6 December 2025.

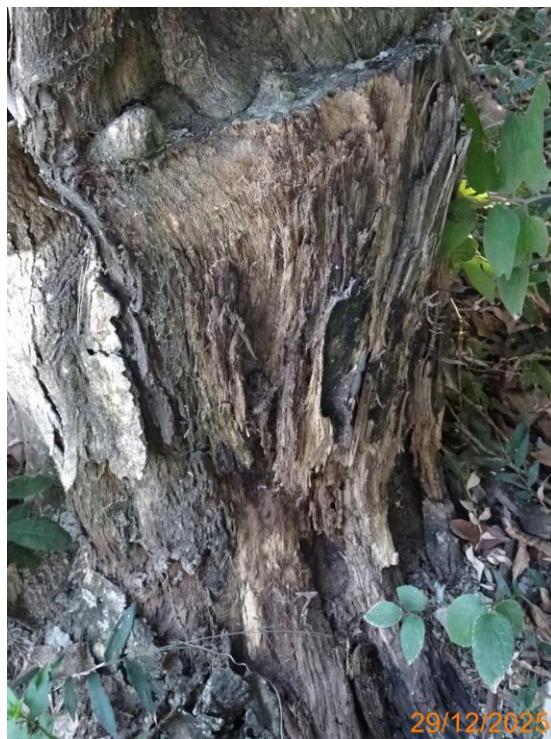
19: U043_Crack on trunk

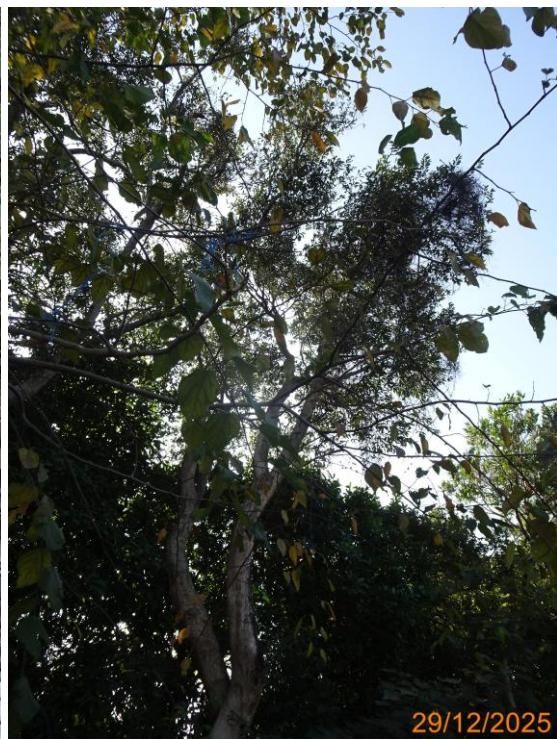
20: U043_Crown

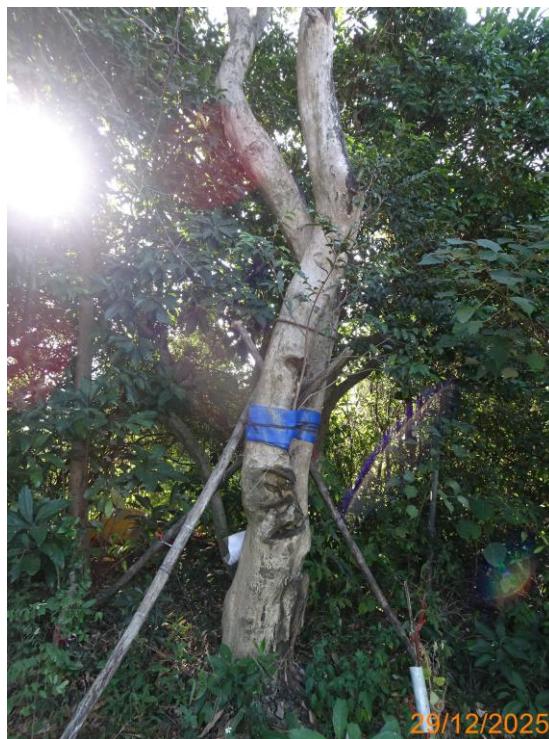
21: U043_Trunk

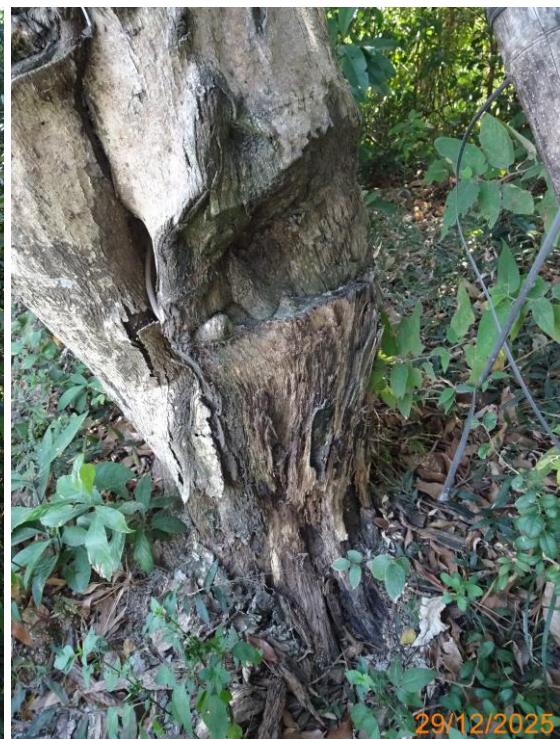
22: U043_Wound on trunk#1

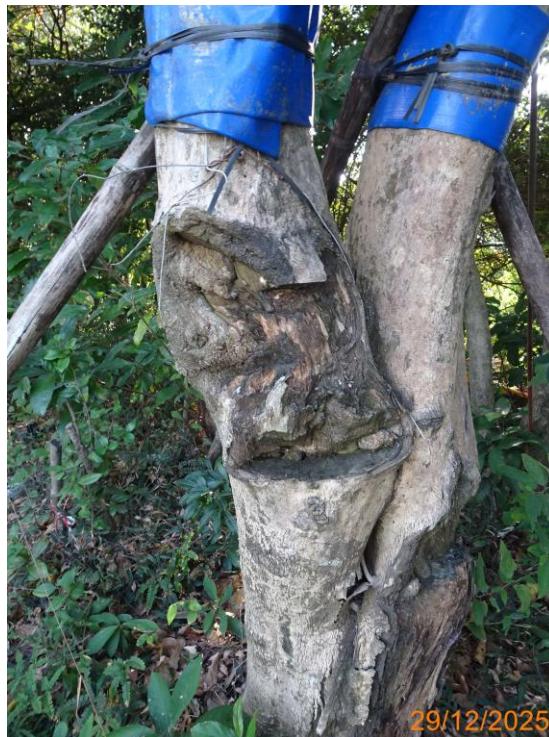
23: U043_Wound on trunk#2
