**Agreement No. CE 64/2020 (EP)  
Environmental Team for  
Tung Chung New Town  
Extension (West) –  
Design and Construction**

Monthly Environmental Monitoring & Audit Report  
for February 2026

**Environmental Permit No. EP-519/2016**

**Tung Chung New Town Extension (West)**

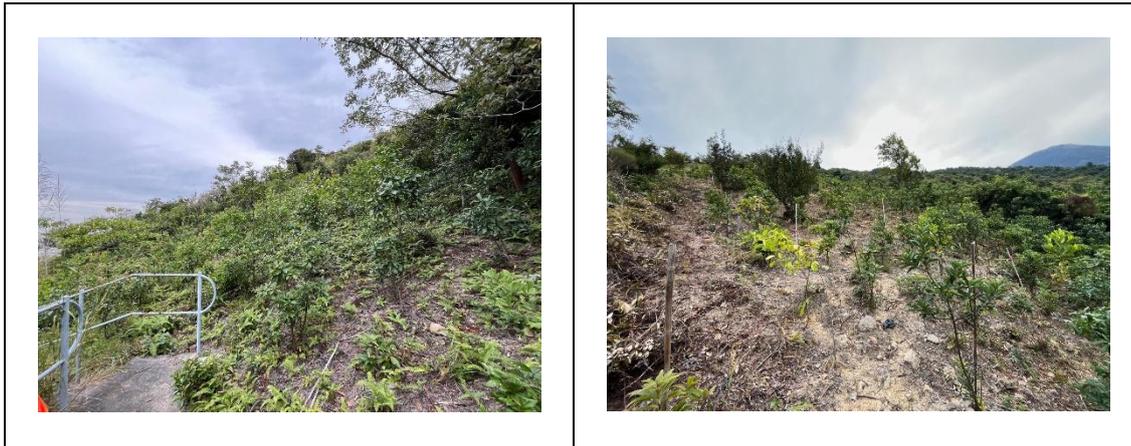
**Table 7.6: Photos of the Compensation Woodland Planting**

Compensation Woodland Planting was completed in May 2022. With the approval from EPD on the monitoring proposal in October 2022, the monitoring for Compensation Woodland was commenced in November 2022. Photos of the Compensation Woodland planting are shown in **Table 7.6**.

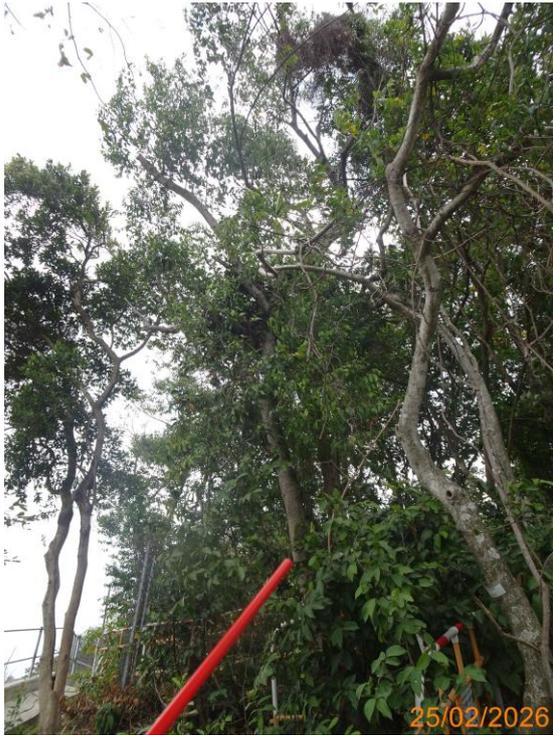
1: T8217

Monthly monitoring was conducted by QB appointed under Contract 5 on 25 February 2026. Branch failure was found at the individual of *Canthium dicoccum* (Tree No. T8217). The failure was suspected to be caused by strong wind induced by Typhoon WIPHA and adverse weather in July 2025. Overall condition of the individual and its remaining part was fair. One of the epicormic branch attached to the individual of *Canthium dicoccum* (Tree No. T8231) under Contract 5 was found fallen from its own trunk on 3 May 2024 after the inclement weather. A second instance of epicormic failure was found at the individual which was suspected to be caused by the adverse

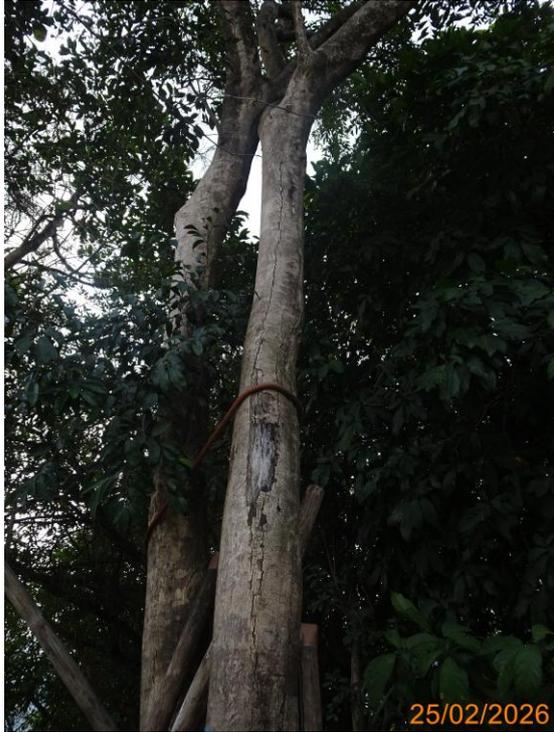
9: U041\_Abnormal bark crack

weather in July 2025. The overall condition of the individual and its remaining part was fair. No obvious old termite tracks were found at the individual of *Aquilaria sinensis* (Tree No. U041) under Contract 5 during the reporting period. Peeling off of bark near trunk base was observed at the individual and internal decay was worsening with sounding test. Abnormal bark crack was observed at the individual. The risk of trunk failure was high as the trunk wound was significantly decayed. Adjustment of staking was carried out at the individual. Wound wood development was observed at the individual of *Gmelina chinensis* (Tree No. U042) under Contract 5. Root zone was partially restricted by existing slope surface. Crack on trunk base was found at the individual of *Aquilaria sinensis* (Tree No. U043) under Contract 5. Fungal fruiting bodies were found on the trunk occasionally and the trunk structure of the individual was weak. The structural condition of the individual would be kept monitoring by QB. Application of fungicide and insecticide were carried out at T8217, T8231, U041, U042 and U043. Trunk protection pads were readjusted for T8231, U041, U042 and U043.

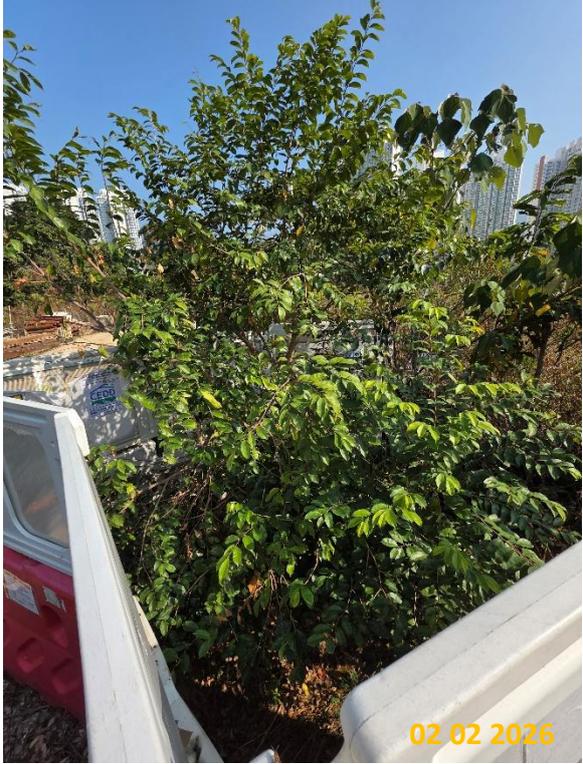
<p>A11 – Overall view</p>	<p>A11 – Crown condition. Foliage density reduced on current inspection probably due to the dry weather.</p>

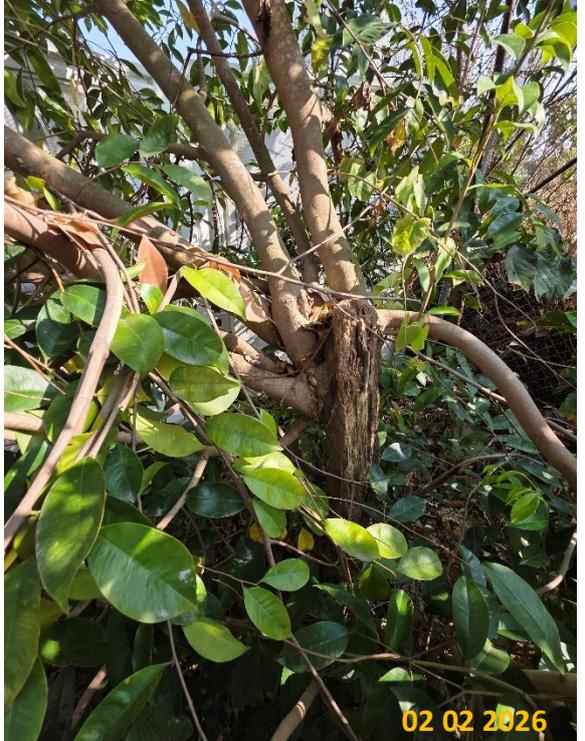
<p>02 02 2026</p>
<p>A11 – Shoots are epicormic generated from cut trunk which is decaying severely</p>	<p>A11 - Soil condition</p>

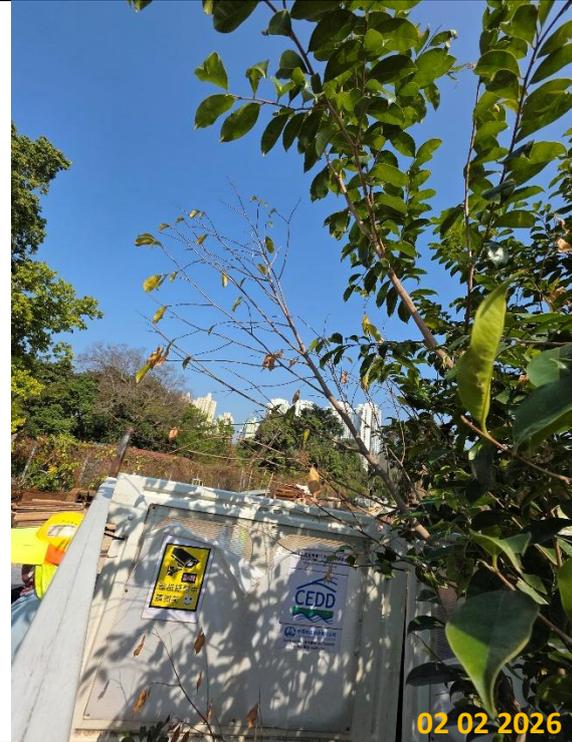
A11 – Wilting twigs due to previous physical damage on Nov 2025

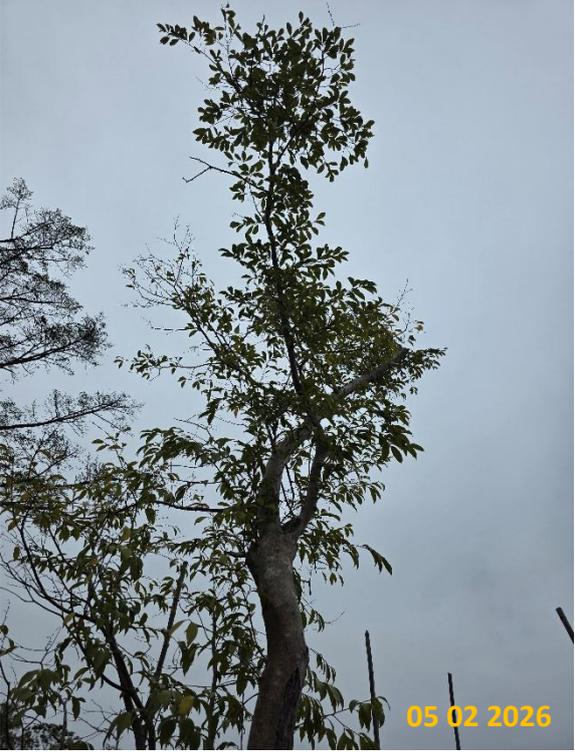
<p>A8 – Overall view</p>	<p>A8 – Crown condition. Foliage density is low since Super Typhoon dated Sep 2025.</p>

<p>A close-up photograph of the crown of tree A8. The foliage is sparse and thin, indicating low density. The tree is supported by a wooden tripod frame. A yellow date stamp '05 02 2026' is visible in the bottom right corner.</p>
<p>A8 – Pruning wound previously damaged by typhoon KOINU (Oct 2023)</p>	<p>A8 – Trunk and root condition.</p>

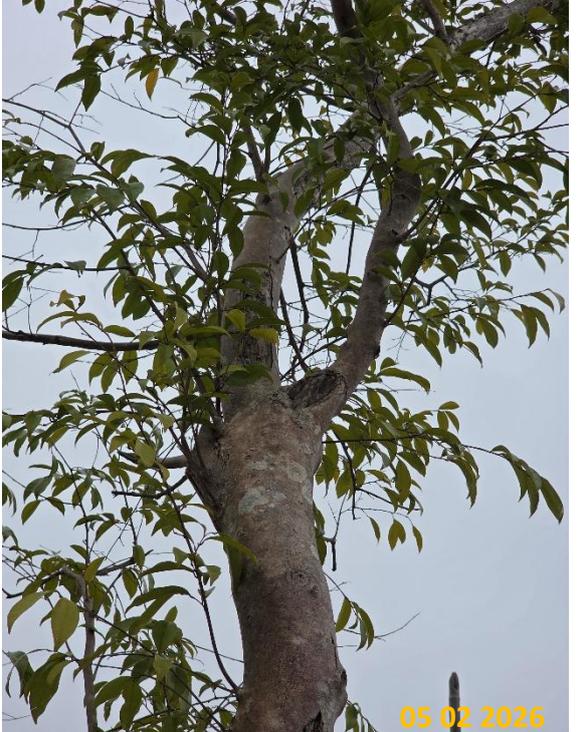
<p>A close-up photograph of the trunk of tree A8, showing a significant pruning wound. The wound is a deep, irregular cut in the bark, with some internal wood visible. The surrounding foliage is green. A yellow date stamp '05 02 2026' is visible in the bottom right corner.</p>

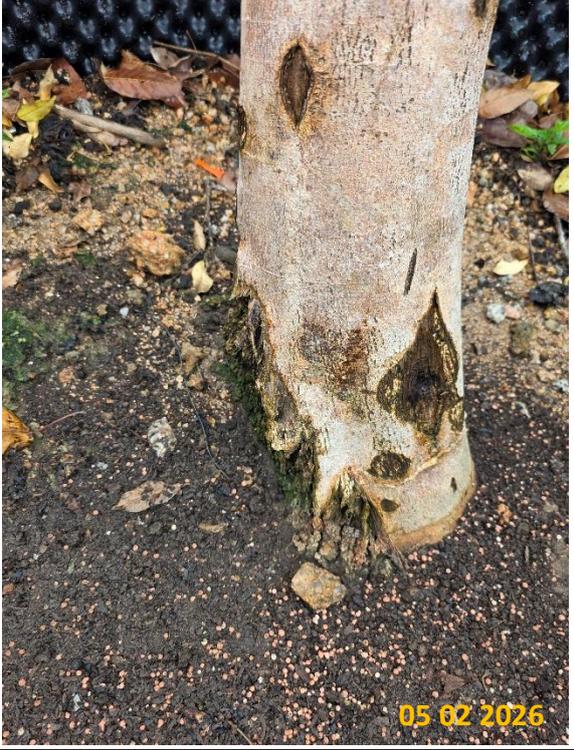
<p>A8 – Decaying wound at trunk base (size: ~180mm x170mm)</p>	<p>A8 – Decaying wound on trunk</p>

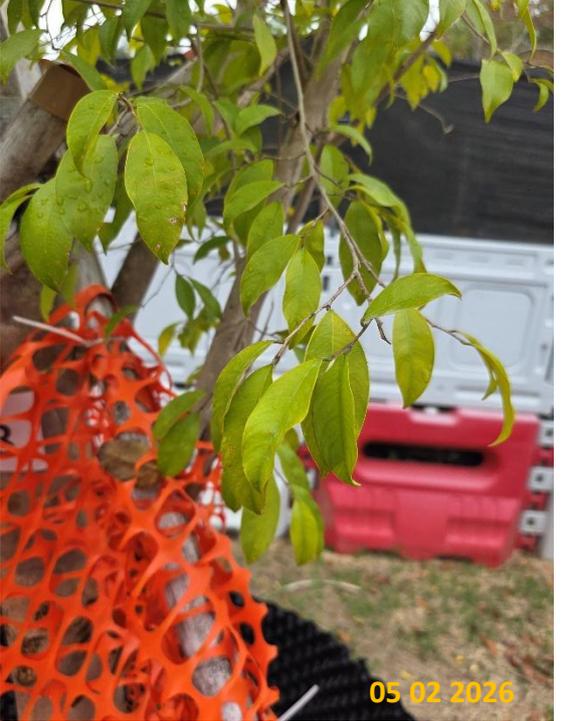
<p>A8 – Ant nest was not found</p>	<p>A8 – Leaves chlorosis and thin</p>

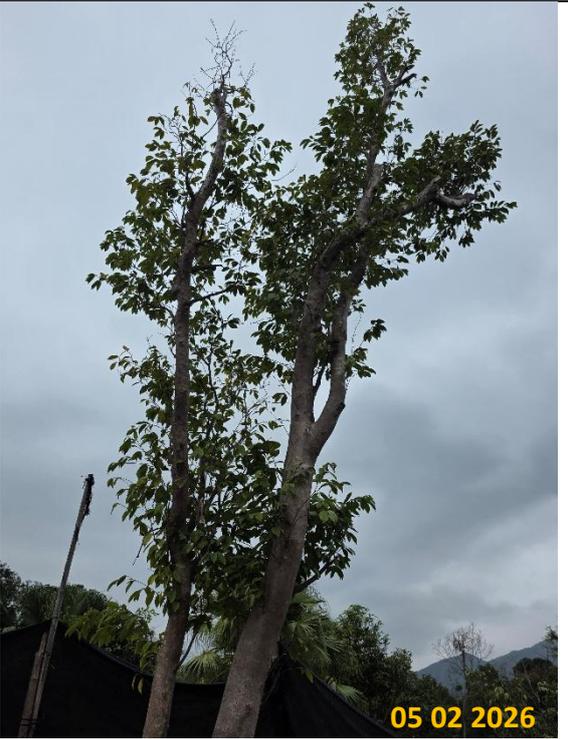
<p>05 02 2026</p> <p>This photograph shows a young tree with a sparse canopy of green leaves. The tree is supported by a wooden tripod structure. Its base is wrapped in black protective mesh and secured with orange safety netting. The tree is situated in a cleared area next to a row of white and red plastic safety barriers. In the background, there are more trees and a cloudy sky.</p>	<p>A12 - Dieback observed.</p>

<p>05 02 2026</p> <p>This close-up photograph of the tree's canopy shows several dead, brown branches extending from the main green foliage, indicating dieback. The tree is supported by a wooden tripod structure. The background shows a cloudy sky and some distant trees.</p>
<p>A12 - Foliage density reduced significantly after previous inclement weather.</p>

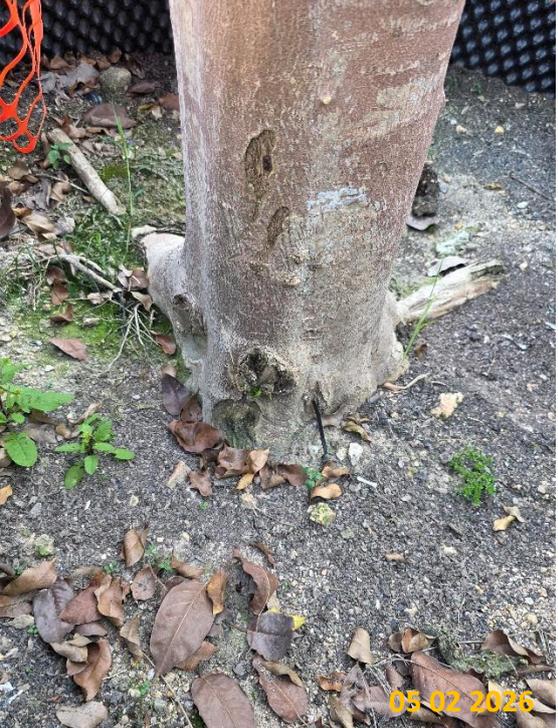
<p>A12 –Wound at trunk base</p>

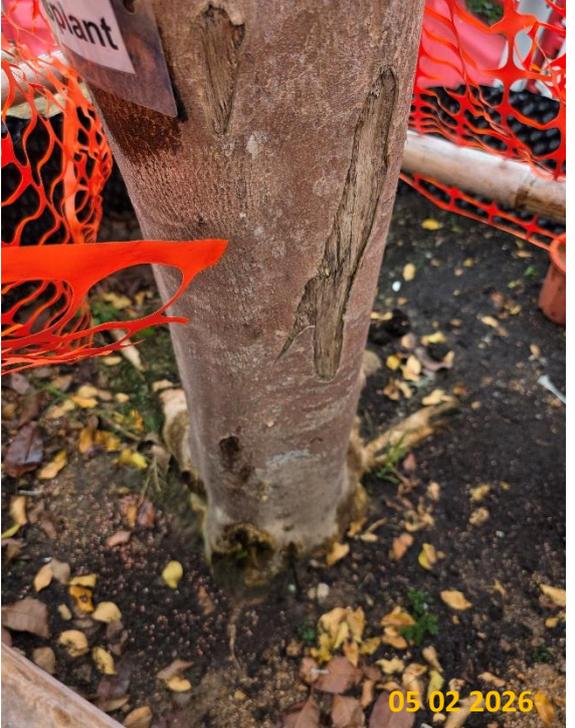
<p>05 02 2026</p>	<p>A12 – Decaying wound on trunk</p>

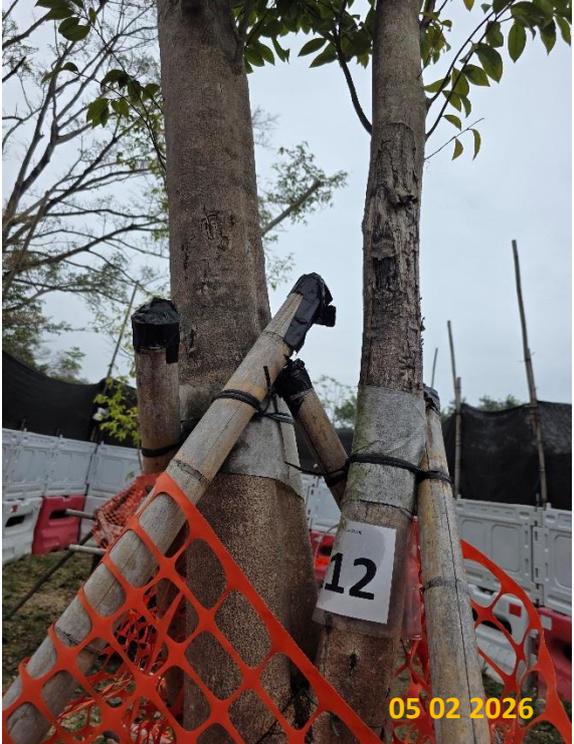
<p>05 02 2026</p>
<p>A12 – Epicormics on trunk. Decaying wound on Trnnk.</p>
