**Agreement No. CE 64/2020 (EP)  
Environmental Team for  
Tung Chung New Town  
Extension (West) –  
Design and Construction**

Monthly Environmental Monitoring & Audit Report  
for August 2026

**Environmental Permit No. EP-519/2016**

**Tung Chung New Town Extension (West)**

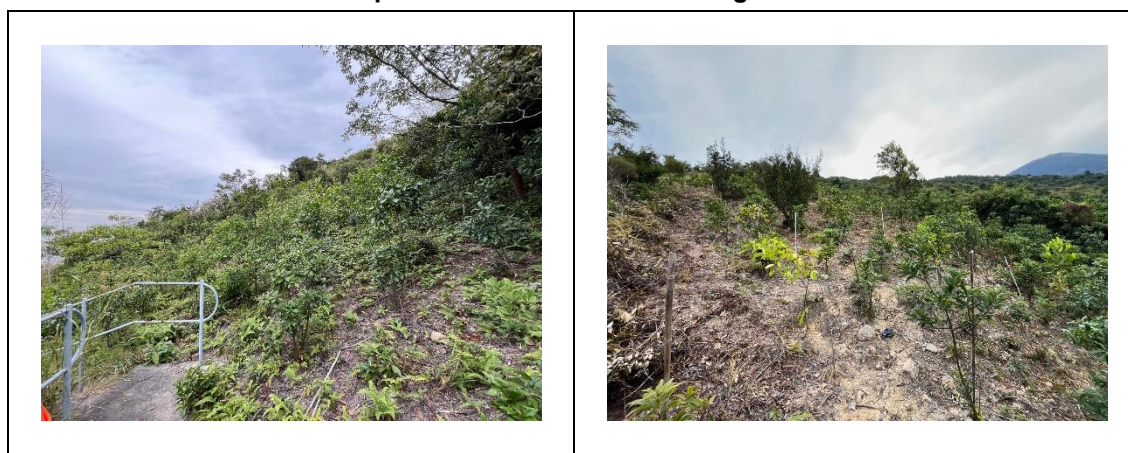
**Table 7.6: Photos of the Compensation Woodland Planting**

Compensation Woodland Planting was completed in May 2022. With the approval from EPD on the monitoring proposal in October 2022, the monitoring for Compensation Woodland was commenced in November 2022 and completed in November 2025. Photos of the Compensation Woodland planting are shown in **Table 7.6**.

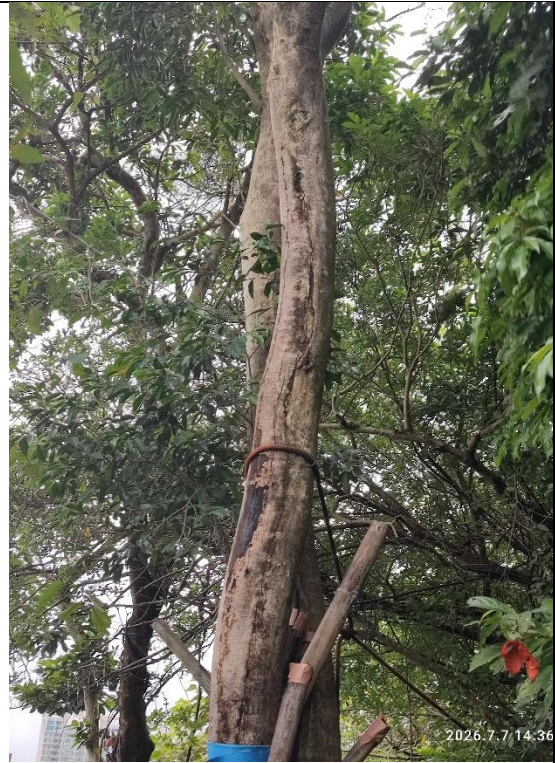
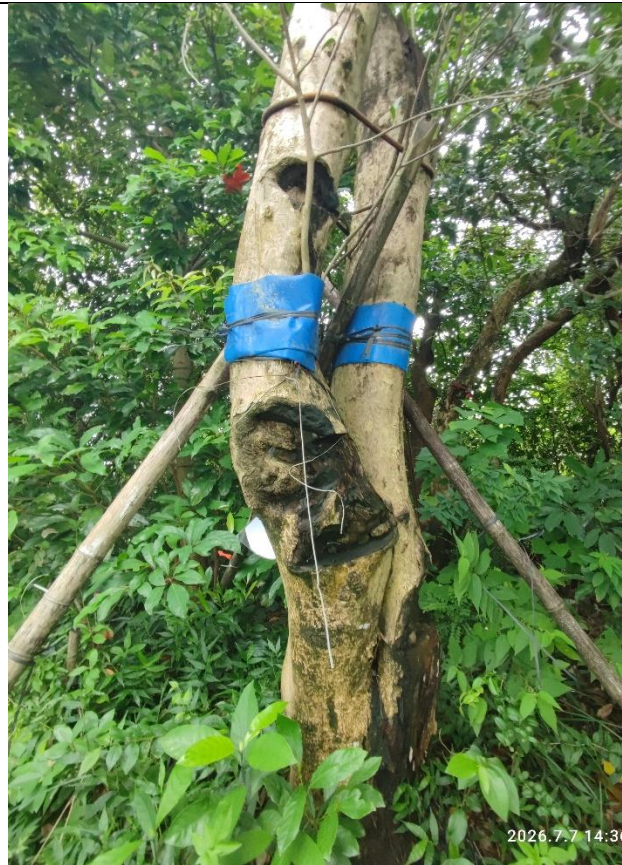
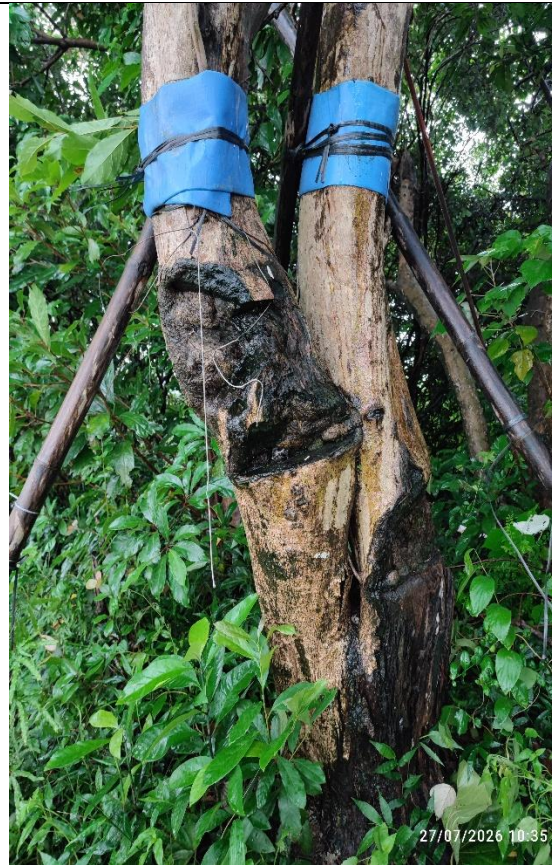
**U043 – Trunk condition**

**U043– Trunk condition**

| Tree No. | Species | | | Measurements | | | Amenity Value<br>(High(H) / Medium (M) / Low(L) | Tree Condition (Good(G) / Average(A) / Poor(P)) | | | Recommendation<br>(Retain / Transplant / Remove) | Findings | Remark |
|---|---|---|---|---|---|---|---|---|---|---|---|---|---|
| U043 | <i>Aquilaria sinensis</i> | 土沉香 | RPPHK;<br>Cap.586;<br>IUCN:VU | 9 | 310 | 4 | M | A | P | P | Retain | Crack on trunk base. Trunk wound significantly decayed. High trunk failure risk. | Located closed to cut slope. |

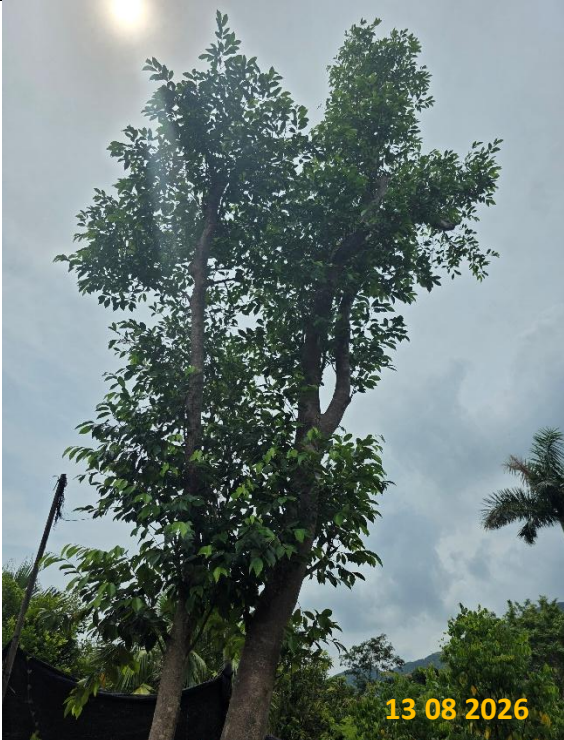
| <p>A12 - Overall View</p> <p>13 08 2026</p> | <p>A12 - Dieback observed.</p> <p>13 08 2026</p> |

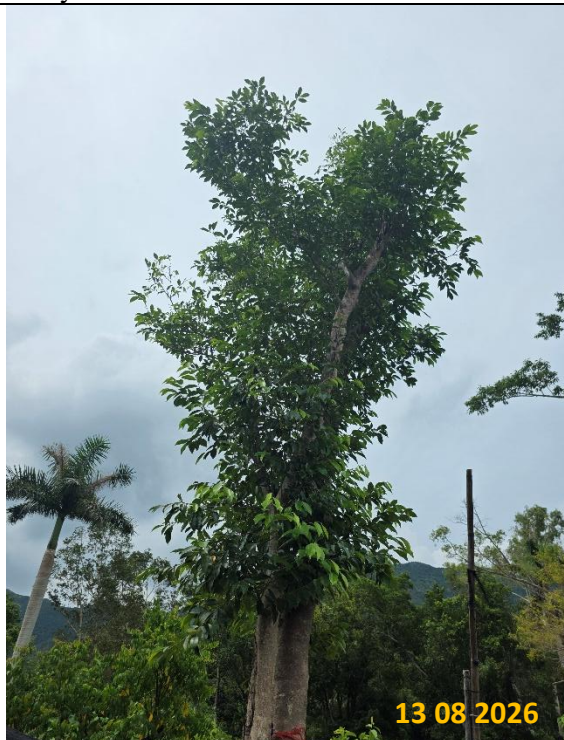
| <p>A12 - Foliage density reduced after repeatedly heavy rains</p> <p>13 08 2026</p> | <p>A12 – Trunk and root condition</p> <p>13 08 2026</p> |

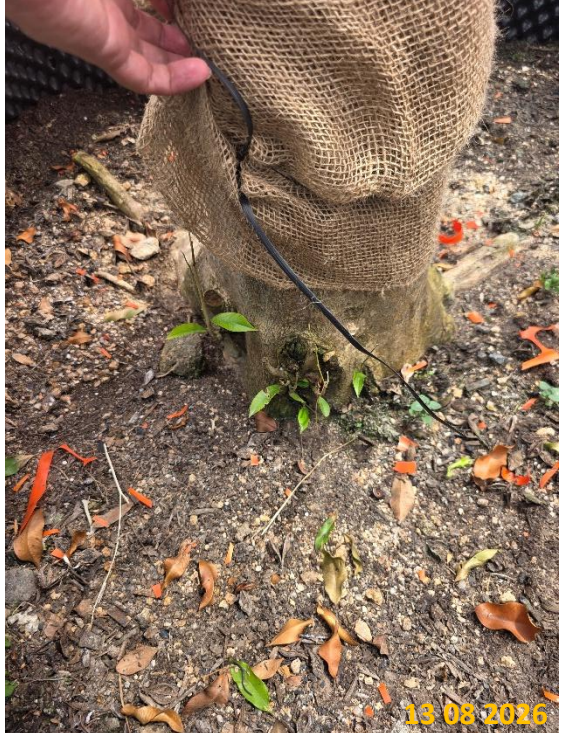
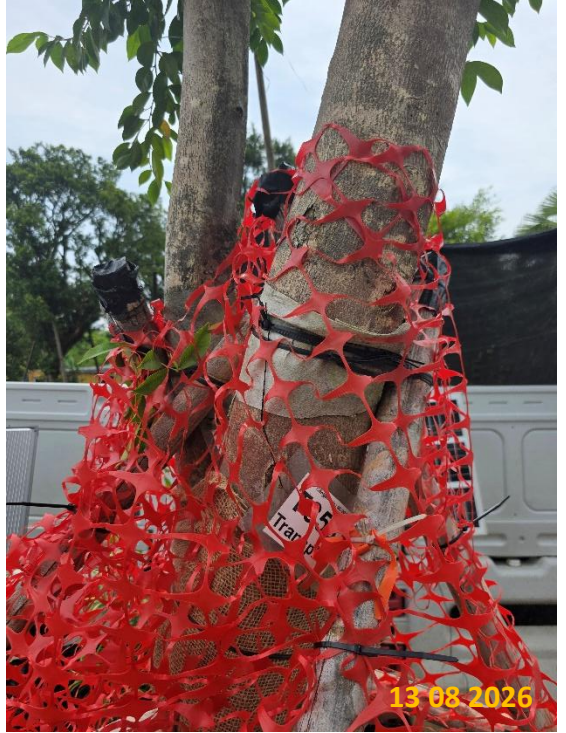
| <p>A12 –Wound at trunk base</p> | <p>A12 – Epicormics on trunk. Decaying wound on Trnnk.</p> |
| <p>A close-up photograph of a tree trunk base. The trunk is wrapped in a coarse, light-brown burlap material. A dark, irregular wound is visible at the base of the trunk, where the burlap meets the ground. The ground is covered with dry, brown leaves and some small green plants. A yellow date stamp '13 08 2026' is in the bottom right corner.</p> | <p>A photograph of a tree trunk wrapped in red plastic netting. The netting is secured with black straps. A small white tag with the number '5' and the word 'Tran' is attached to the netting. The trunk shows signs of decay and epicormics (small, new growths) at the base. A yellow date stamp '13 08 2026' is in the bottom right corner.</p> |
