Agreement No. CE 64/2020 (EP) Environmental Team for Tung Chung New Town Extension (West) – Design and Construction

Monthly Environmental Monitoring & Audit Report for January 2025

Environmental Permit No. EP-519/2016

Tung Chung New Town Extension (West)

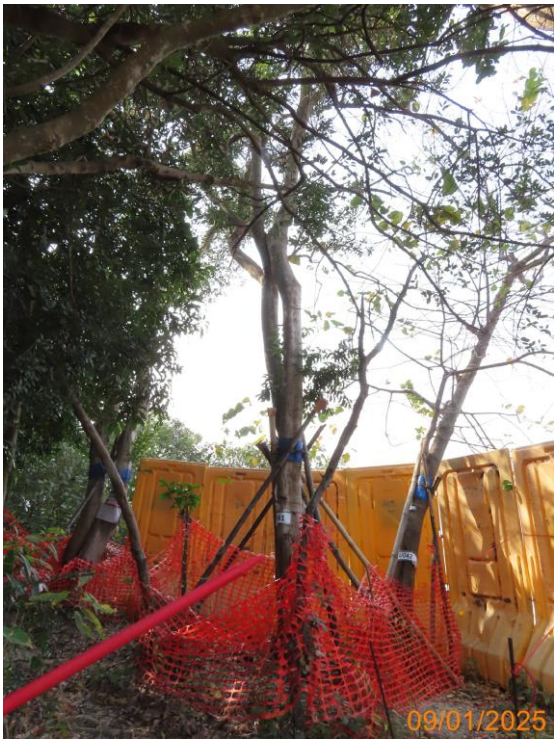
Monthly monitoring was conducted by QB appointed under Contract 5 on 9 January 2025. One of the epicormic branch attached to the individual of *Canthium dicoccum* (Tree No. T8231) under Contract 5 was found fallen from its own trunk on 3 May 2024 after the inclement weather. The overall condition of the individual and its remaining part was fair. Application of insecticides and fungicides on wound was carried out. No obvious old termite tracks were found at the individual of *Aquilaria sinensis* (Tree No. U041) under Contract 5 during the reporting period. Peeling off of

4: T8231

5: T8231_Trunk base

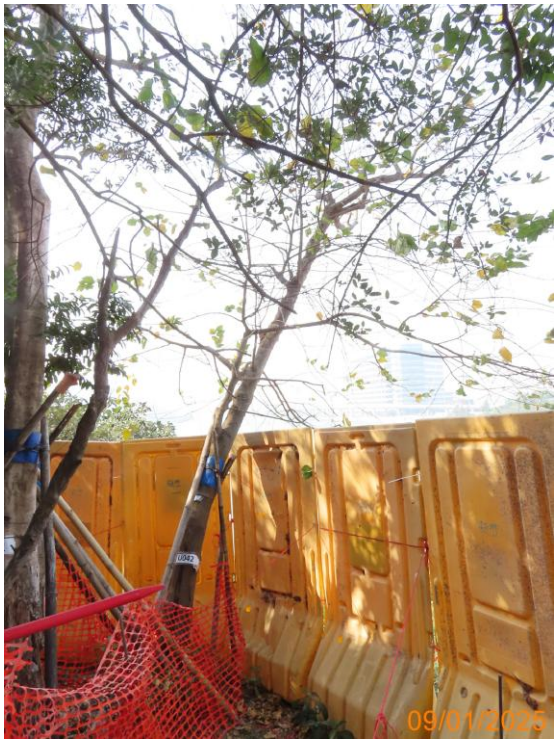
bark near trunk base was observed at the individual and internal decay was worsening with sounding test. Abnormal bark crack was observed at the individual. The risk of trunk failure was high as the trunk wound was significantly decayed. Adjustment of staking was carried out at the individual during the reporting period. Wound wood development was observed at the individual of *Gmelina chinensis* (Tree No. U042) under Contract 5. Reduced foliage density was observed at the individual due to seasonal variation. Root zone was partially restricted by existing slope surface. Application of insecticide on the wound was carried out. Crack on trunk base was found at the individual of *Aquilaria sinensis* (Tree No. U043) under Contract 5. Fungal fruiting bodies were found on the trunk and the trunk wound was significantly decayed. The trunk structure of the individual was weak. The structural condition of the individual would be kept monitoring by QB. Application of fungicide and insecticide were carried out at U041 and U043. Trunk protection pads were readjusted for U041, U042 and U043. No specific observations were made for the individual of *Canthium dicoccum* (Tree No. T8217) during the reporting period.

6: U041

7: U041_Abnormal bark crack on trunk

11: U041_Wood damage at trunk union#2

12: U041_Wood damage at trunk union#3

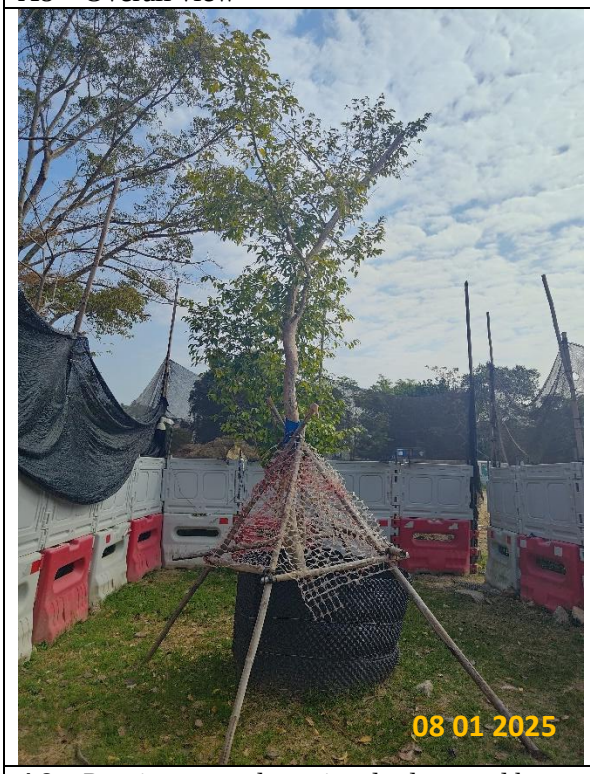
A8 – Overall view	A8 – Crown condition.

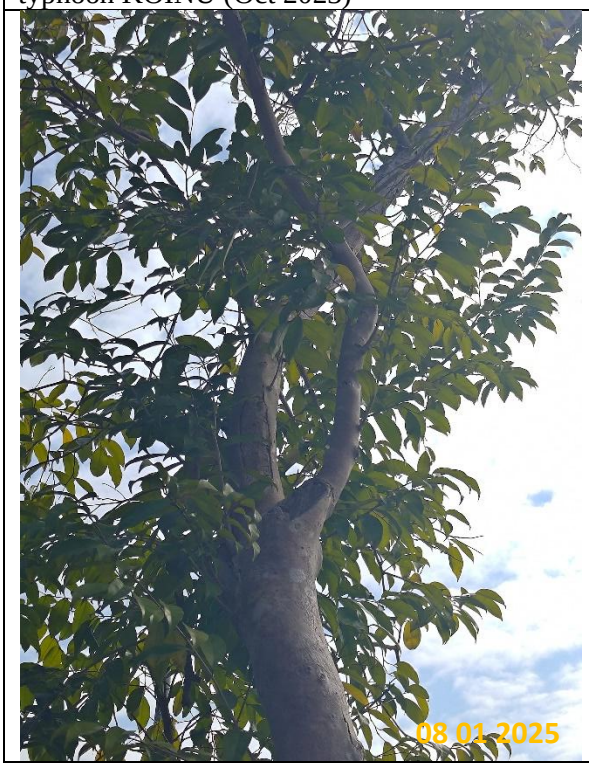
A8 – Pruning wound previously damaged by typhoon KOINU (Oct 2023)	A8 – Trunk and root condition.

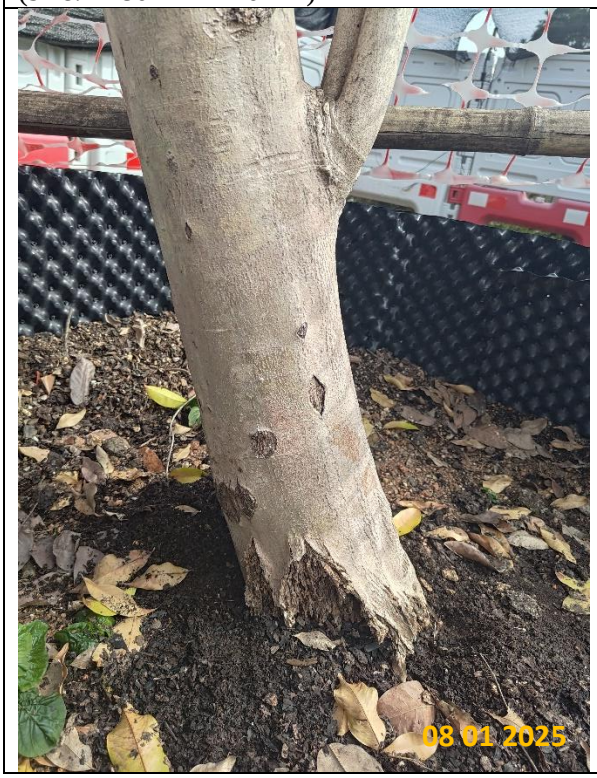
A8 – Decaying wound at trunk base (size: ~180mm x170mm)	A8 – Decaying wound on trunk

Manual watering was carried out for A8 during the reporting period. The watering frequency is one to two times per week.	Manual watering was carried out for A12 during the reporting period. The watering frequency is one to two times per week.

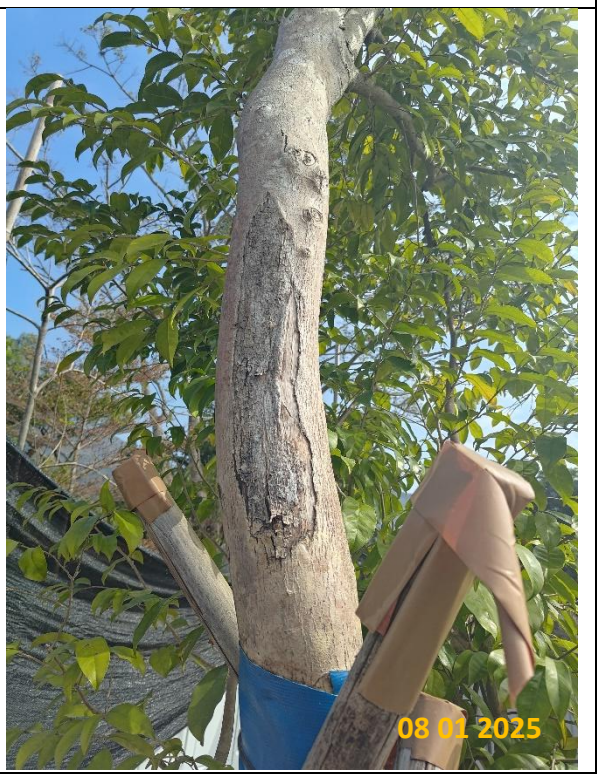
A12 - Overall View	A12 - Dieback observed. Dead branches were removed on 07/12/2024

A12 - Foliage density is still low.	A12 – Trunk and root condition

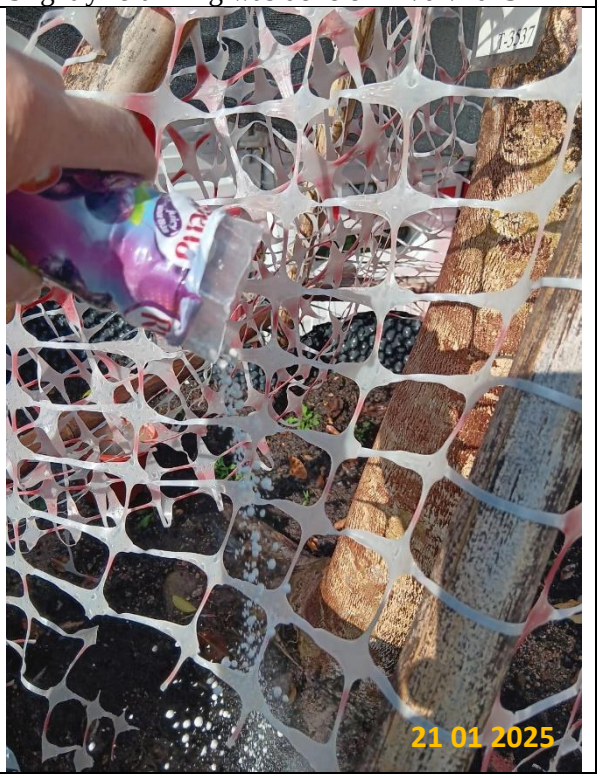
CCTV and fencing are in order.	Slightly fertilizing was done on 21/01/2025

CCTV Screen captures at day-time	CCTV Screen captures at day-time

CCTV Screen captures at night-time	CCTV Screen captures at night-time
