NL/2020/05 Photographic record (Monthly Monitoring Report for Preservation of Plant Species of Conservation Importance – Nov 2023)

Tree Schedule for Survey of Plant Species of Conservation Importance

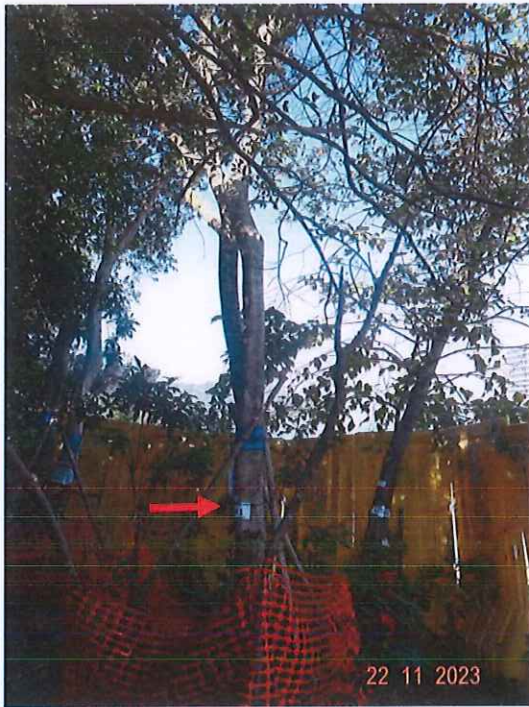
4: U041

| Tree No. | Species | | | Measurements | | | Amenity Value (High(H) / Medium (M) / Low(L)) | Tree Condition (Good(G) / Average(A) / Poor(P)) | | | Recommendation (Retain / Transplant / Remove) | Findings | Remark |
|---|---|---|---|---|---|---|--|---|---|---|--|--|--|
| U041 | <i>Aquilaria sinensis</i> | 土沉香 | RPPHK; Cap.586; IUCN:VU | 10 | 318 | 4 | M | A | P | A | Retain | No obvious old termite track was found, damage of wood tissue was observed. Application of termiticide is recommended. | Located closed to cut slope and fenced off by 2m high barrier. Application of termiticide was conducted on 28 November 2023. |

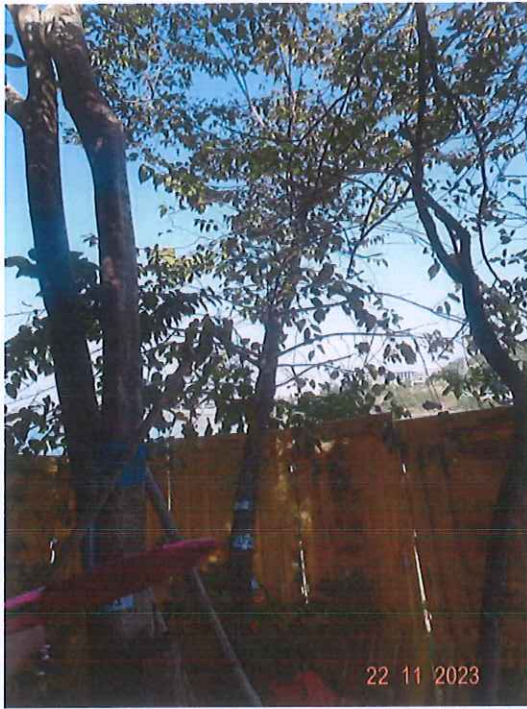
9: U042

| Tree No. | Species | | | Measurements | | | Amenity Value (High(H) / Medium (M) / Low(L)) | Tree Condition (Good(G) / Average(A) / Poor(P)) | | | Recommendation (Retain / Transplant / Remove) | Findings | Remark |
|---|---|---|---|---|---|---|--|---|---|---|--|--|--|
| U042 | <i>Gmelina chinensis</i> | 石梓 | RPPHK | 6 | 150 | 2 | M | A | P | A | Retain | Large wound near trunk base with wound wood development. Application of insecticide is recommended. | Located closed to cut slope and fenced off by 2m high barrier. Application of insecticide was conducted on 28 November. |

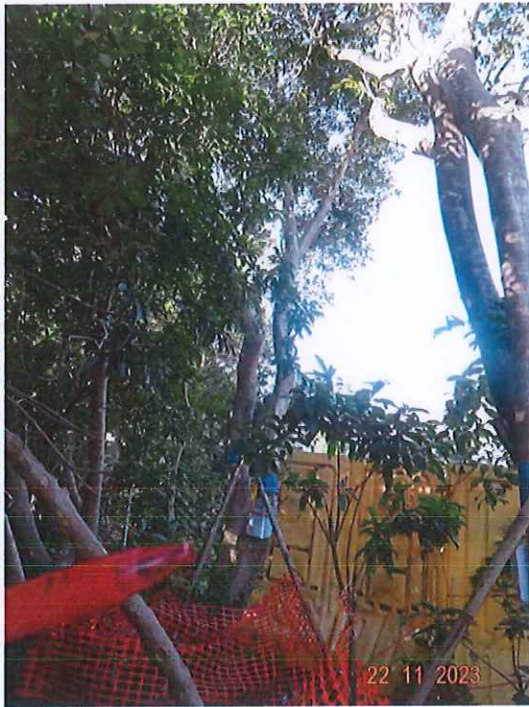
12: U043

| Tree No. | Species | | | Measurements | | | Amenity Value (High(H) / Medium (M) / Low(L)) | Tree Condition (Good(G) / Average(A) / Poor(P)) | | | Recommendation (Retain / Transplant / Remove) | Findings | Remark |
|---|---|---|---|---|---|---|--|---|---|---|--|--|--|
| U043 | <i>Aquilaria sinensis</i> | 土沉香 | RPPHK; Cap.586; IUCN:VU | 9 | 310 | 4 | M | A | P | A | Retain | Fungal fruiting bodies near trunk base. Application of fungicide is recommended. | Located closed to cut slope and fenced off by 2m high barrier. Application of fungicide was conducted on 28 November 2023. |

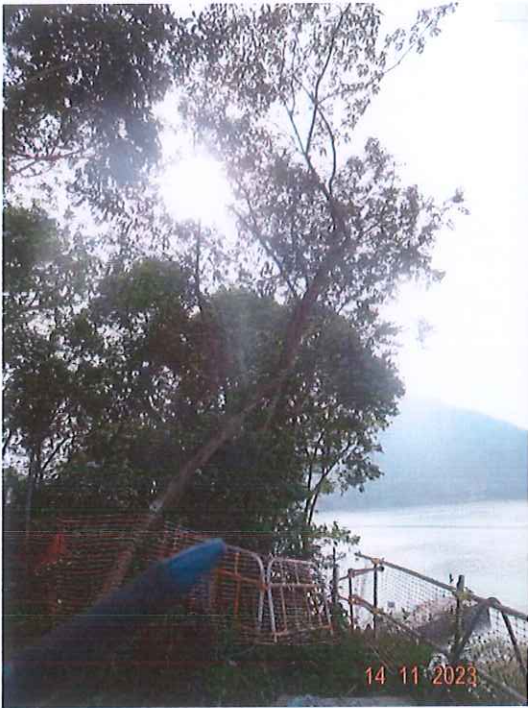
17: Silt rock and protection zone
