Tree Schedule for Survey of Plant Species of Conservation Importance

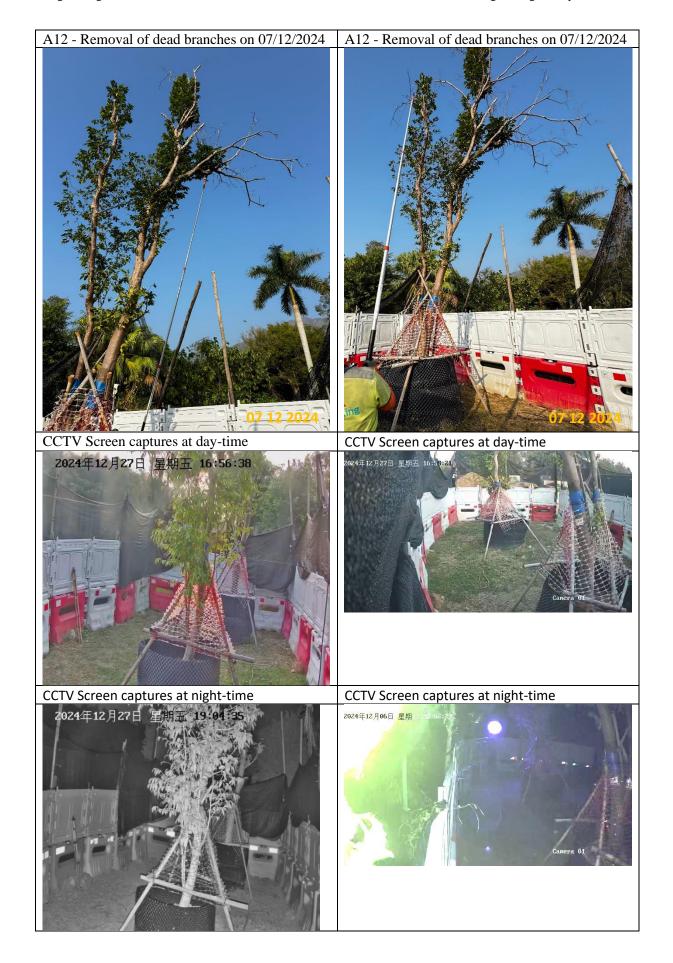
No.	Species		Conservatio n	Measurements			Tree Condition (Good(G) / Average(A) / Poor(P))			Recommendation (Retain / Transplant /	Findings	Remark
	Scientific Name	Chinese name	Status	DBH (mm)	Height (m)	Crown (m)	Form	Health	Structure	Remove)		
A8 (T8996)	Aquilaria sinensis	土沉香	RPPHK; Cap.586; IUCN:VU	110	5	4	Р	А	Р	Transplant	No specific observation.	Originally located at Site 1. Trunk wounds were observed before transplant operation. Shallow root. Sudden defoliation happened in May 2023 but recovered in Aug 2023. It was translocated to the temporary holding nursery on 29 Sep 2023. A branch (5cm) was broken and foliage density decreased due to typhoon in Oct 2023.
A12 (T3537)	Aquilaria sinensis	土沉香	RPPHK; Cap.586; IUCN:VU	185	8	3	Р	Р	Α	Transplant	The foliage density is low.	Originally located at Site 5. Trunk wounds were observed before transplant operation. Shallow root. Original root ball was full of stones which were removed partially during the translocation. It was translocated to the temporary holding nursery on 29 Sep 2023. It collapsed during typhoon dated Oct 2023 resulted in largely reduction in foliage density. It was slightly lean after a typhoon event dated 13-14 Nov 2024 (reinstated). Removal of dead branches was conducted on 07/12/2024.
