Tung Chung New Town Extension – Site Formation and Infrastructure Works at Tung Chung Valley, Phase 1

Tree Schedule for Survey of Plant Species of Conservation Importance

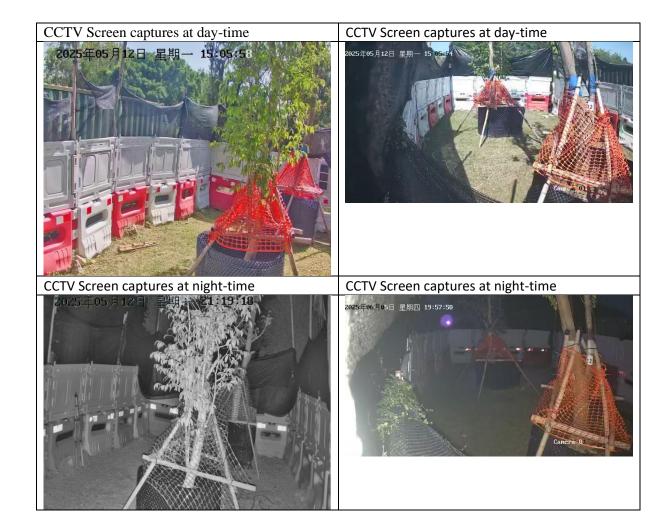
Manual watering was carried out for A8 during the reporting period. The watering frequency is one to two times per week.

Manual watering was carried out for A12 during the reporting period. The watering frequency is one to two times per week.
