**Tree Schedule for Survey of Plant Species of Conservation Importance**

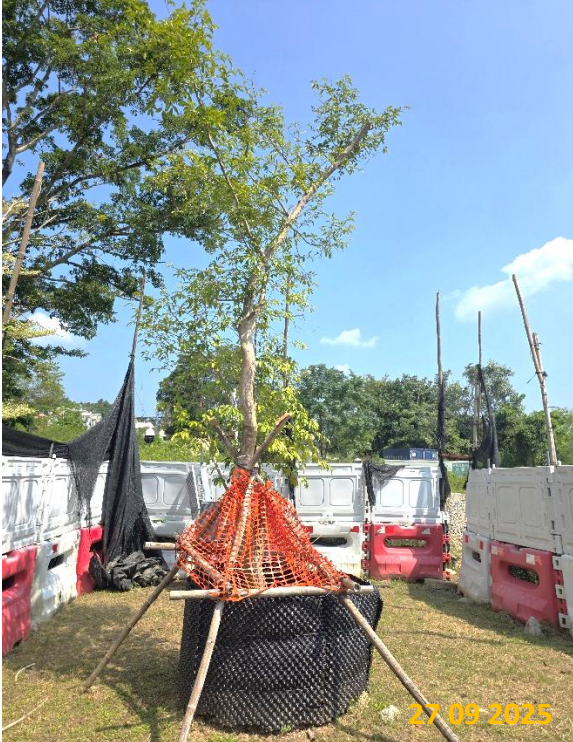
| No. | Species | | Conservation Status | Measurements | | | Tree Condition (Good(G) / Average(A) / Poor(P)) | | | Recommendation (Retain / Transplant / Remove) | Findings | Remark |
|---|---|---|---|---|---|---|---|---|---|---|---|---|
| A8<br>(T8996) | <i>Aquilaria sinensis</i> | 土沉香 | RPPHK;<br>Cap.586;<br>IUCN:VU | 110 | 5 | 4 | P | P | P | Transplant | The foliage density is low and further reduced after recent inclement weather events. No obvious wound wood production. Severity of the insect feeding was low. | Trunk wounds were observed before transplant operation. Shallow root. Sudden defoliation happened in May 2023 but recovered in Aug 2023. It was translocated to the temporary holding nursery on 29 Sep 2023. A branch (5cm) was broken due to typhoon in Oct 2023. Decaying wounds and exposed dead woods on trunk. |

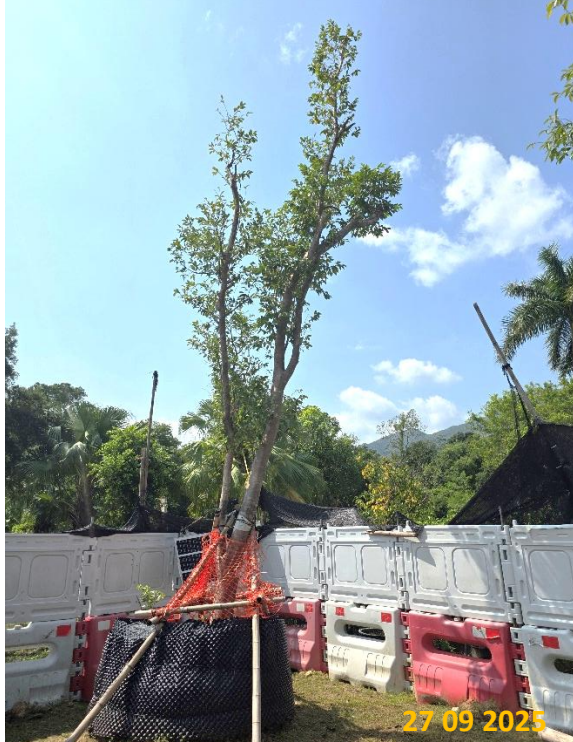
| No. | Species | | Conservation Status | Measurements | | | Tree Condition (Good(G) / Average(A) / Poor(P)) | | | Recommendation (Retain / Transplant / Remove) | Findings | Remark |
|---|---|---|---|---|---|---|---|---|---|---|---|---|
| A12<br>(T3537) | <i>Aquilaria sinensis</i> | 土沉香 | RPPHK;<br>Cap.586;<br>IUCN:VU | 185 | 8 | 3 | P | P | A | Transplant | The foliage density is low and further reduced after recent inclement weather events. No obvious wound wood production. Severity of the insect feeding was low. | Trunk wounds were observed before transplant operation. Shallow root. Original root ball was full of stones which were removed partially during the translocation. It was translocated to the temporary holding nursery on 29 Sep 2023. It collapsed during typhoon dated Oct 2023 resulted in largely reduction in foliage density. It was slightly lean after a typhoon event dated 13-14 Nov 2024 and reinstated. Decaying wounds and exposed dead woods on trunk. |
