Tree Schedule for Survey of Plant Species of Conservation Importance

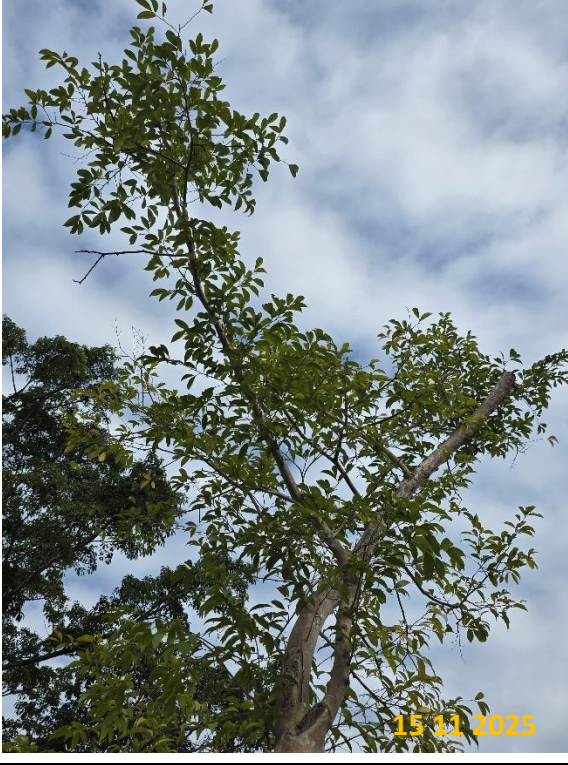
A8 – Overall view	A8 – Crown condition. Foliage density is low since Super Typhoon dated Sep 2025.

<p>A close-up photograph of the crown of tree A8, showing sparse green foliage against a cloudy sky. The date '15 11 2025' is printed in yellow at the bottom right.</p>
A8 – Pruning wound previously damaged by typhoon KOINU (Oct 2023)	A8 – Trunk and root condition.
