**Tree Schedule for Survey of Plant Species of Conservation Importance**

Tung Chung New Town Extension – Site Formation and Infrastructure Works at Tung Chung Valley, Phase 1

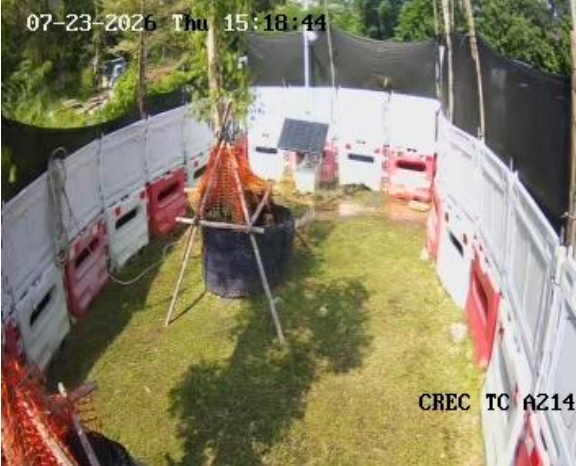
| <p>CCTV Screen captures at day-time</p> <p>07-23-2026 Thu 15:18:44</p> <p>CREC TC #214</p> | <p>CCTV Screen captures at day-time</p> <p>07-23-2026 Thu 15:18:46</p> <p>CREC TC #215</p> |

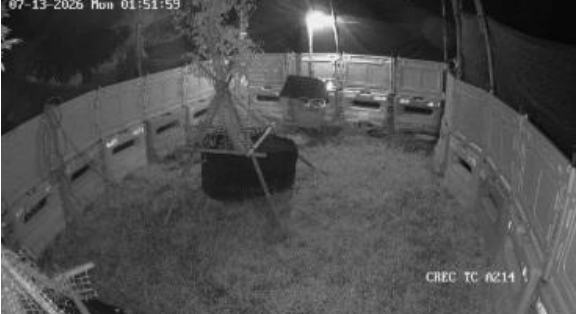
| <p>CCTV Screen captures at night-time</p> <p>07-13-2026 Mon 01:51:59</p> <p>CREC TC #214</p> | <p>CCTV Screen captures at night-time</p> <p>07-13-2026 Mon 01:21:57</p> <p>CREC TC #215</p> |
