**Tree Schedule for Survey of Plant Species of Conservation Importance**

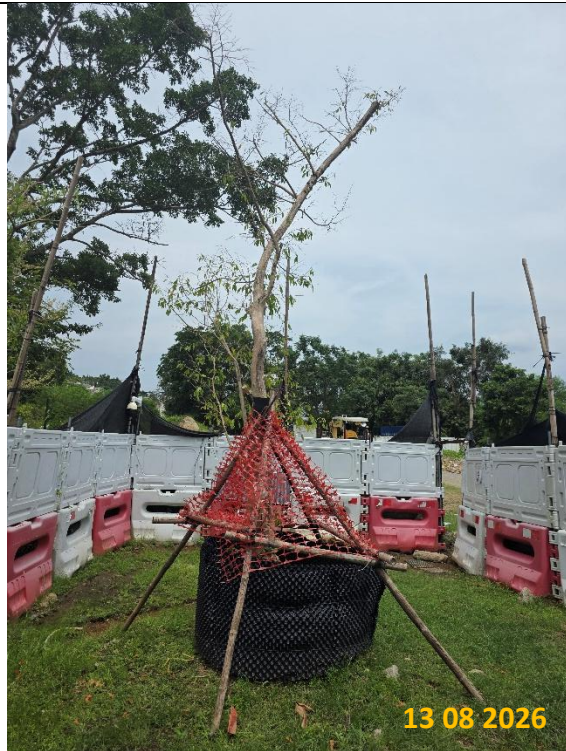
A8 – Overall view

| No. | Species | | Conservation Status | Measurements | | | Tree Condition (Good(G) / Average(A) / Poor(P)) | | | Recommendation (Retain / Transplant / Remove) | Findings | Remark |
|---|---|---|---|---|---|---|---|---|---|---|---|---|
| A8<br>(T8996) | <i>Aquilaria sinensis</i> | 土沉香 | RPPHK;<br>Cap.586;<br>IUCN:VU | 110 | 5 | 4 | P | P | P | Transplant | No obvious wound wood production.<br>Very low foliage density.<br>Dieback<br>Severity of the insect feeding was low. | Trunk wounds were observed before transplant operation. Shallow root. Sudden defoliation happened in May 2023 but recovered in Aug 2023. It was translocated to the temporary holding nursery on 29 Sep 2023. A branch (5cm) was broken due to typhoon in Oct 2023. Decaying wounds and exposed dead woods on trunk. The foliage density is low especially after inclement weather events on Aug/Sep 2025.<br>The tree recovered partially on Spring 2026. However recent heavy raining, hot weather on June and July resulted in the reduction in foliage density. Foliage density becomes very low after tropical cyclone warning signal No. 9 event. |

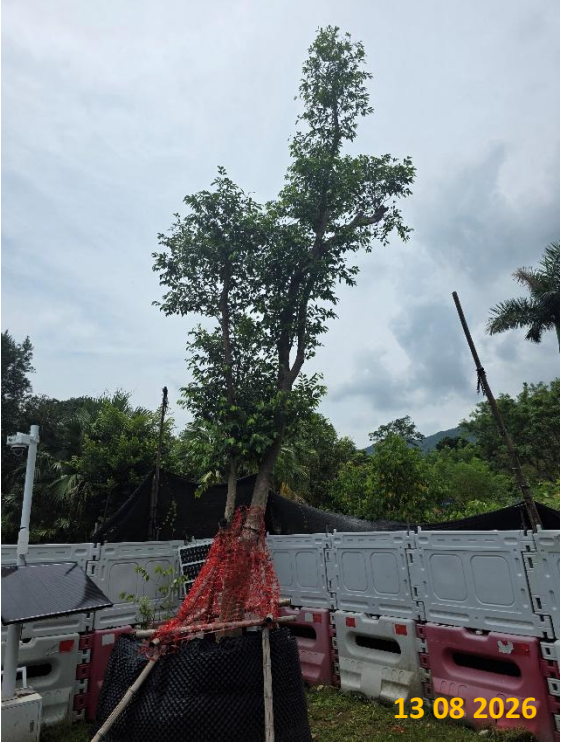
| <p>A12 - Overall View</p> <p>13 08 2026</p> | <p>A12 - Dieback observed.</p> <p>13 08 2026</p> |

| No. | Species | | Conservation Status | Measurements | | | Tree Condition (Good(G) / Average(A) / Poor(P)) | | | Recommendation (Retain / Transplant / Remove) | Findings | Remark |
|---|---|---|---|---|---|---|---|---|---|---|---|---|
| A12<br>(T3537) | <i>Aquilaria sinensis</i> | 土沉香 | RPPHK;<br>Cap.586;<br>IUCN:VU | 185 | 8 | 3 | P | P | A | Transplant | No obvious wound wood production.<br>Severity of the insect feeding was low. | Trunk wounds were observed before transplant operation. Shallow root. Original root ball was full of stones which were removed partially during the translocation.<br>It was translocated to the temporary holding nursery on 29 Sep 2023. It collapsed during typhoon dated Oct 2023 resulted in largely reduction in foliage density. It was slightly lean after a typhoon event dated 13-14 Nov 2024 and reinstated. Decaying wounds and exposed dead woods on trunk. The foliage density is low especially after inclement weather events on Aug/Sep 2025.<br>The tree recovered partially on Spring 2026. However recent heavy raining, hot weather on June and July resulted in the reduction in foliage density. |

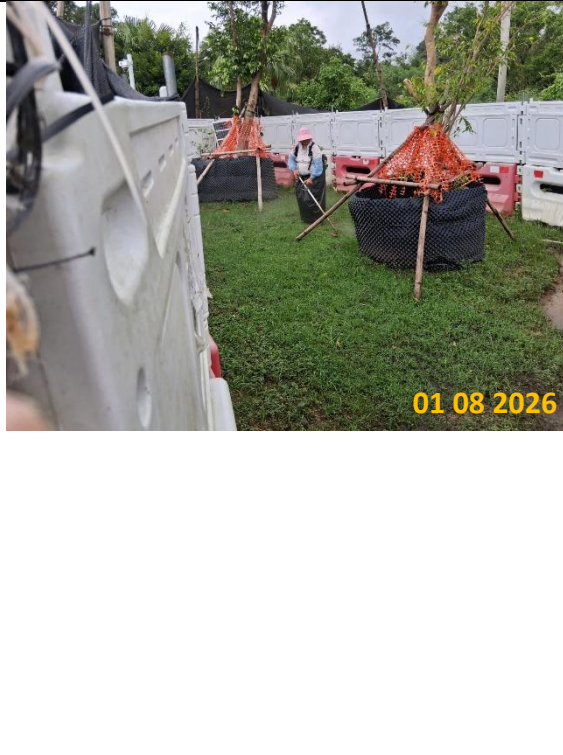
| <p>Fencing is in order during inspection</p> | <p>Grass cutting and weeding was conducted on 1 August 2026.</p> |
