**Agreement No. CE 64/2020 (EP)
Environmental Team for
Tung Chung New Town
Extension (West) –
Design and Construction**

Monthly Environmental Monitoring & Audit Report
for December 2024

Environmental Permit No. EP-519/2016

Tung Chung New Town Extension (West)

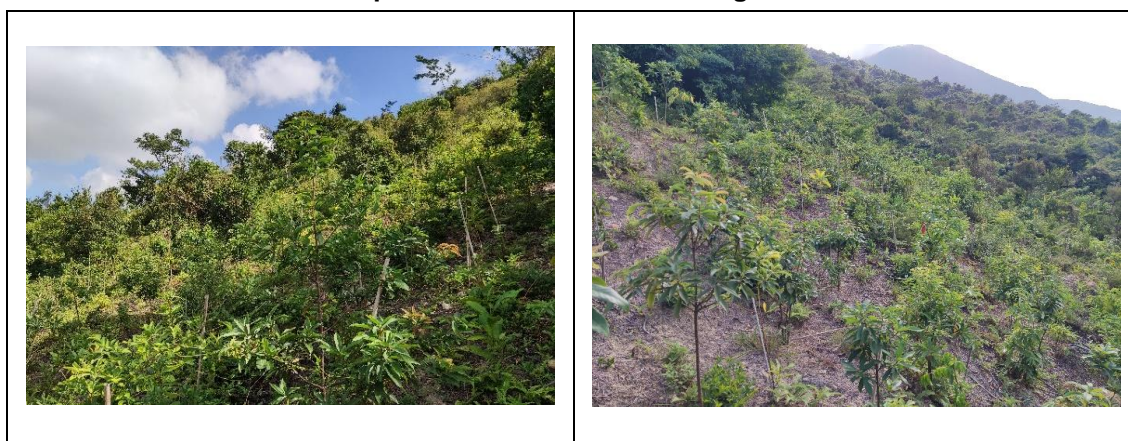
Table 7.6: Photos of the Compensation Woodland Planting

Compensation Woodland Planting was completed in May 2022. With the approval from EPD on the monitoring proposal in October 2022, the monitoring for Compensation Woodland was commenced in November 2022. Quarterly post-planting monitoring report for November 2024 was submitted to EPD on 27 December 2024. Photos of the Compensation Woodland planting are shown in **Table 7.6**.

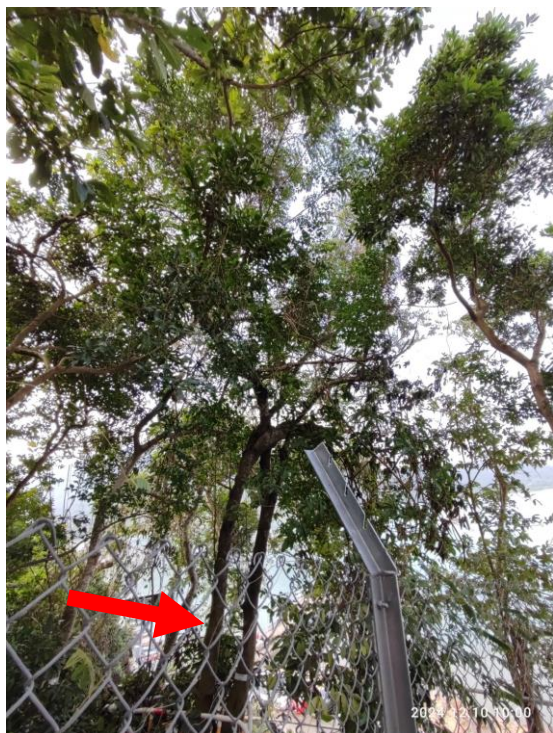
1: T8217

Peeling off of bark near trunk base was observed at the individual and internal decay was worsening with sounding test. Abnormal bark crack was observed at the individual. The risk of trunk failure was high as the trunk wound was significantly decayed. Adjustment of staking was carried out at the individual during the reporting period. Wound wood development was observed at the individual of *Gmelina chinensis* (Tree No. U042) under Contract 5. Reduced foliage density was observed at the individual due to seasonal variation. Root zone was partially restricted by existing slope surface. Application of insecticide on the wound was carried out. Crack on trunk base was found at the individual of *Aquilaria sinensis* (Tree No. U043) under Contract 5. Fungal fruiting bodies were found on the trunk and the trunk wound was significantly decayed. The trunk structure of the individual was weak. The structural condition of the individual would be kept monitoring by QB. Application of fungicide and insecticide were carried out at U041 and U043. Trunk protection pads were readjusted for U041, U042 and U043. No specific observations were made for the individual of *Canthium dicoccum* (Tree No. T8217) during the reporting period.

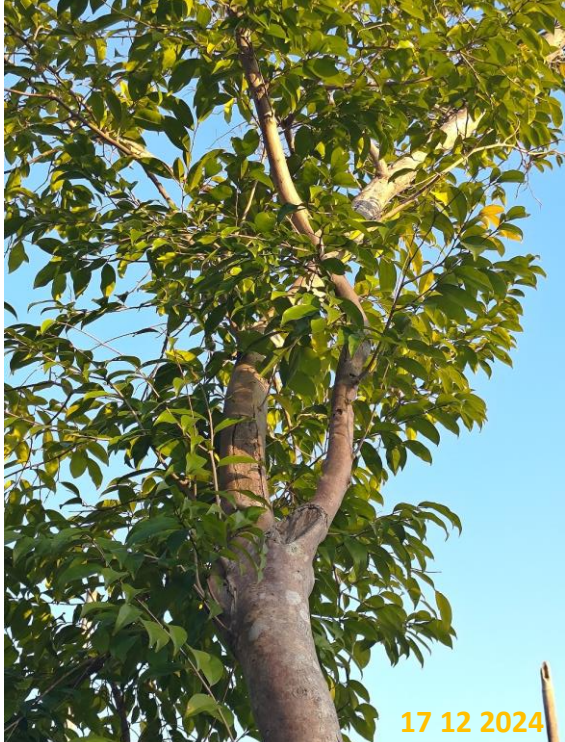
<p>17 12 2024</p> <p>This photograph shows a close-up of a pruning wound on the trunk of tree A8. The wound is a vertical cut in the bark, showing the underlying wood. The surrounding leaves are green.</p>	<p>A8 – Trunk and root condition.</p>

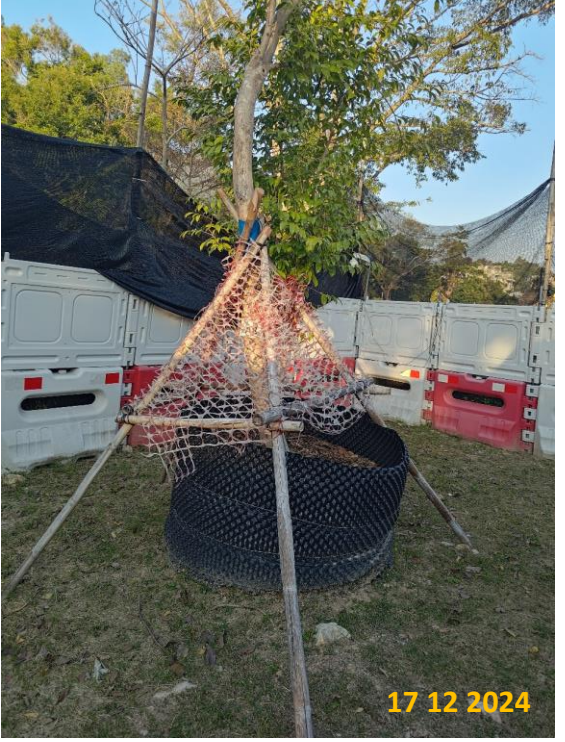
<p>17 12 2024</p> <p>This photograph shows the trunk and root area of tree A8. The tree is supported by a black mesh structure held up by wooden poles. In the background, there are white and red plastic barriers and other trees. The sky is clear and blue.</p>

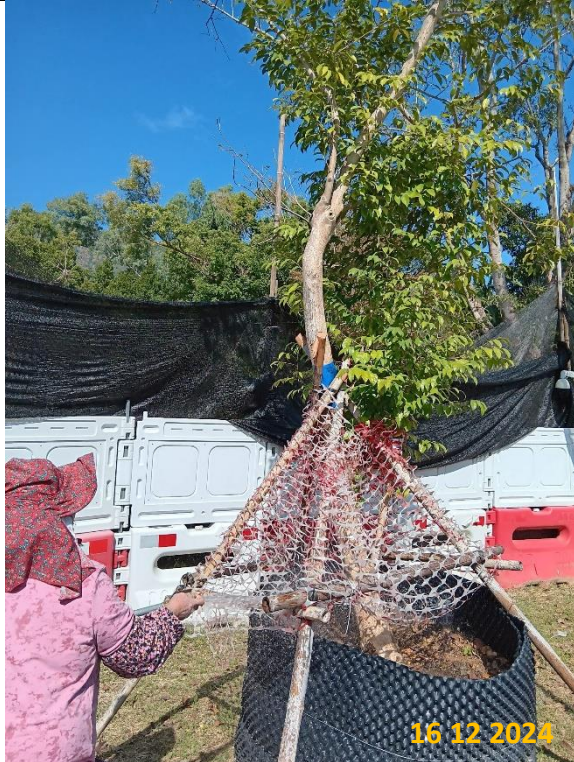
Manual watering was carried out for A8 during the reporting period. The watering frequency is one to two times per week.

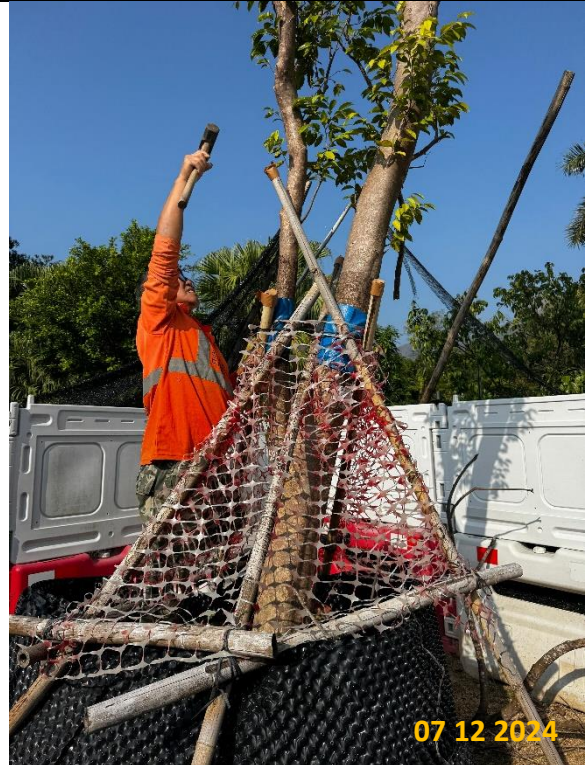
Adjustment on staking was done on 07/12/2024
